# Montana Department of Corrections

## Biennial Report on Heritage Properties

2018 - 2019

The Montana Department of Corrections  
Biennial Report on Heritage Properties  
2018 – 2019

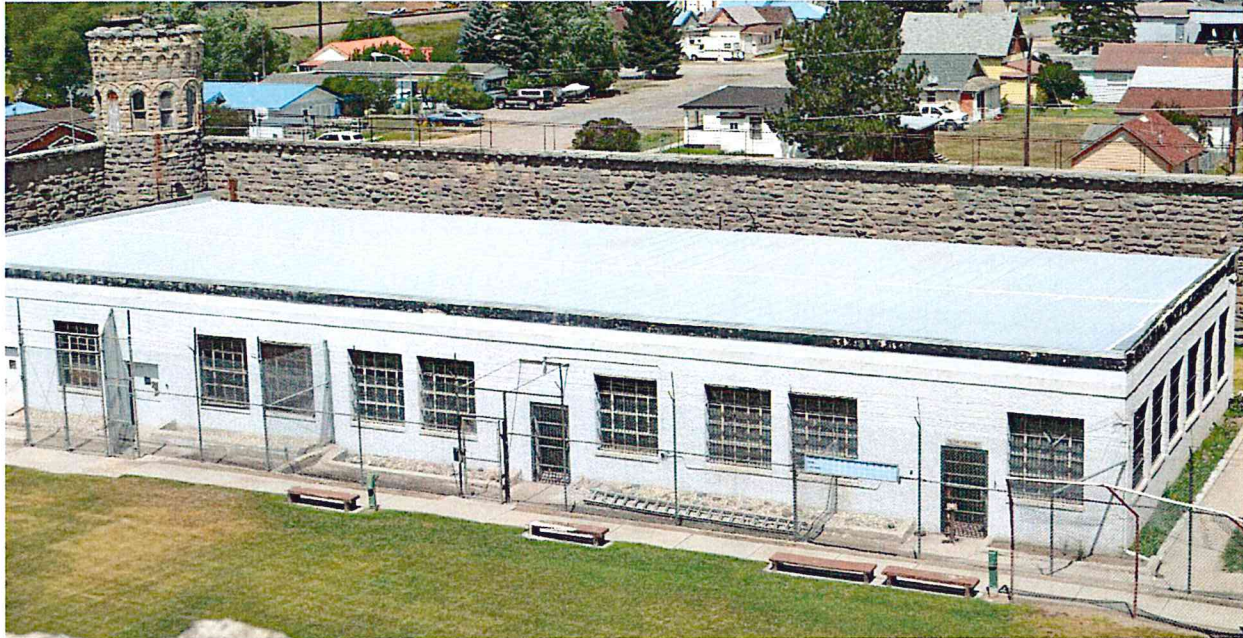
Administration Building – Old Roof

1. **Replaced 12,500 square feet of the ballast covered roof on the Administration Building (HS8). This was previously identified as Priority #2 on the 2016 – 2017 Historical Structure Report.** The roof replacement began in July 2018 and was completed on July 26<sup>th</sup>, 2019. The total project cost was \$76,600. Funding in the amount of \$50,000 was received through a Montana Department of Tourism and Development grant. The remaining \$26,200 was funded through Foundation revenues. The project was contracted to AMBS Roofing Company and the Department of Corrections (DOC) Fire Crew assisted with demolition. Roof replacement included: Adding a frame structure to the north end of the building to slope the roof, allowing water to drain away from the building; covering existing drain holes in the vented gutter; installing collection boxes and down spouts; installation of Celotex board and reinforced ethylene propylene diene terpolymer (EPDM) rubber roofing; and installation of termination bars on perimeter, sidewall and eaves. Pictures of the roof replacement are provided in **Attachment B**.

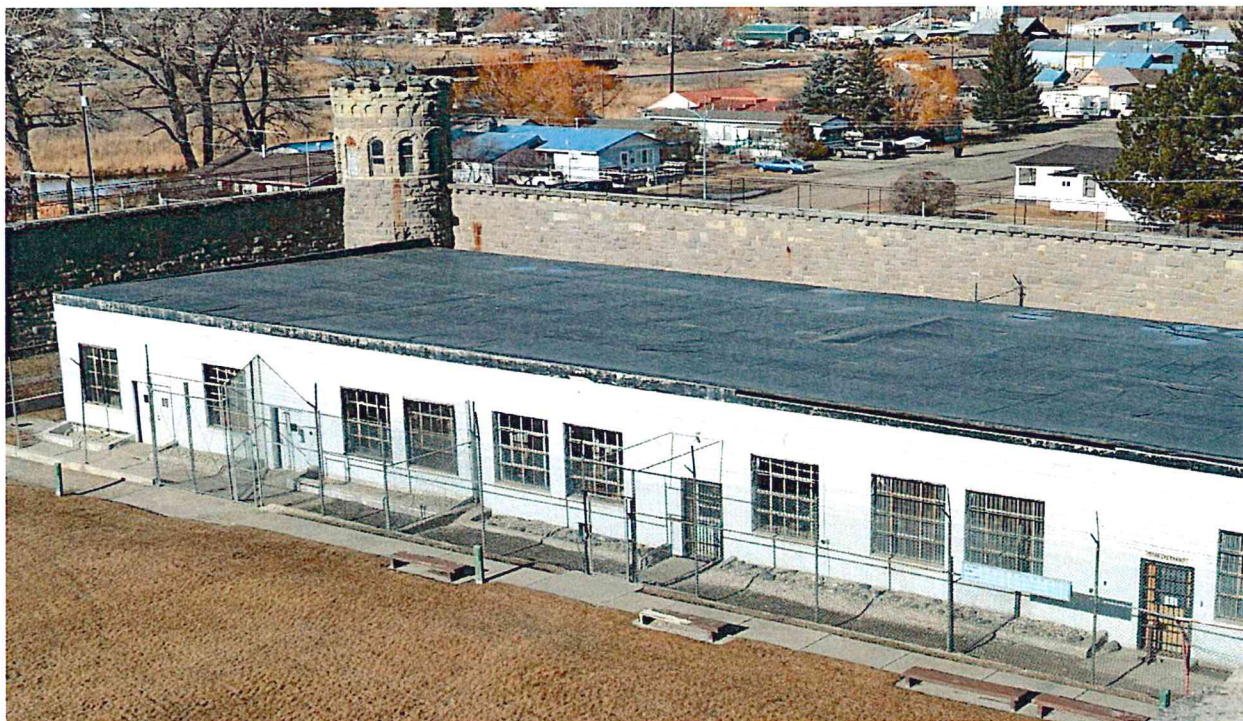
Administration Building – New Roof 2019

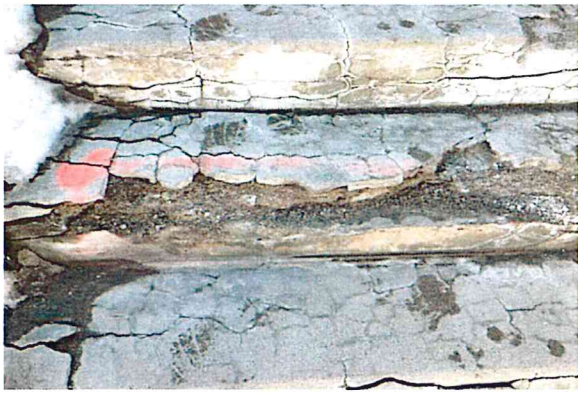
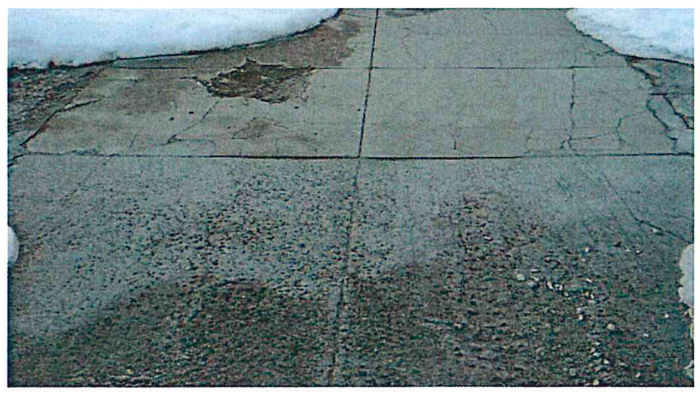
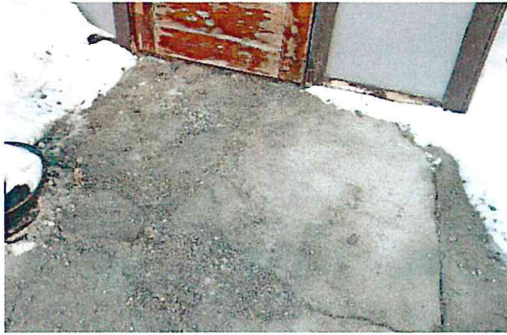
Steps and sidewalk examples before repairs

3. **265' of 4' wide x 4" thick sidewalk was replaced throughout the complex. In addition, replaced a section of the concrete stairs entering the Administration Building (HS8) were replaced.** The sidewalk replacement began in June of 2019 and was completed in September 2019. The work was performed by the Powell County Museum (Museum) maintenance staff, the DOC Fire Crew and the DOC Community Workers assigned to the Museum. The total cost of materials was \$4,000. Pictures of the sidewalk and step replacement are provided in Attachment B.

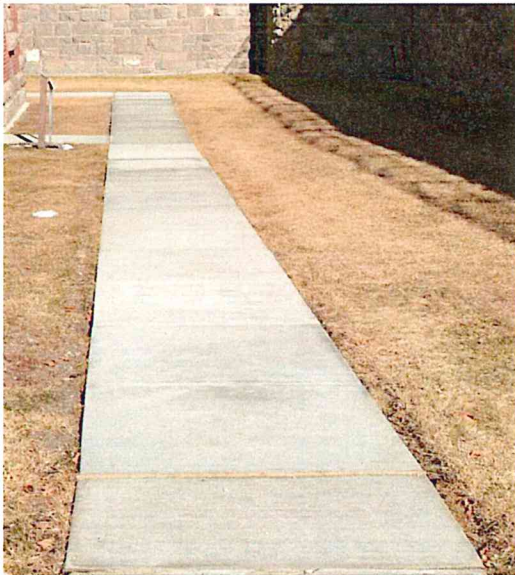
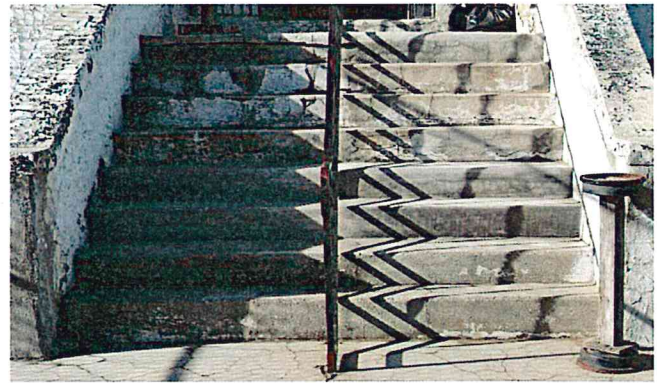
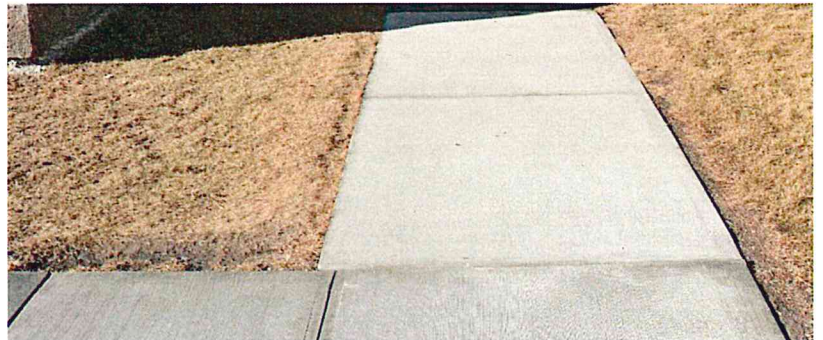
Sidewalk repair examples  
2019
