# Montana Department of Corrections

## Biennial Report on Heritage Properties

2016 – 2017

Report to the Montana Preservation Review Board

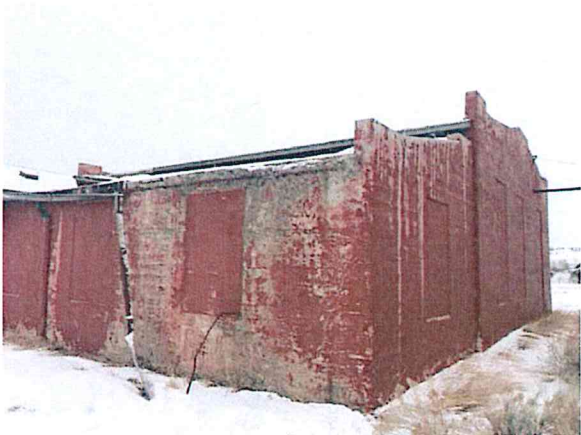
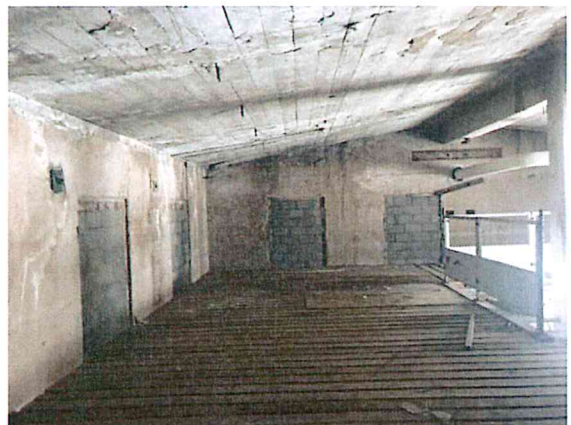
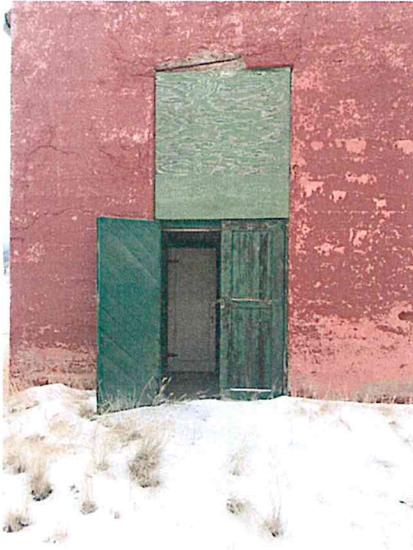
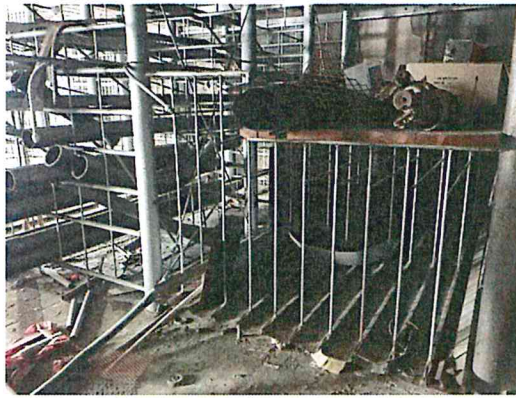
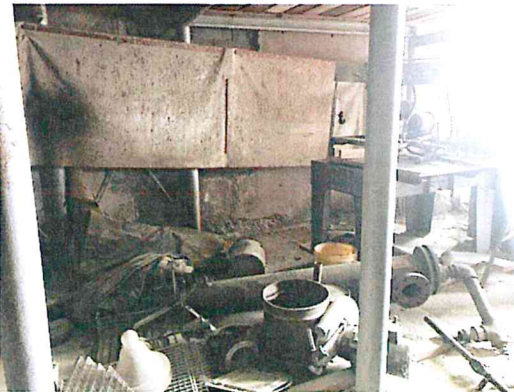
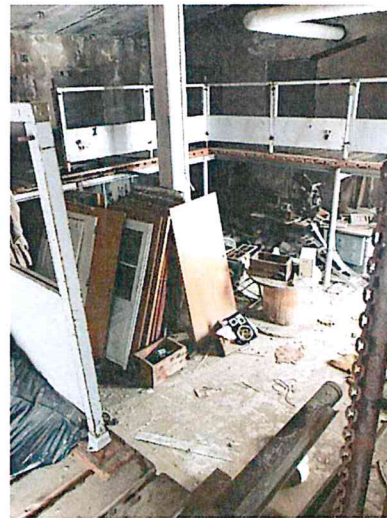
### Continued Pictures – Old Laundry #23

1. **Old Laundry - #23:** This building has never been occupied by the Department of Corrections. Staff stated they had not been in the building since Riverside was established in Boulder. The power has been disconnected and there is no water service to the building. The exterior of the building is brick and cement block with a dark red paint. The interior of the building is cluttered and appears to be used for storage. There are old windows, doors and light fixtures along with miscellaneous pieces of parts and equipment scattered throughout. There is a loft area which is partially used for storage and the remainder is vacant. The building needs to be cleaned out and evaluated for structural integrity.

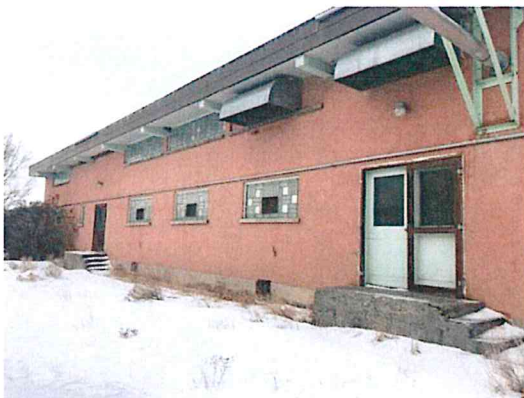
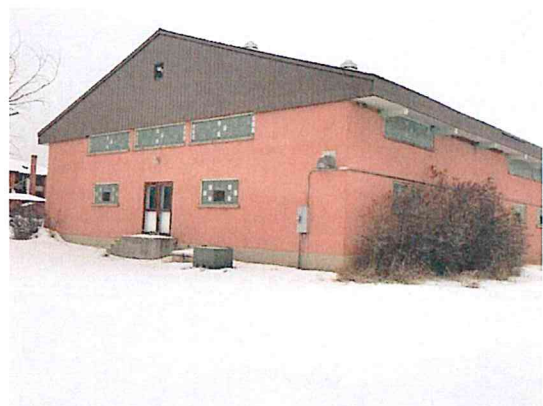
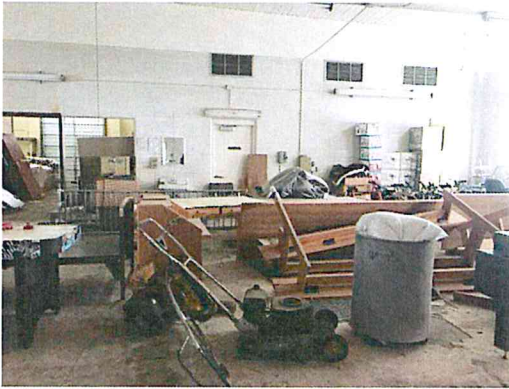
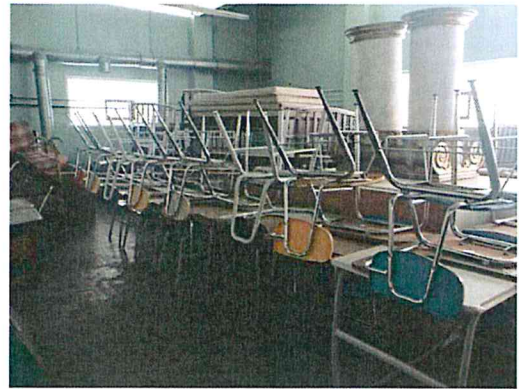
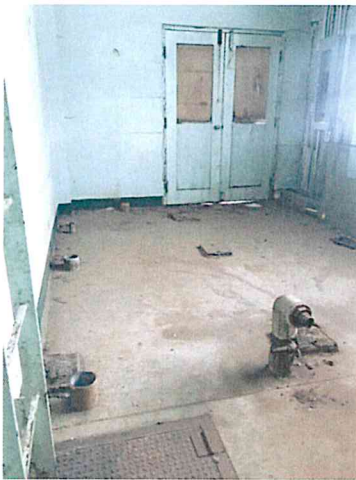
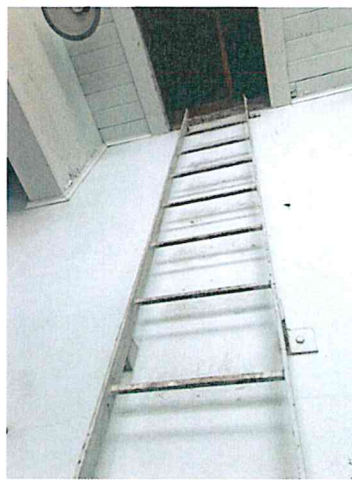
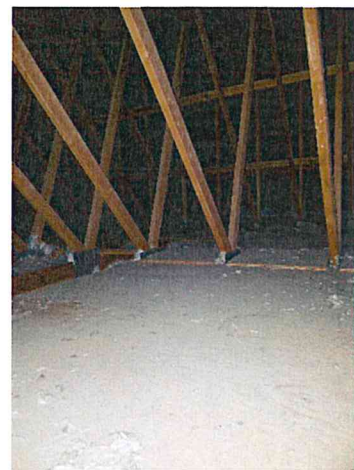
### Continued Pictures – Laundry #24

2. **Laundry - #24:** This building has been used by the Department of Corrections since Riverside was established in Boulder. The building appears in good structural shape. The main floor of the building is currently used for cold storage and what appears as a “dumping ground” for unused or unneeded items. There is an attic area that is accessible through a ladder into the ceiling that is vacant. The building needs to be cleaned out and the use re-evaluated.

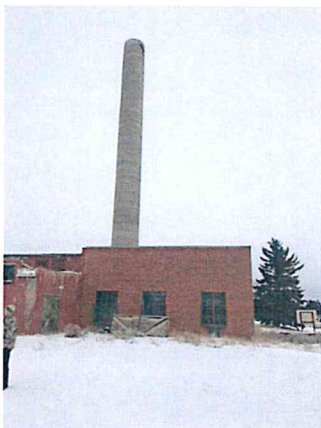
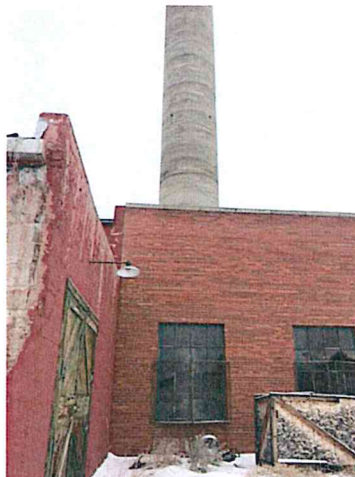
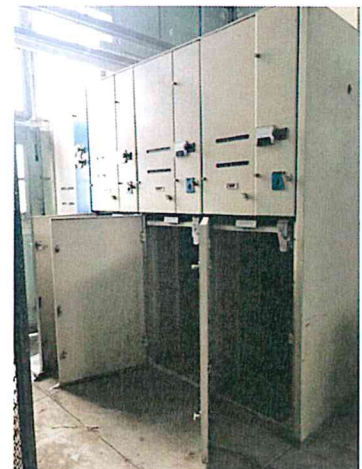
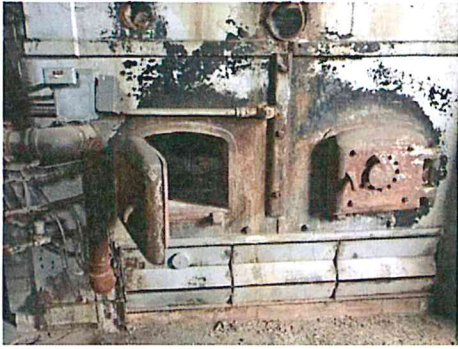
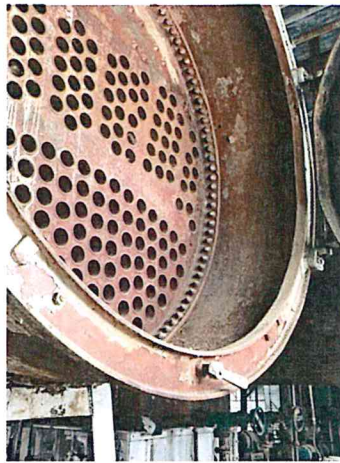
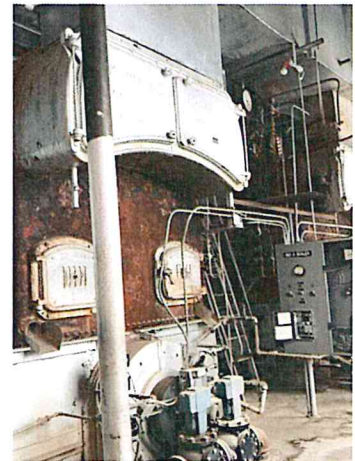
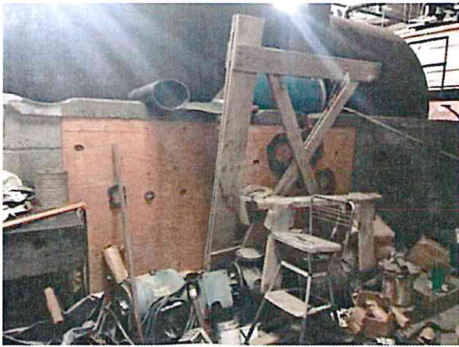
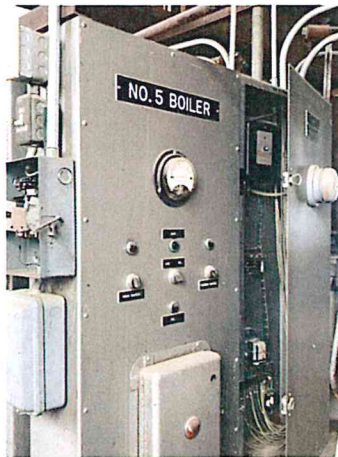
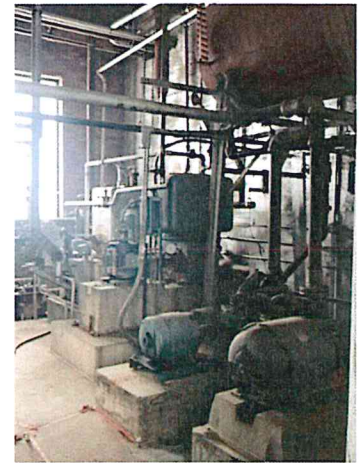
### Continued Pictures – Powerhouse #44

3. **Powerhouse - #44:** This building has never been occupied by the Department of Corrections. Staff stated they had not been in the building since Riverside was established in Boulder. It appears one day someone walked out and shut the lights off as there are calendars on the wall for 1996. The power has been disconnected and there is no water service to the building. The exterior of the building is brick and cement block with a dark red paint. The interior of the building still houses the five old boilers that ran the campus. In addition, there are several generator parts and odds and ends of equipment, parts and clutter at need to be removed. The boilers need to stay intact.

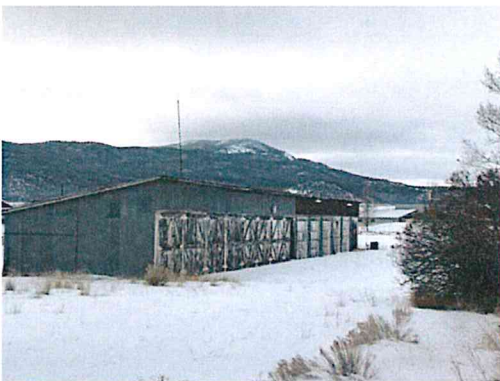
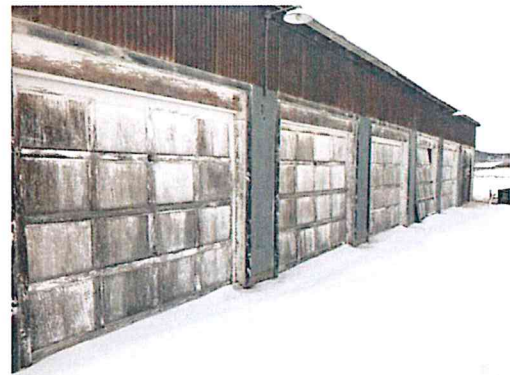
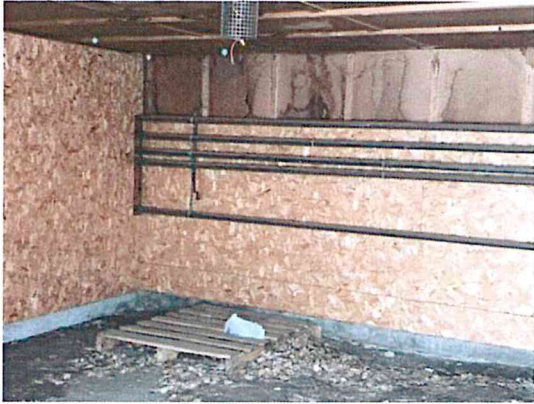
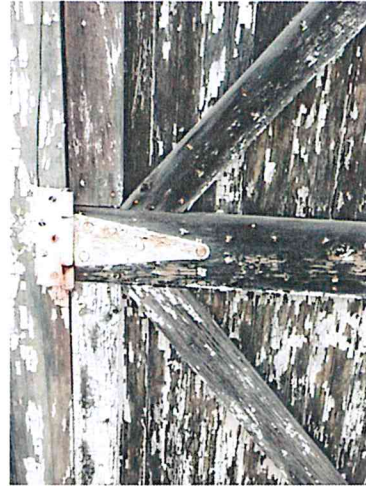
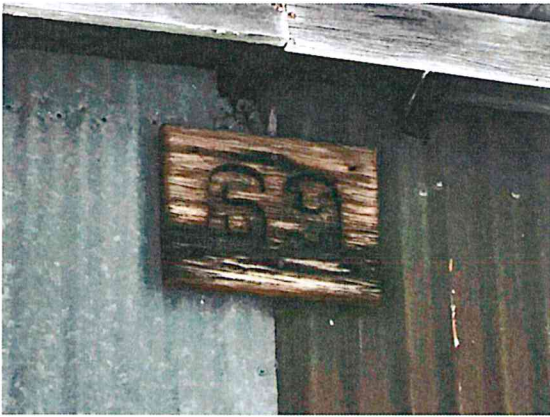
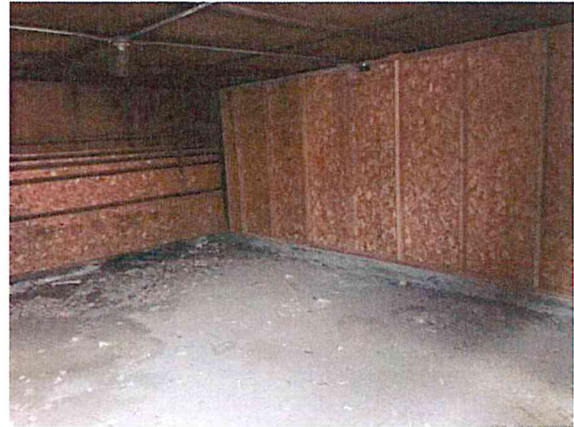
**Continued Pictures – Garage #69**

4. **Garage - #69:** This building is not currently used by the Department of Corrections. There are several empty bays in the garage. The power has been disconnected and there is no water service to the building. Two of the bays are currently being used by the Youth Dynamics Program for storage. The building appears to be in good condition with very little, if anything, in the stalls. The doors are not in good working condition.

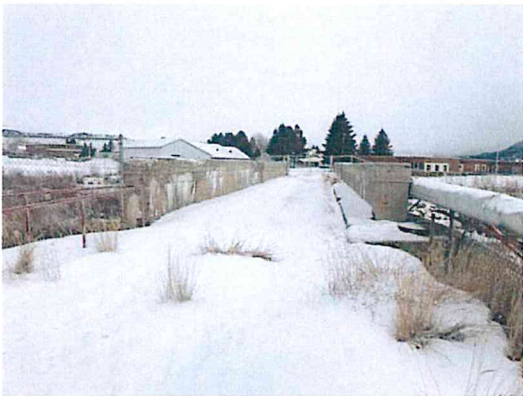
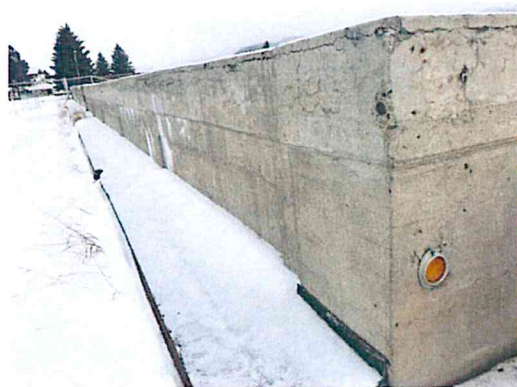
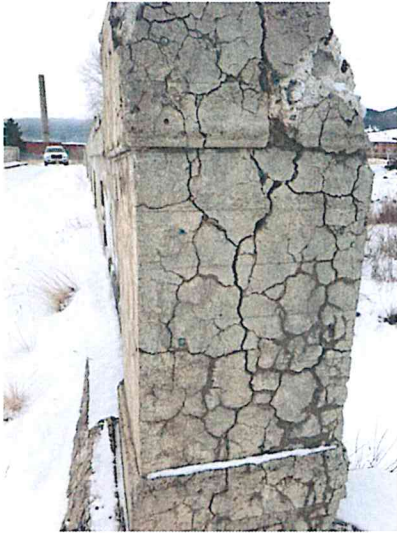
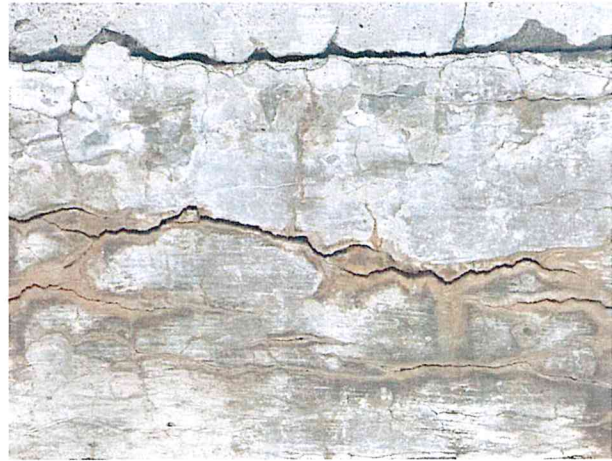
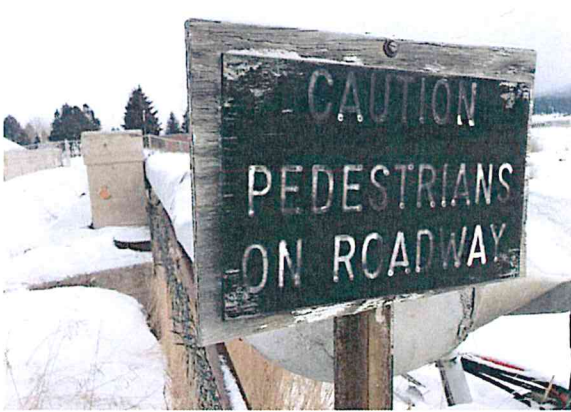
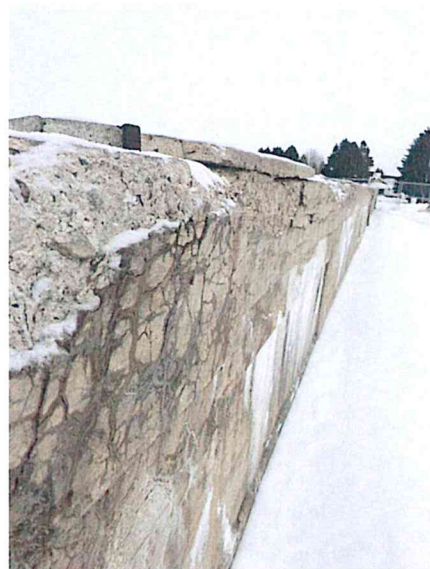
### Continued Bridge - #71

5. Bridge - #71: The bridge structure is in poor condition and can only be used for pedestrian traffic. I do not have any additional information on the bridge.
