DEPARTMENT OF ADMINISTRATION'S SIXTH BIENNIAL
STATE-OWNED HERITAGE PROPERTIES

Presented to the Preservation Review Board Pursuant to MCA 22-3-42 (4)

February 2022

FACILITIES CONDITION ASSESSMENT SUMMARY REPORT

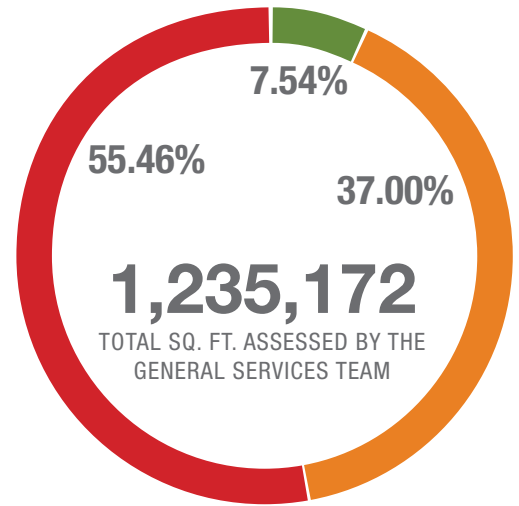
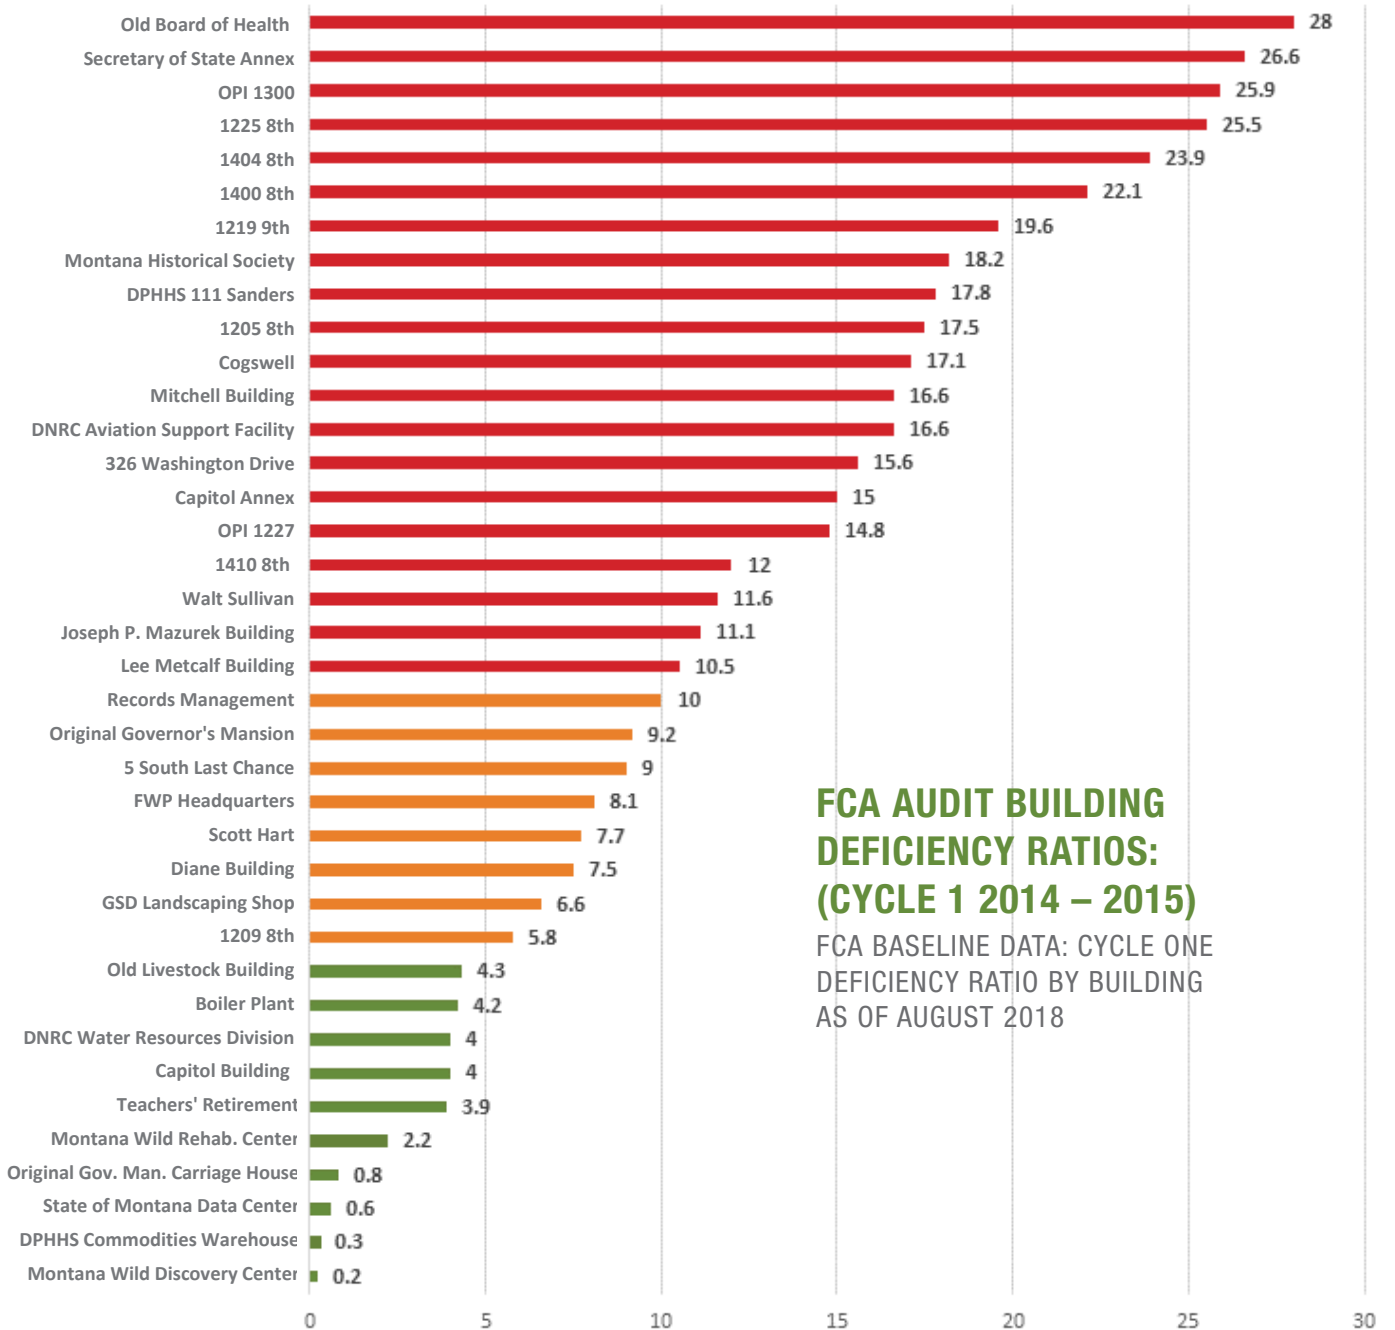
SQUARE FOOTAGE CONDITION BREAKDOWN

PERCENT OF TOTAL
685,026	55.46%
SQUARE FOOTAGE RATED AS FAIR

PERCENT OF TOTAL
457,053	37.00%
SQUARE FOOTAGE RATED AS GOOD  	PERCENT OF TOTAL
93,093	7.54%
