Montana Historical Society
Biennial Report on State-Owned Heritage Properties
to the Preservation Review Board
Pursuant to MCA 22-3-424 (4)
February 1, 2016

2015 Bridge Inspection report summary (excerpt)

Images from bridge inspection

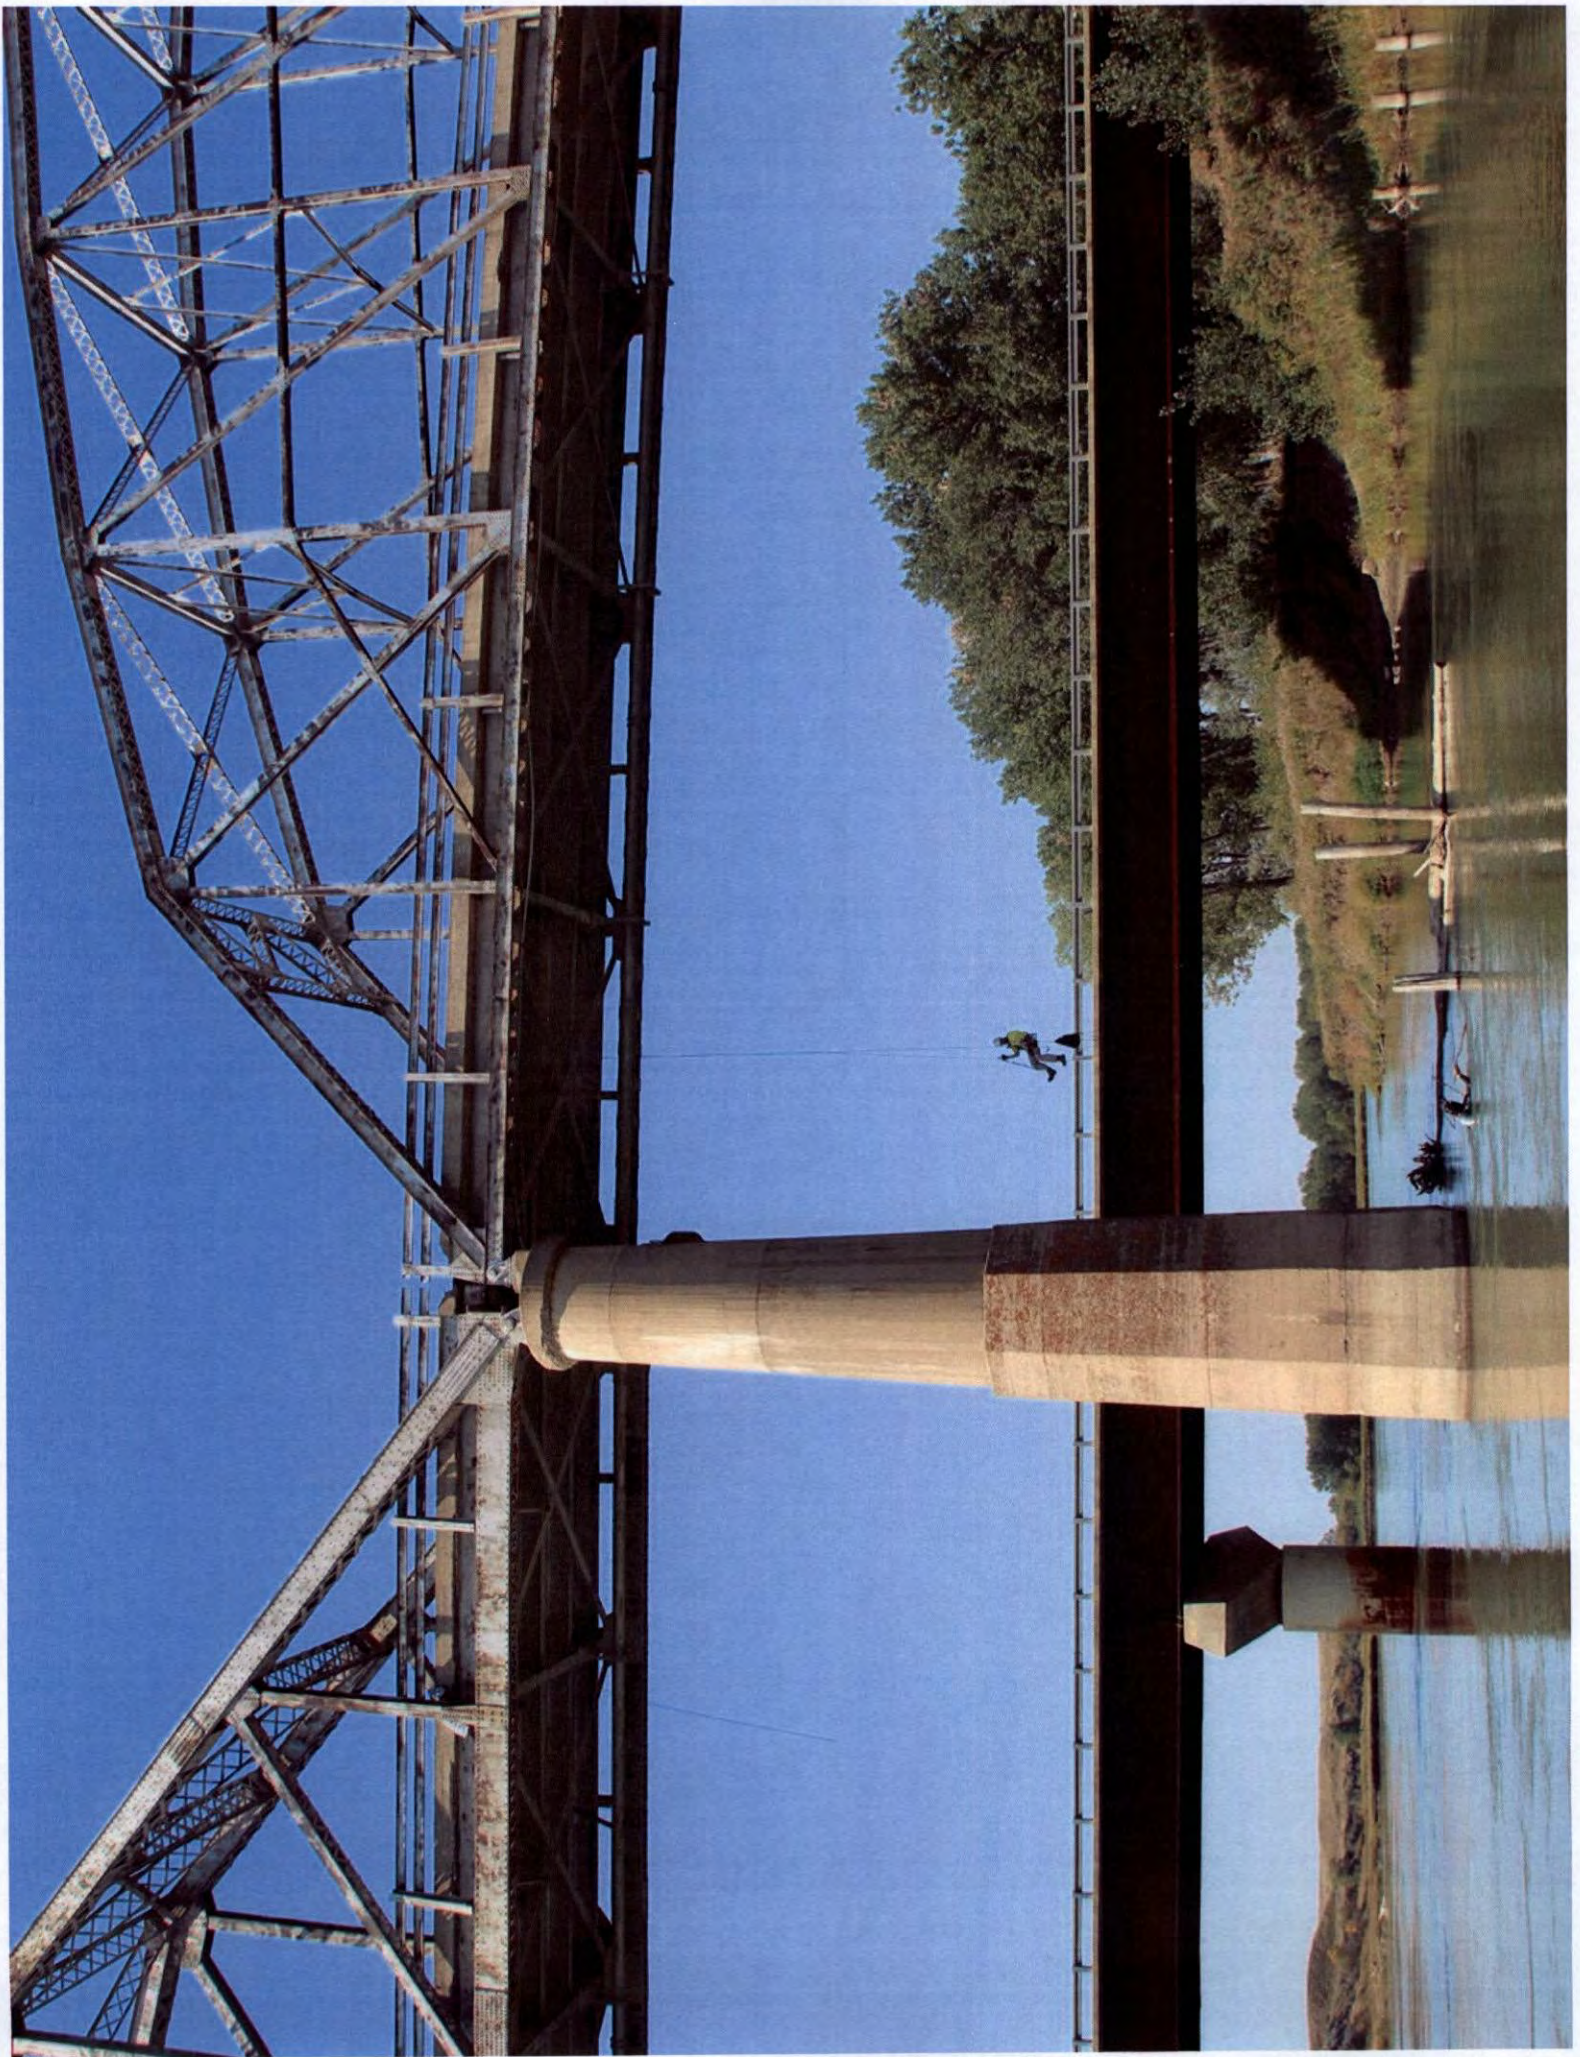
The steel truss is in fair condition. Visual inspection of the truss from the deck, combined with targeted close-up drone and climbing inspection of a sampling of the connections, revealed no major deterioration or deformation. There is significant coating failure (paint loss) throughout the truss. See attached "Truss Paint Loss" photo.

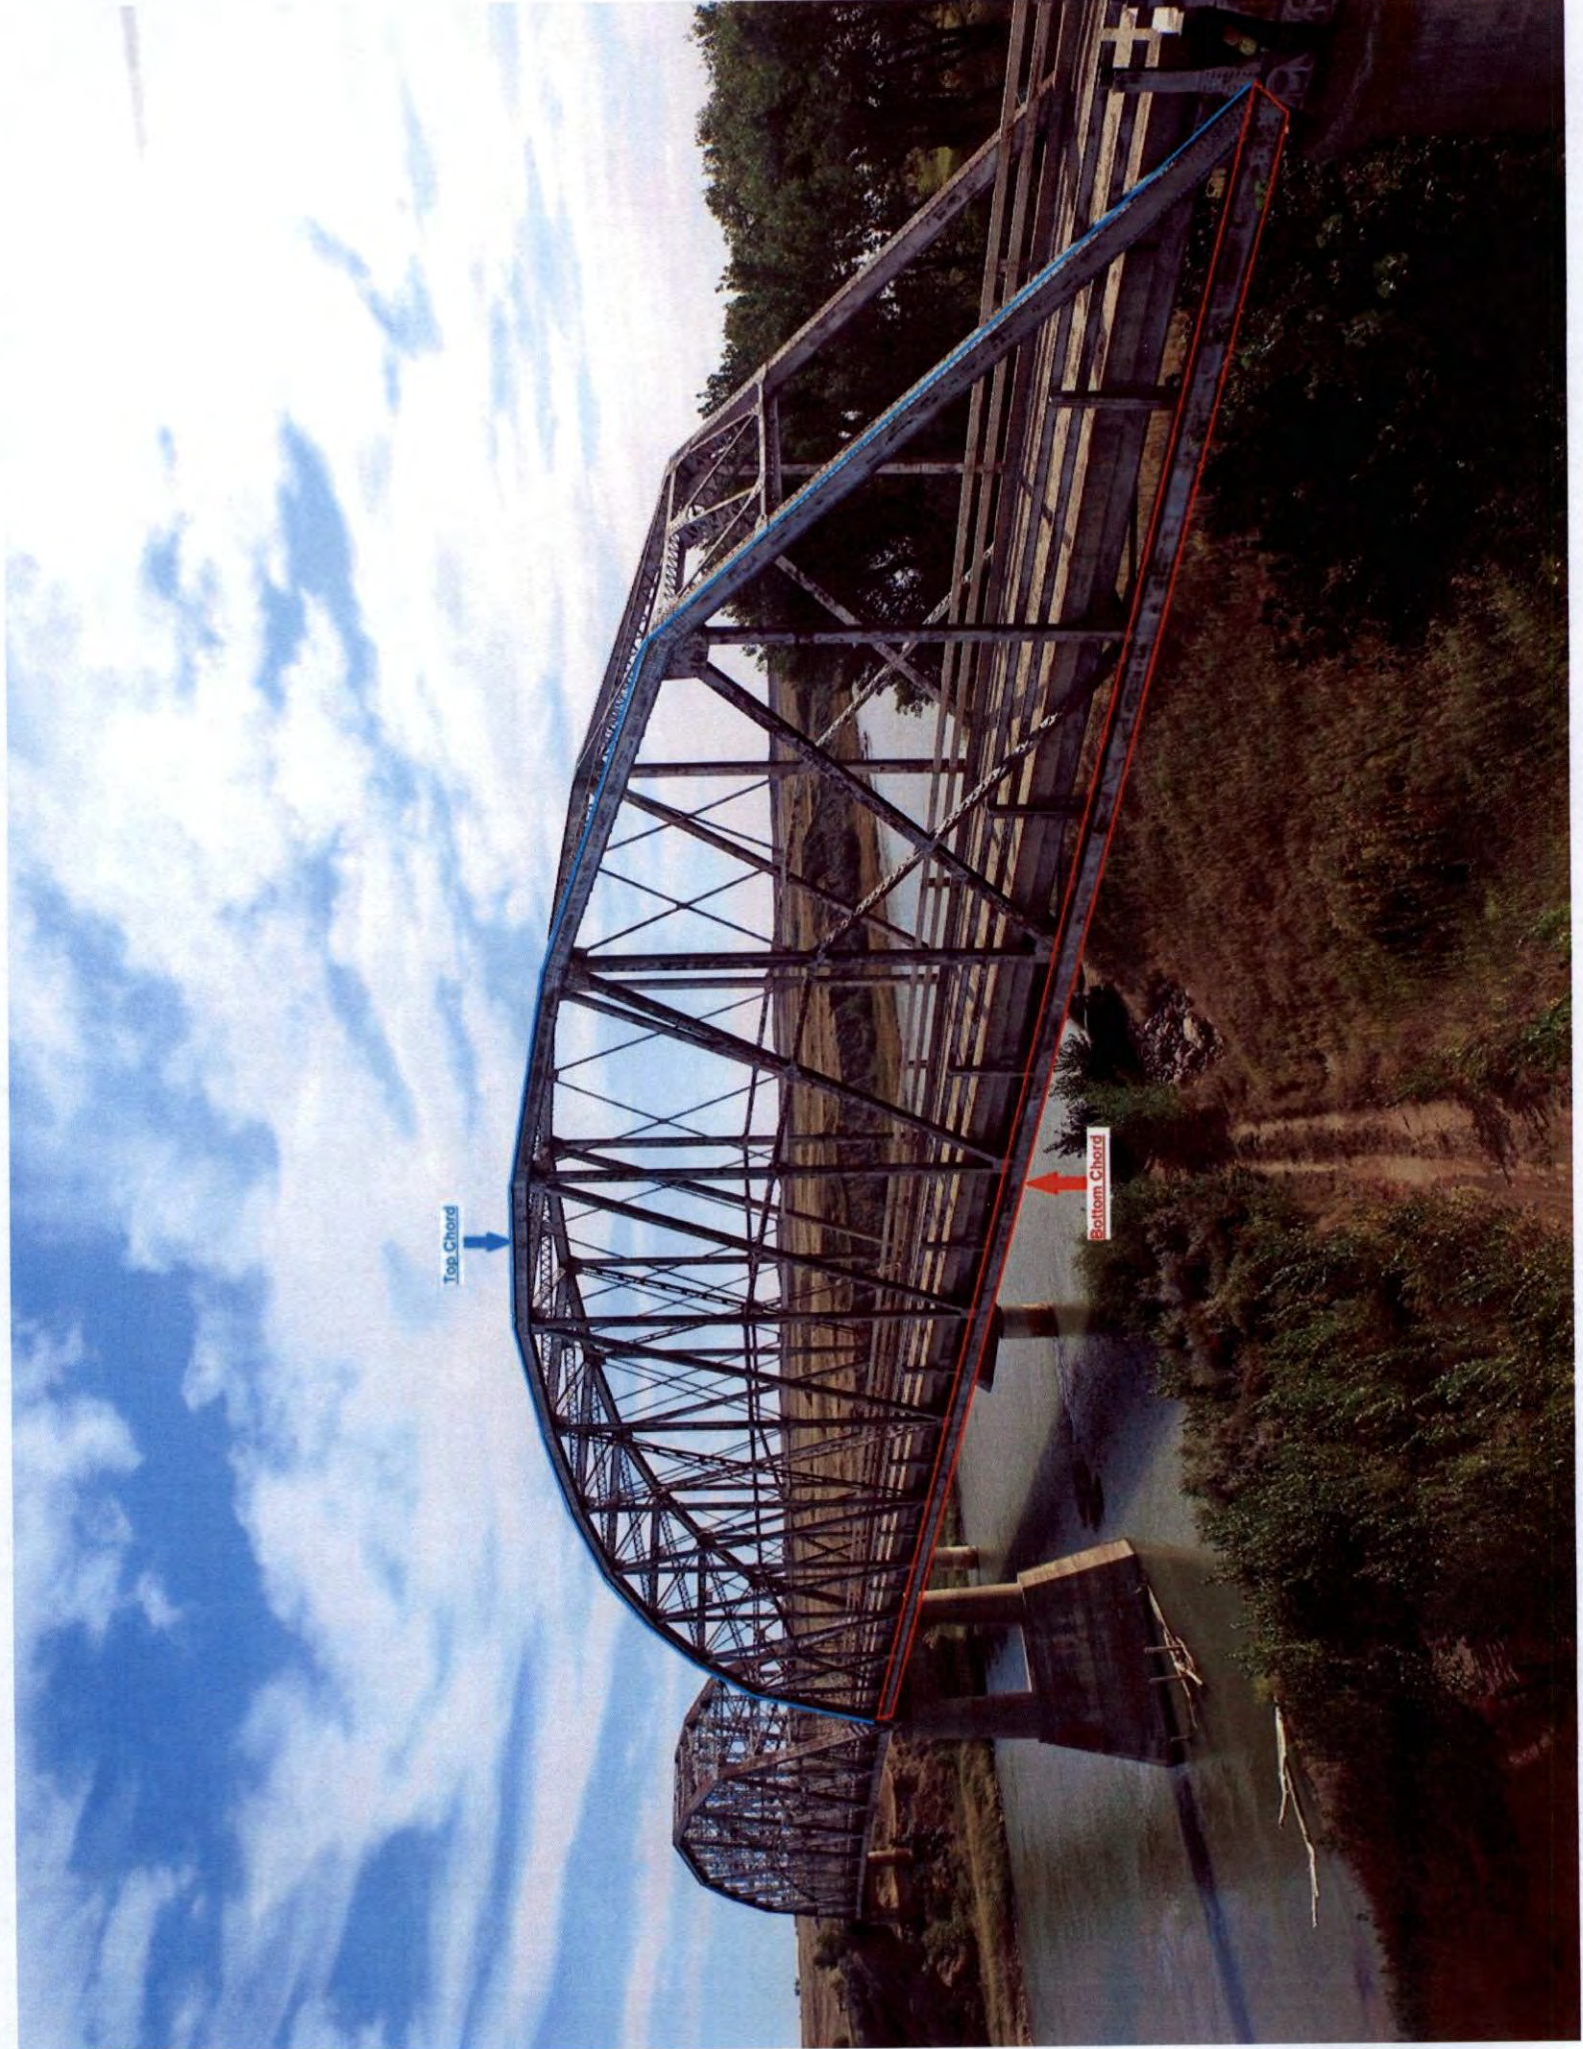
- The floorbeams in the truss spans are in fair condition. There is minor to moderate corrosion with flaking at several floor beam connections to the lower cord (bottom horizontal members of the truss - see attached "Truss" photo). This is typical of a structure of this age and level of service. See attached "Floorbeam corrosion" photo.

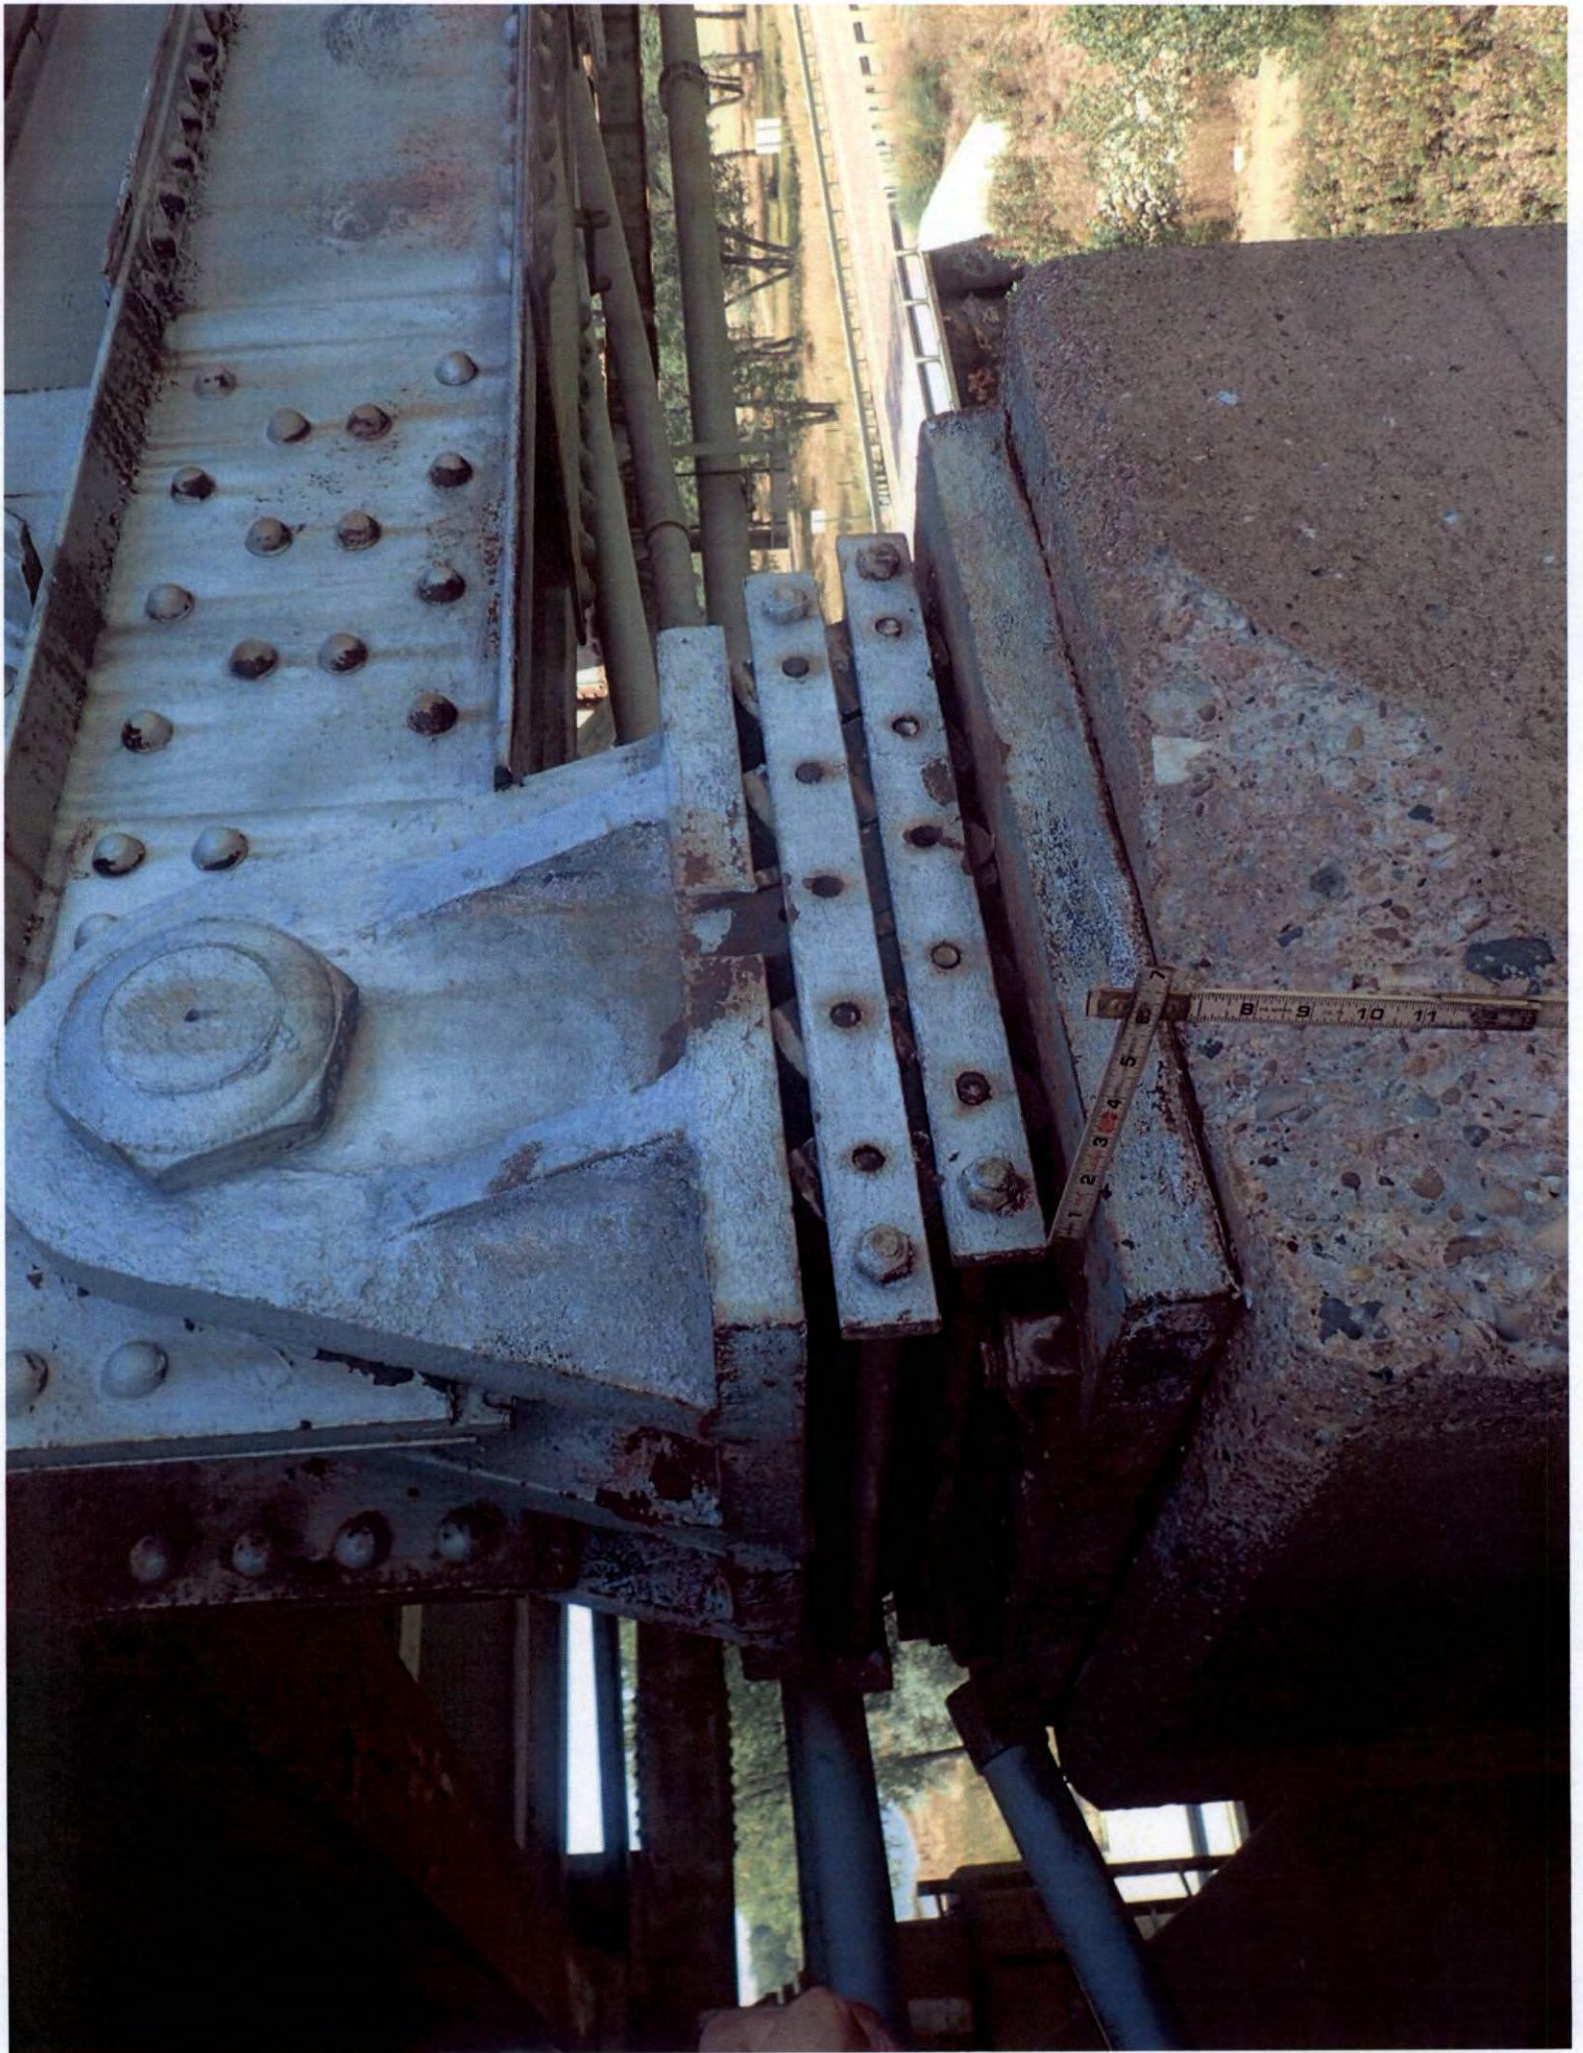
Transverse

- o The deck underside has widespread transverse cracks with efflorescence (salts and other minerals that leach out of cracks in concrete leaving a white stain, indicating water flow).

- § "Transverse" means oriented parallel to the width of the bridge, as opposed to "Longitudinal" cracks that are oriented parallel to the length of the bridge. See attached "Transverse vs Longitudinal" Photo.

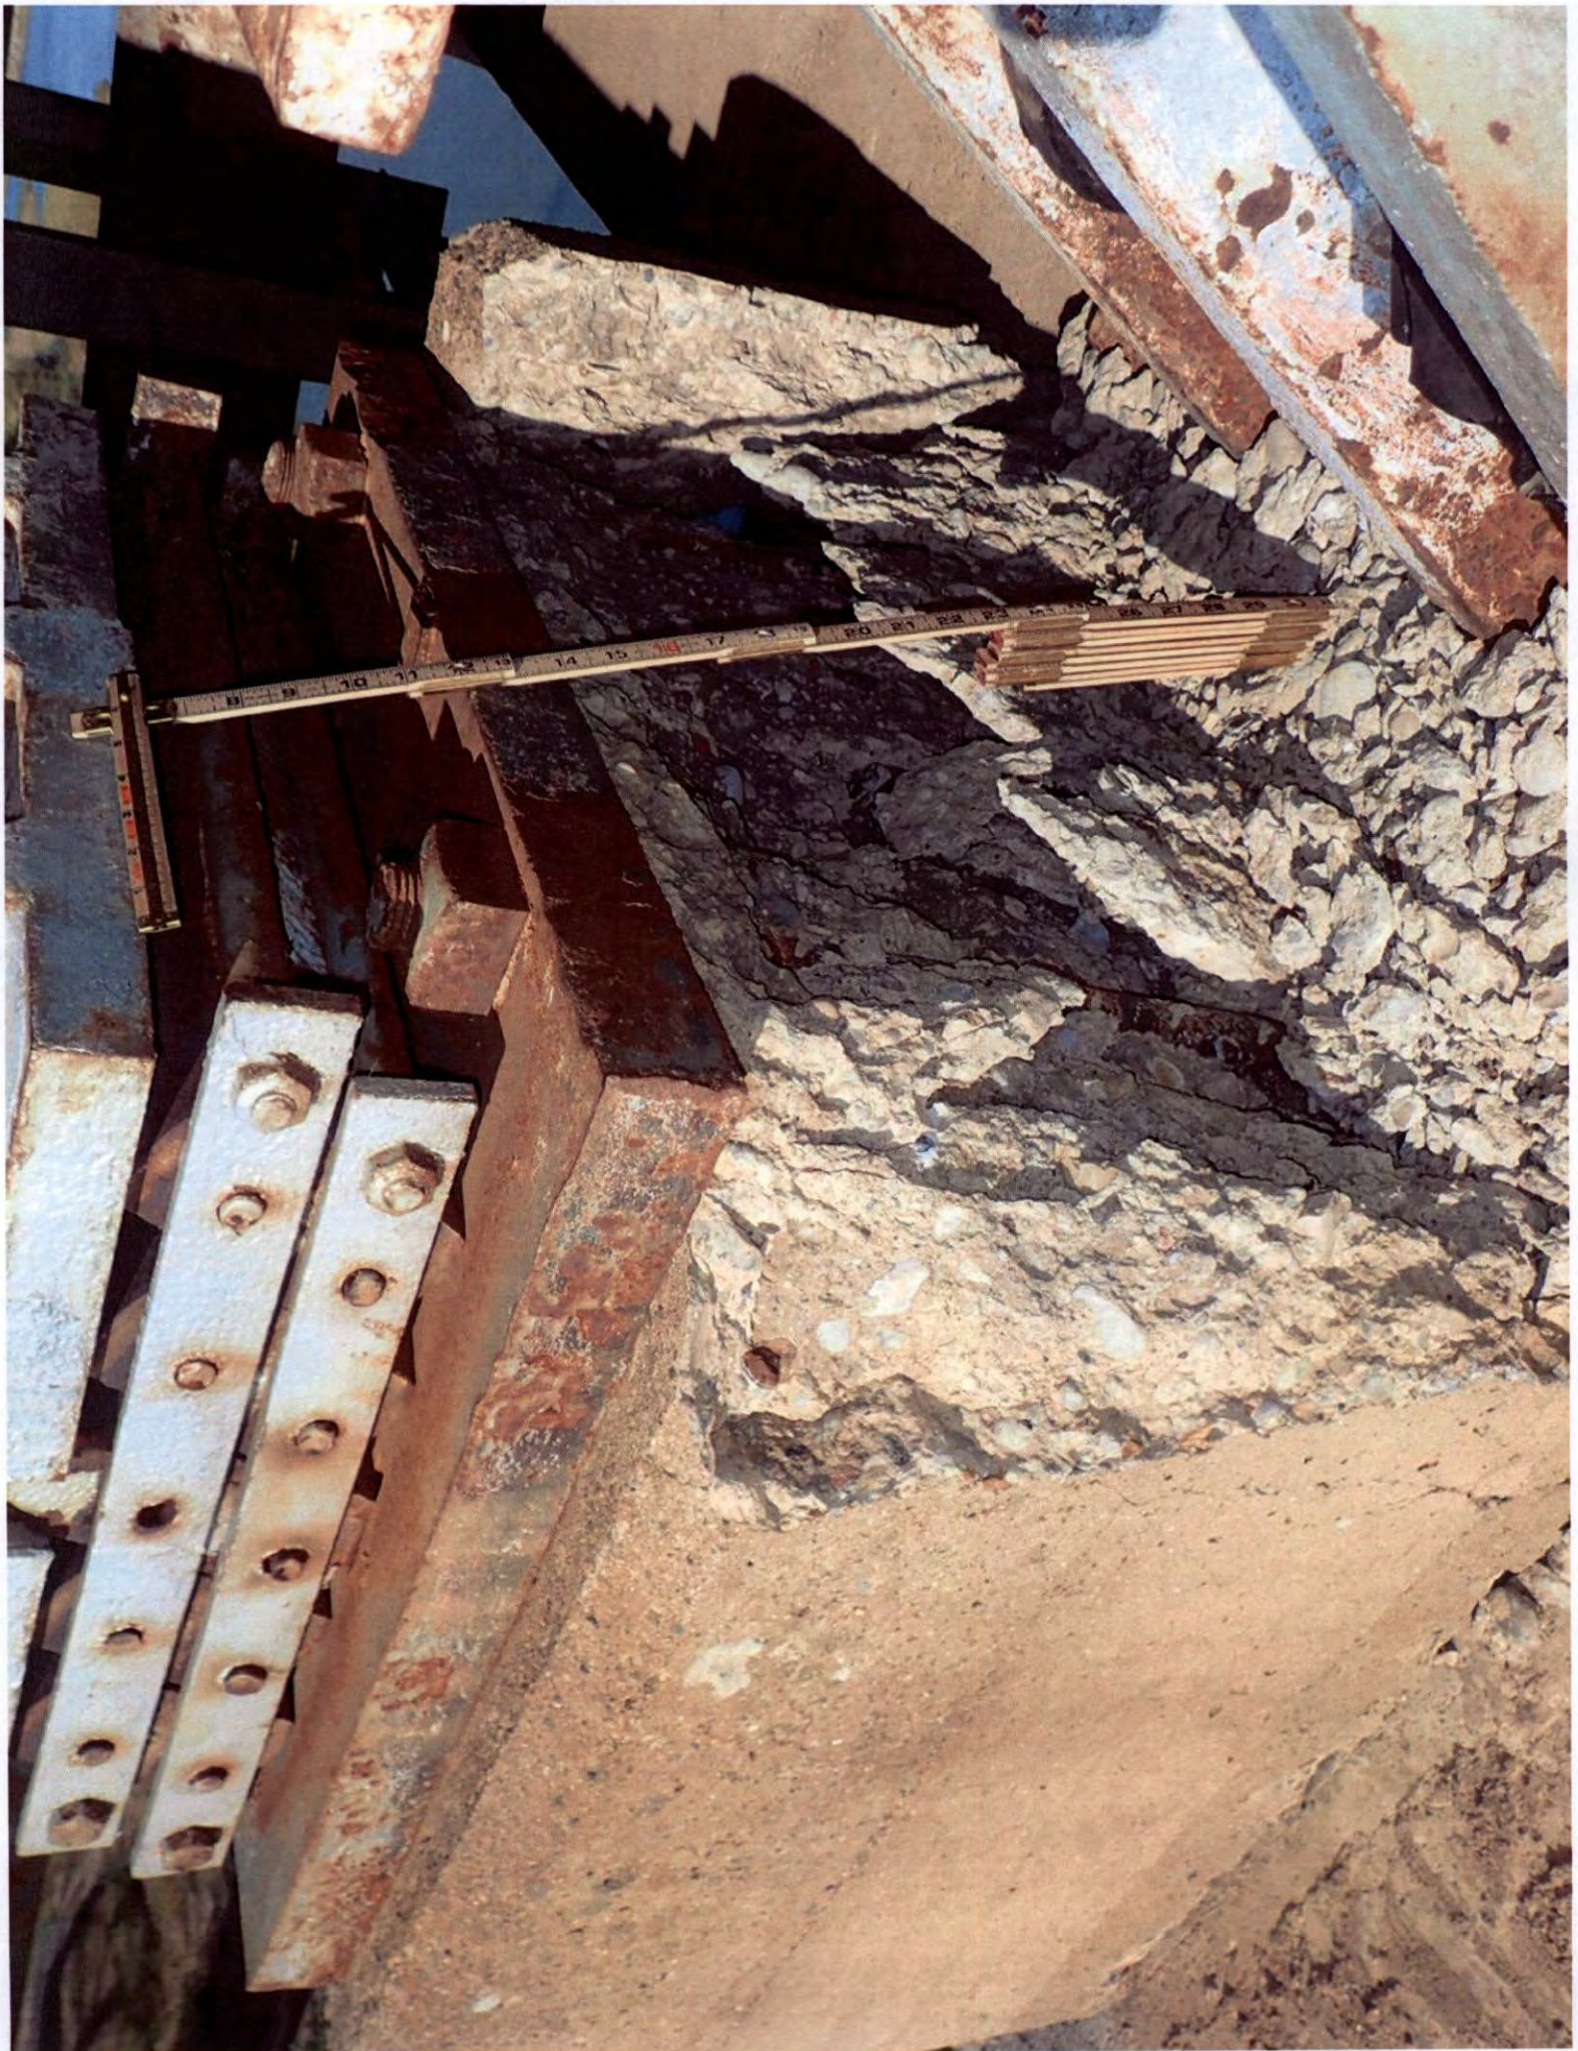
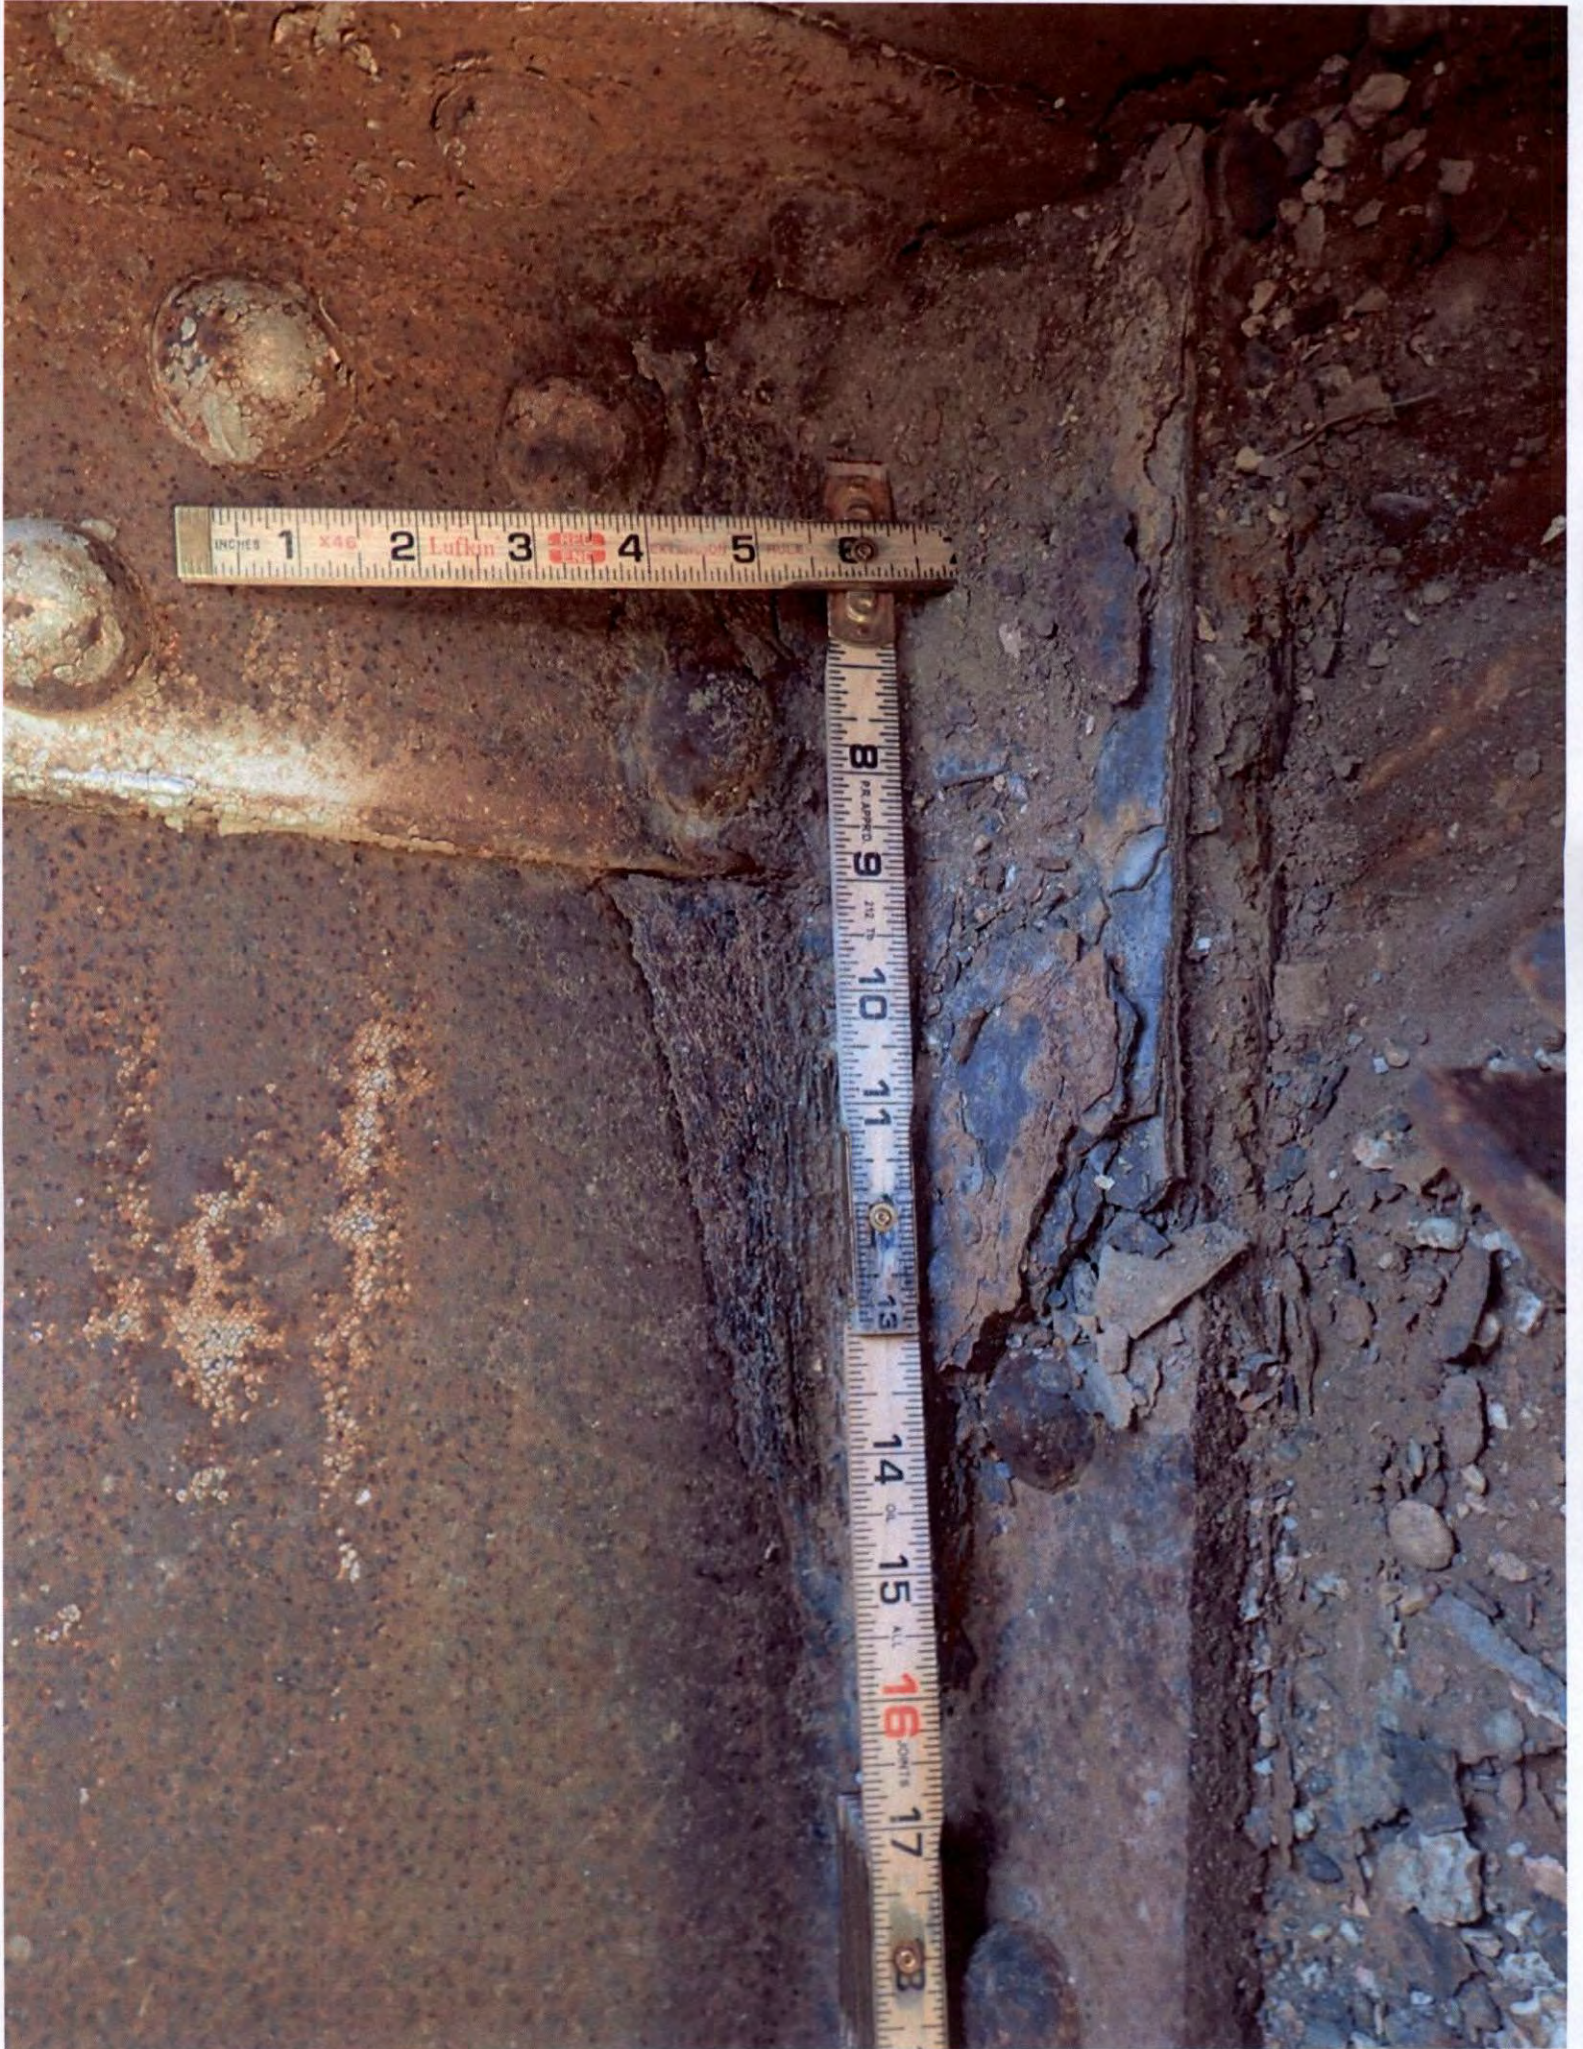
- The deck is in fair to poor condition.
 - o The top of the deck has widespread abrasion damage ("chewed up" concrete), up to 1" deep. See attached "Deck abrasion" photo.

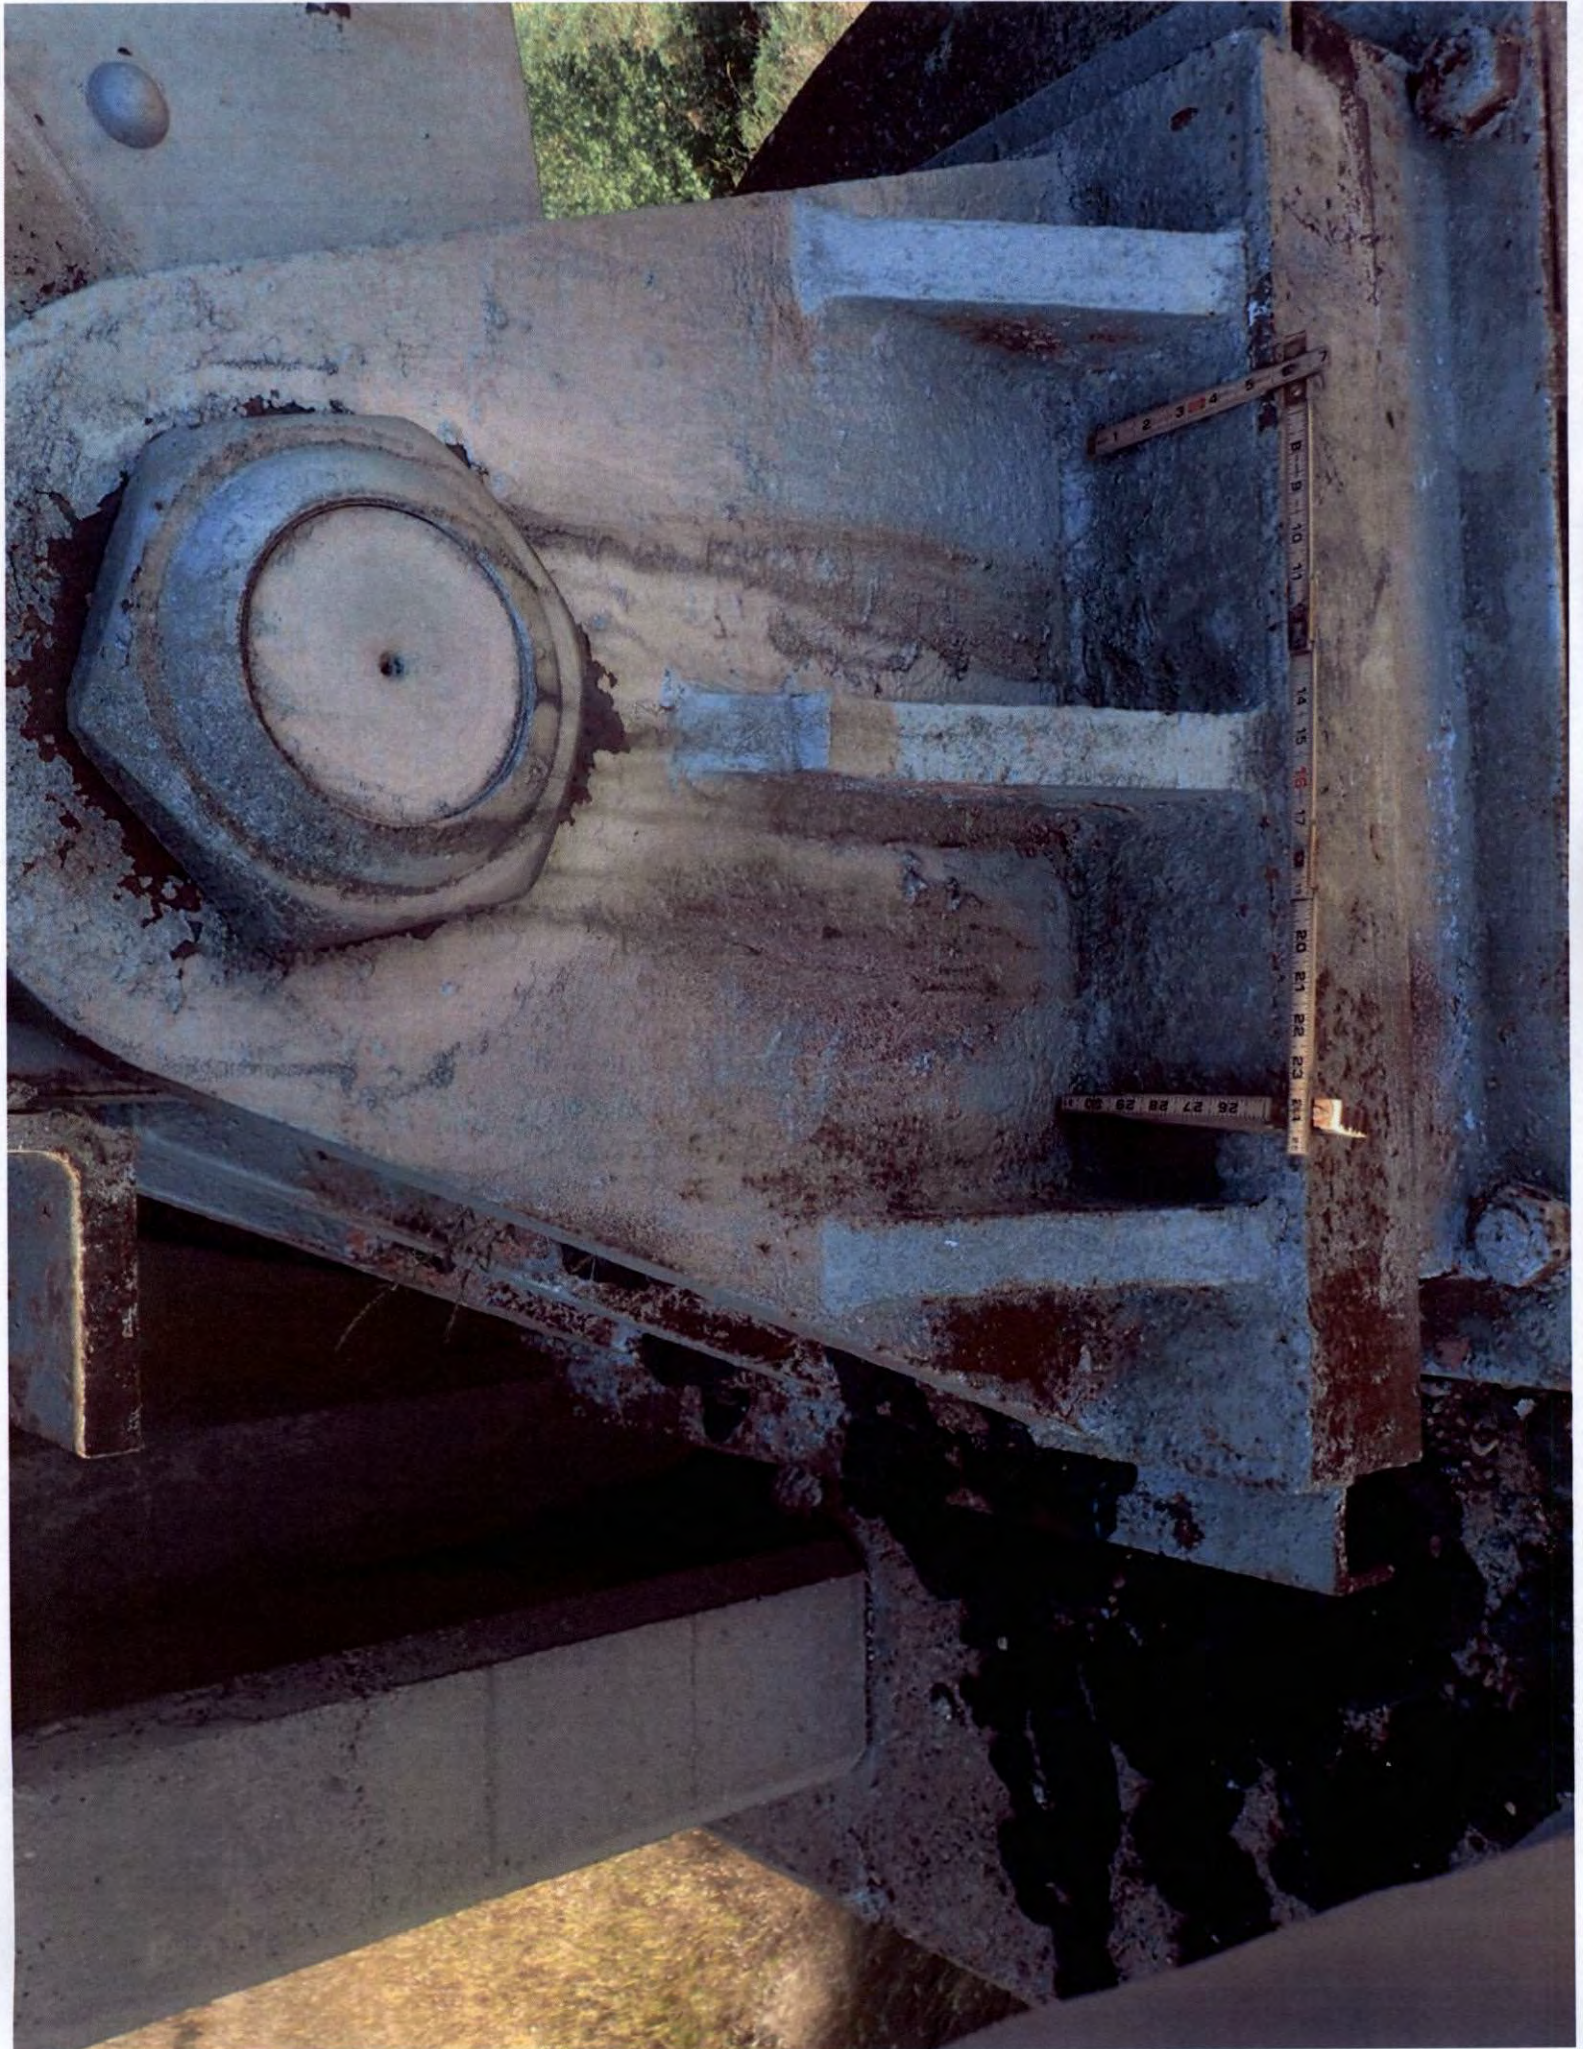
- The Girders in the approach spans are in fair to good condition with minor coating (paint) failure (loss) and some surface corrosion.
- The bearings are in fair to poor condition. Several expansion bearings are fully expanded, with the remaining bearings approaching full expansion. See attached "Pier 2_East Expansion Bearing", "Pier 3_East Expansion Bearing", and "Pier 4_East Expansion Bearing" photos. The most significant instance is at pier 3, where full expansion of the West Expansion Bearing has caused spalling around the anchor bolts in the West bearing pedestal. See attached "Pier 3_West Expansion Bearing" photo. This was the most significant finding of the inspection.

Overall the bridge is in fair condition. The most significant finding is related to the expansion bearings. Bearing repairs can be fairly costly, but I believe that routine monitoring should suffice, since this structure is not carrying traffic.
