# Biennial Report to the Montana Preservation Review Board

on the Stewardship, Status and Maintenance Needs of  
the Heritage Properties of Montana State University

For the Reporting Cycle 2016-2017

February 23, 2018

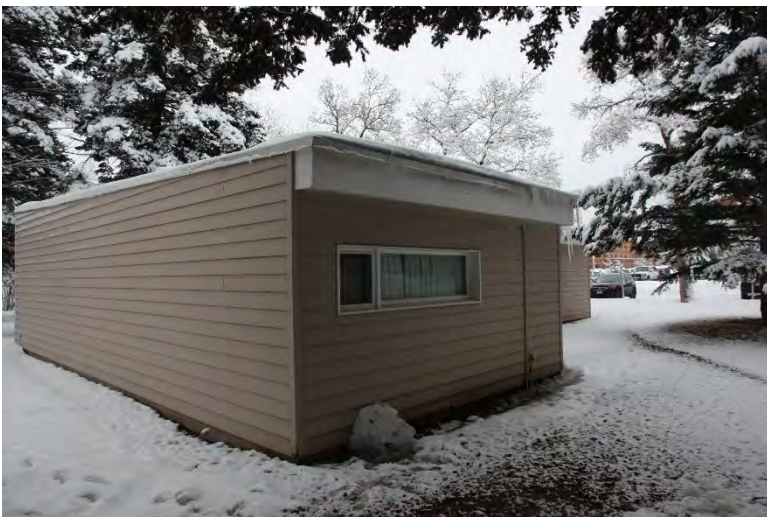
*Figure 2: Danforth Chapel, January 11, 2018, at MSU-Bozeman. The wood fascias are wet, causing the paint to flake off. This might be indicative of ice melt getting behind the sheet metal drip cap.*

1. Danforth Chapel has been downgraded from excellent to good condition. Paint is flaking from wet wood fascia boards.
2. Romney Hall (Gym) has been downgraded from good to fair condition, The building was well-built, thus is stable; yet its electrical, mechanical, and plumbing systems are outdated and severely deficient; the building is not handicapped accessible; and

- ~ **Taylor Hall (24GA1887)** repair masonry elements and restore main north entrance stairs and canopy.
- ~ **Danforth Chapel (24GA1796)** replace roof and paint fascias and siding.

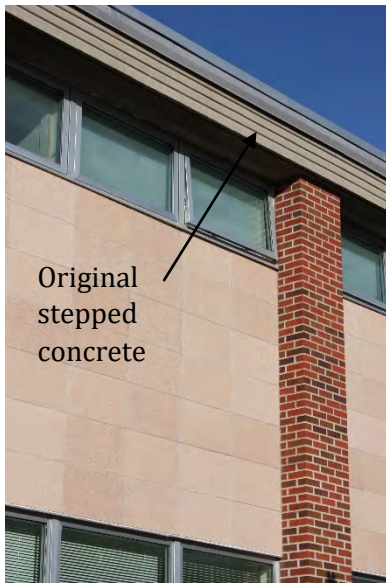
Figure 3: AJM Johnson Hall at MSU-Bozeman, with original parapet detail. Photograph taken October 20, 2011.

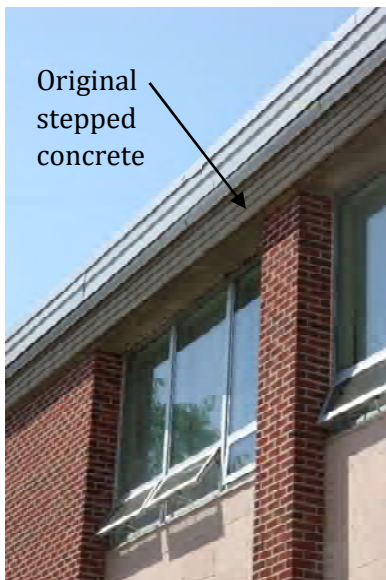
Figure 4: AJM Johnson Hall at MSU-Bozeman, with increased parapet height after roofing project completed in 2017.

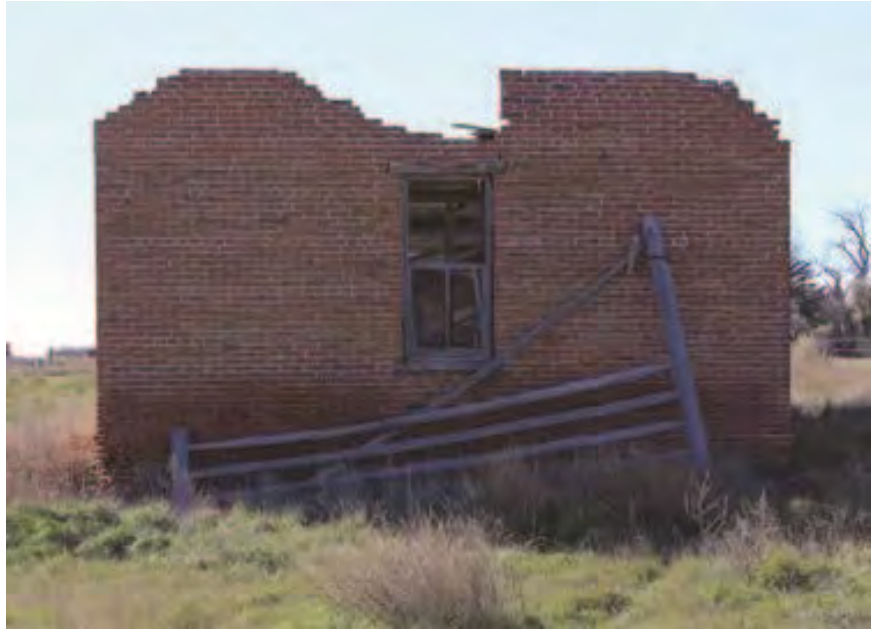
The integrity and condition of the buildings at the resources at Fort Assinniboine range from good to fair, with the exception of the Field Officers Stable #2 (c.1880) which weathered a 2015 storm that collapsed its roof and the top portions of the masonry walls. This building is now in poor condition. MAES NARC provided \$5,000 to FAPA for maintenance during this cycle (as they had the previous cycle).<sup>4</sup>

*Figure 6: Fort Assinniboine - Field Officers Stable #2. The 2015 storm tore the roof off and the upper portions of the brick walls. Photograph courtesy of the Fort Assinniboine (Boundary Increase and Additional Documentation) nomination, page 107. Photograph taken between October 2015 and June 2016.*

- ~ **Fort Ellis Military Site (24GA0352)** - security lighting and signage.
- ~ **Fort Assiniboine/NARC (24HL0329)** - projects to continue stabilization efforts and repair buildings and structures damaged by a 2015 storm event.

SHPO consulted on the insurance claim for the storm damage to the Field Officers Stable #2.

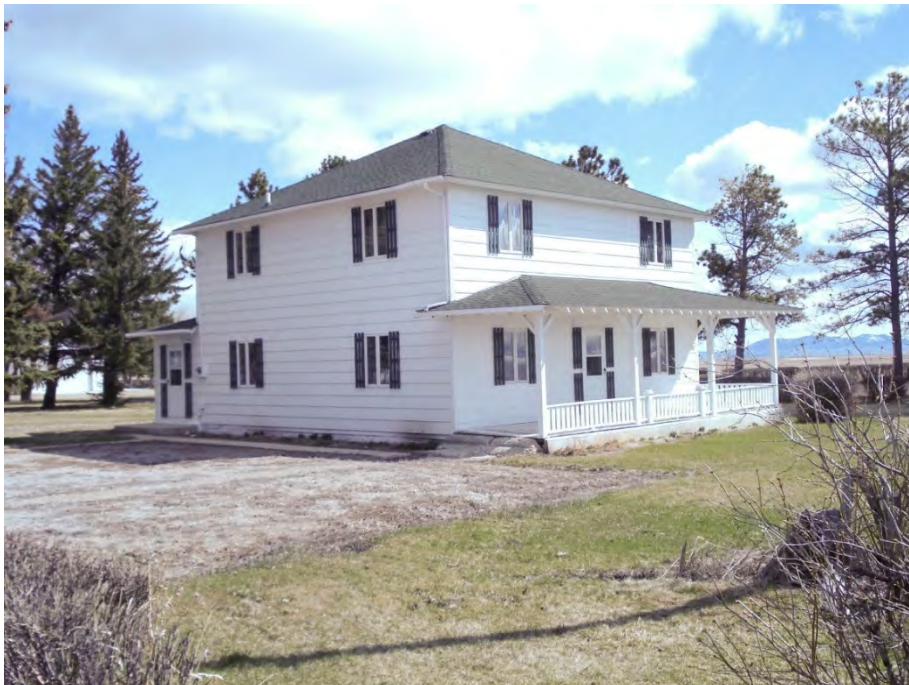
The Farmstead House, built in 1908 a year after the ag station was established, is in good condition. This is an upgrade from “fair” in the last reporting cycle. The asphalt shingles on the hipped roof were replaced in 2016. The rest of the buildings remain in fair to good condition. Both large barns (dated 1911 and 1922) were renovated in 2009.

*Figure 7: Farmstead House (Buildings #4403) at the Central Ag Research Center in Moccasin. Photograph provided by MSU (powerpoint), dated 2011.*

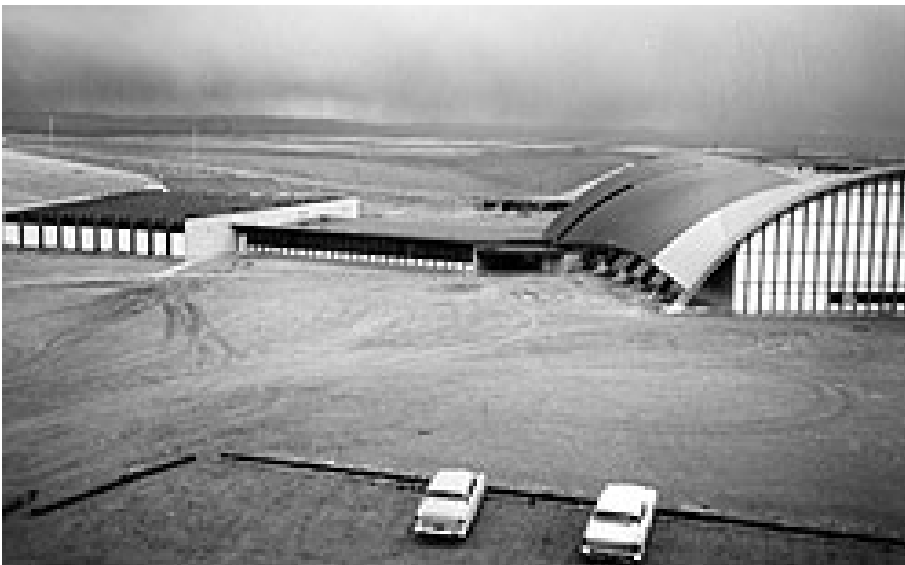
The integrity, status, and condition of the MSU-Northern building – the Northern Gymnasium - is the same as that listed in the prior reporting

*Figure 8: 1955 construction photograph of the MSU-Northern Gymnasium designed by Ozzie Berg.*

cycle. It is ranked “good” for integrity and condition and “satisfactory” for status.

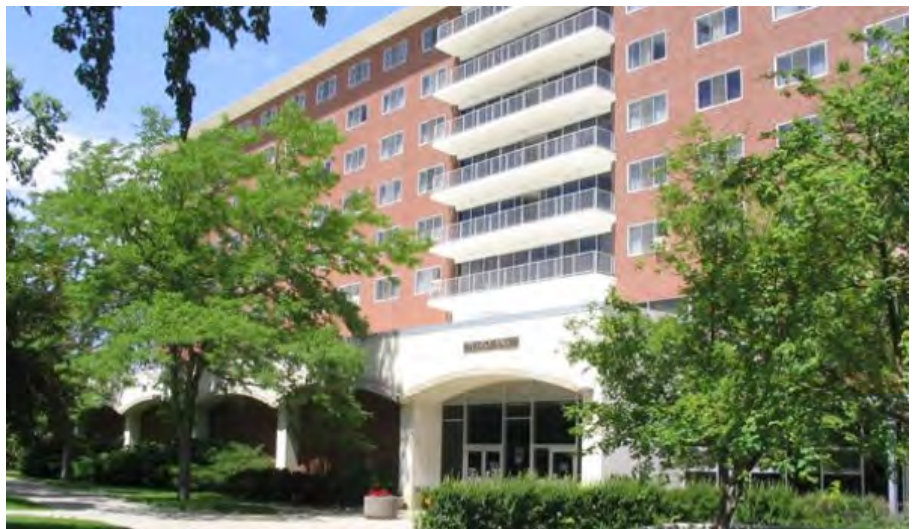
Petro Hall, constructed in 1966, at MSU-Billings reached the fifty-year mark in 2016. Any work planned for this 147,664-square-foot dormitory should be preceded with SHPO consultation. SHPO can then ascertain if it is a heritage property. If so, a Smithsonian number will be assigned and formal consultation will be required for proposed projects. It is our understanding that no exterior changes are planned, but that “Interior

*Figure 9: MSU-Billings - Petro Hall is an 8-story 500-room residence hall constructed in 1966.*

finishes and floor-floor renovations as part of current Auxiliaries master plan” are being completed.<sup>5</sup>

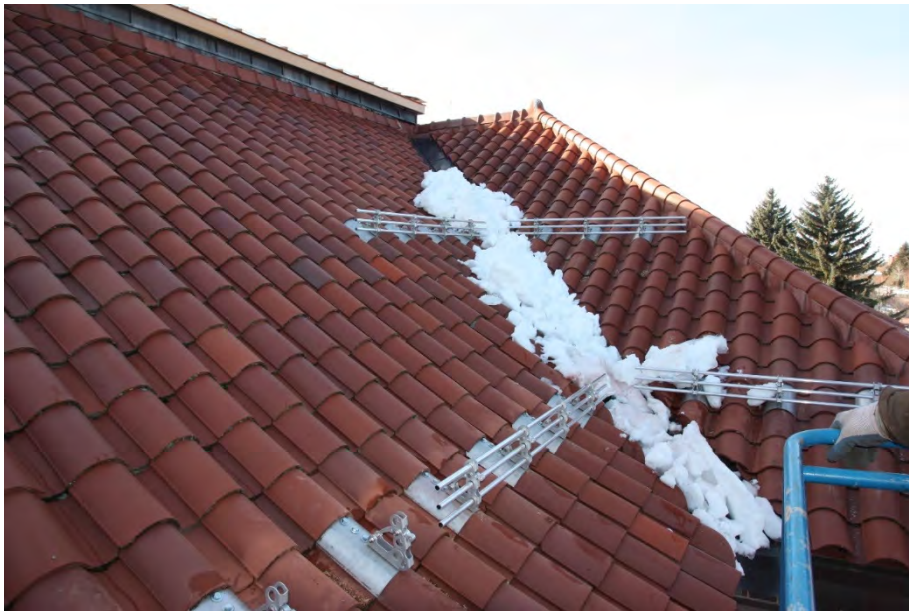
In February 2017, a staff member was struck by falling snow/ice that slid off the north slope of the Roberts Hall roof. MSU Facilities immediately constructed a temporary covered entry to provide safe navigation from the sidewalk into the building. While this might be an isolated instance, dependent upon that particular snowfall and temperature sequence, MSU invested in a more permanent solution to minimize the reoccurrence of snowslides.

MSU hired CTA Architects Engineers Historic Preservation Services who, aided by their envelope specialist and structural engineer Beaudette Consulting Engineers, studied the roofing history, physical conditions, and snow behavior at Roberts Hall, Traphagen Hall, Herrick Hall, and Lewis Hall. All four buildings are of similar vintage (c.1920s) with similarly shaped roofs clad in straight barrel mission clay tiles. All four have had a preponderance of icicles and Roberts and Traphagen Halls' roof configurations were deemed to be potentially conducive to snow slides.

*Figure 11: MSU-Bozeman, Roberts Hall during installation of snow guards. November 21, 2017.*

Based upon CTA's study, MSU immediately proceeded with construction projects at Roberts Hall and Traphagen Hall. The solution – as part of a phased installation – began with installation of snow guards at judicious locations aimed at stopping the snow slides. The snow guard installation at Roberts Hall was completed in mid-December 2017.

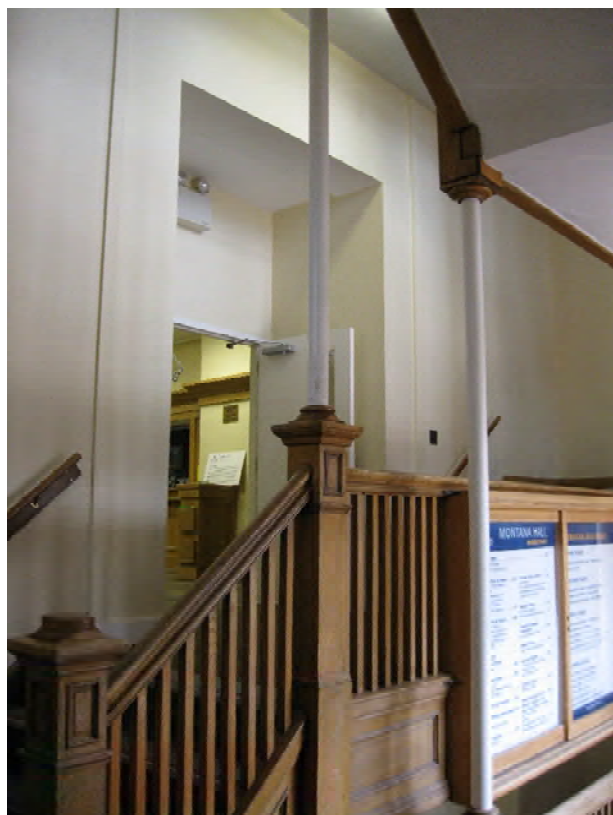
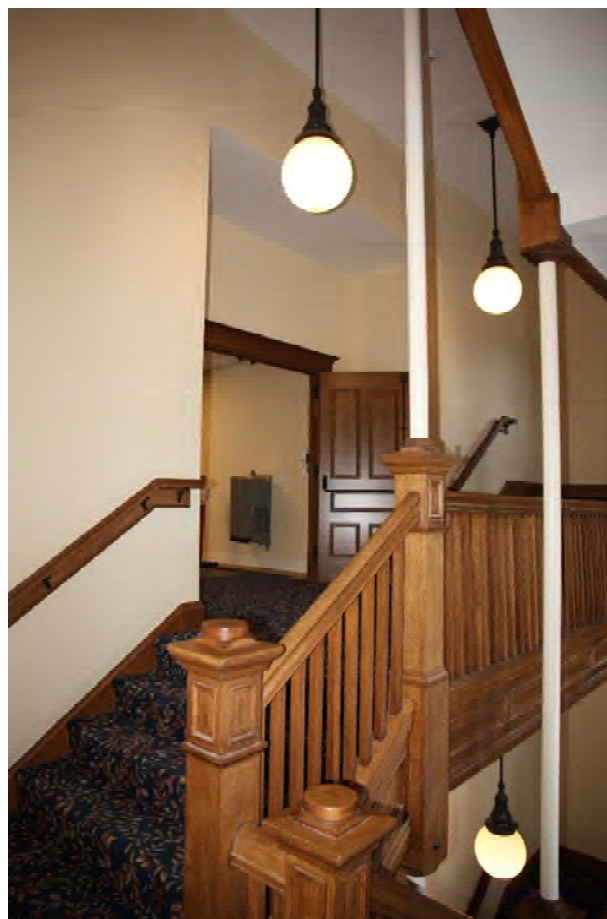
Figure 12: MSU-Bozeman, Montana Hall, interior west stairway. October 2017.

Figure 13: MSU-Bozeman, Montana Hall, interior west stairway. January 11, 2018.

2. Removal of an inappropriate outside wall handrail at the interior west stairway, and replacement with a quarter-sawn white oak handrail and cleat designed to match the existing handrail and trim.

5. Replacement of the hollow metal doors between the west stairway and the public corridors with fire-rated quarter-sawn white oak doors with period-appropriate hardware and trim to match the original.

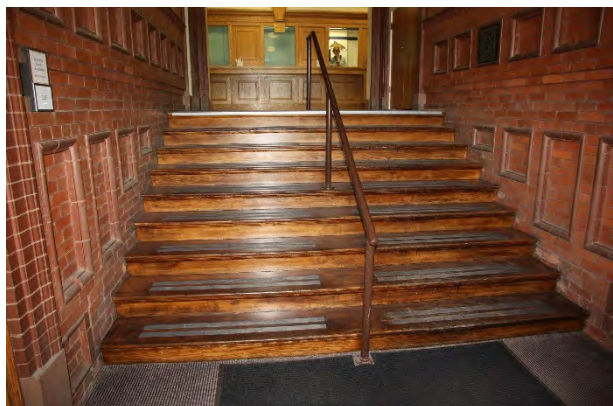
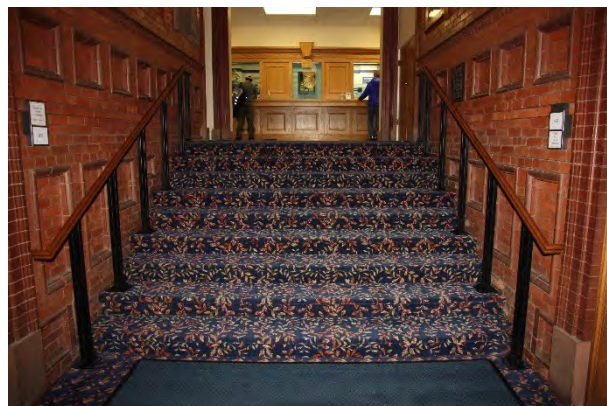
Figure 14: MSU-Bozeman, Montana Hall, interior north stair. May 12, 2017.

Figure 15: MSU-Bozeman, Montana Hall, interior north stair. January 11, 2018.

6. Replacement of the pipe metal handrails in the north interior stairway with a system of wood handrail on black metal support.
7. Removal of the exterior pipe metal handrails at the north and west (main) entries and replacement with period appropriate bronze handrails with lambs tongue terminations.

8. Replacement of surface-mounted fluorescent lighting in the west and north stairways with period-appropriate pendants.
9. Replacement of modern box type exterior light fixtures at the north and west (main) entries with period-appropriate pendant and sconces, respectively.

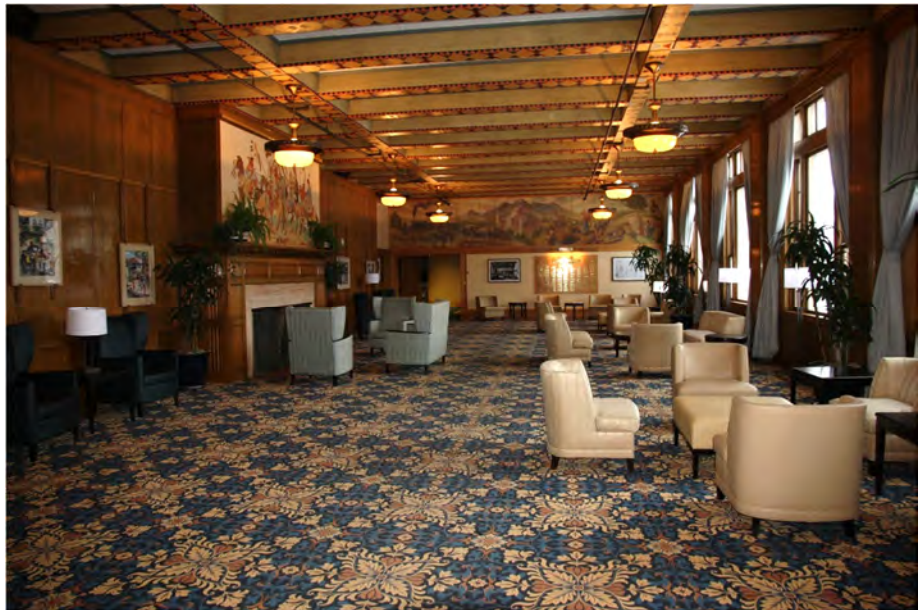
MSU engaged Kristi Miller of KMD Design, of Billings, to prepare a design for a period treatment to the historic Leigh Lounge in the Strand Union Building. The original drawings by Fred Willson (dated July 1939) included interior elevations and details for this exquisite space. The original stenciling at the coffered ceiling, the original pendant light fixtures, the fireplace mural, and the white oak paneling provided a warm and decorative backdrop for the new carpeting and furniture. This historic room is used for receptions and is famous for its use in the film “A River Runs Through It.”

*Figure 16: MSU-Bozeman, Leigh Lounge of the original portion of Strand Union Building. January 11, 2018.*

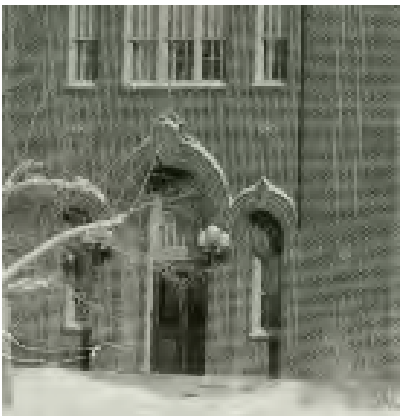
*Figure 17: MSU-Bozeman, Herrick Hall, 1933. Photograph provided by MSU, hres-parc-000330.*

MSU-Bozeman has been replacing light fixtures and interior fittings at Herrick Hall with replica and period fixtures. The current project, scheduled for spring 2018, is to replace exterior sconces at the main west entry with replicas of the original sconces (pictured to the right).

MSU has consulted formally with SHPO for replacement of the exterior sconces of Herrick Hall (with replica fixtures to match those visible on historic photographs). This work is described in greater detail in Heritage Site Stewardship Efforts above.

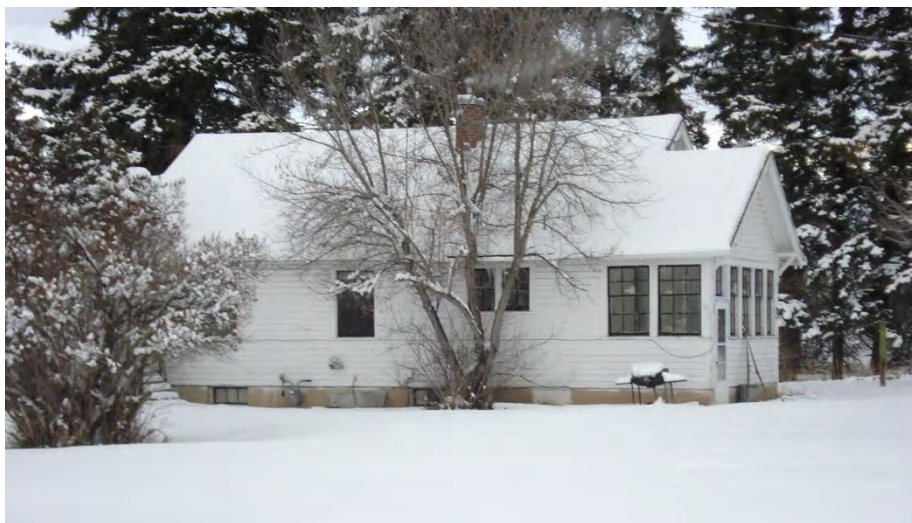
The 1931 residence (#1), designed by Shanley, Willson & Hugenin, benefited from SHPO consultation before the last reporting cycle. The

planned demolition was cancelled and a historian documented – in a Montana Historic Property Record – the ag experiment buildings on site. The building remains on site and is used for storage until improvements can be made for habitation. A study was completed in 2017 to upgrade the residence for a station manager. The project is pending due to funding.

*Figure 18: Fort Ellis, Ranch House No. 1 (Building# 721), as designed by Shanley, Willson & Hugenin in 1931. Photograph provided by MSU (powerpoint).*

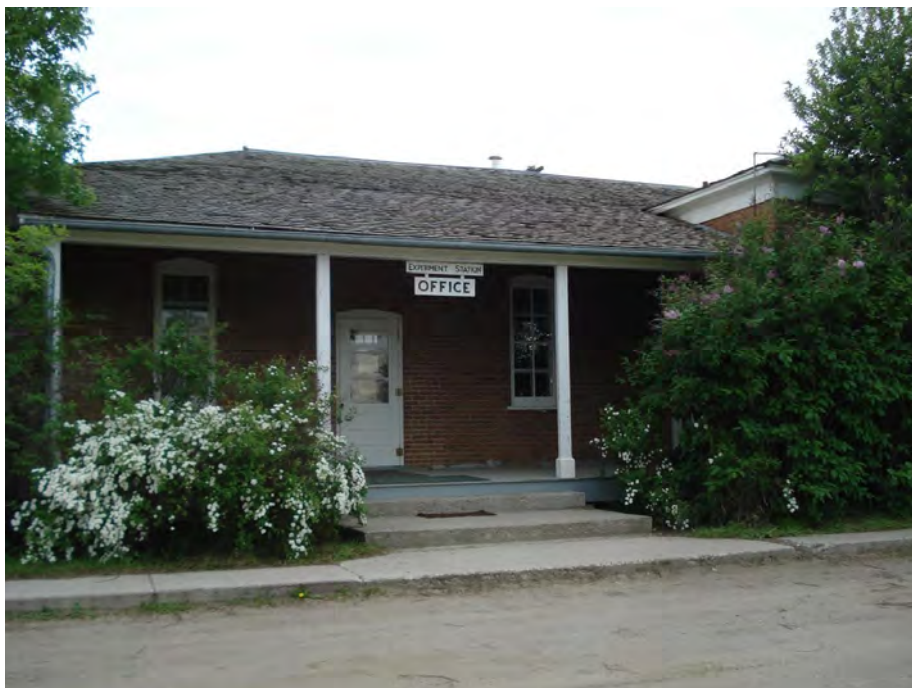
*Figure 19: Fort Assiniboine, Post Library (c.1889), previously used for offices by NARC. The building is now vacant.*

As MAES vacates these buildings, a plan for shifting the care of them to the Montana Historical Society and FAPA should be investigated. Such an arrangement could include provision of some maintenance funding.

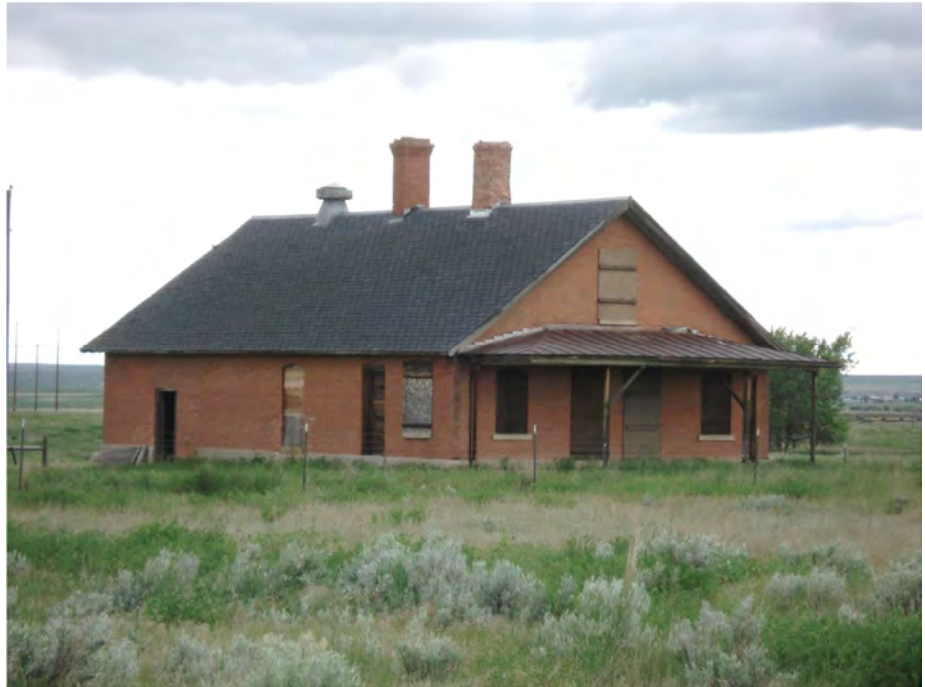
Five of the buildings are maintained by the Montana Historical Society and the Fort Assinniboine Preservation Association (FAPA): the three double cavalry stable guard/shops, the Ordinance Storehouse, and Stable #4 Recreation Hall. Only one of the guard/shops (#10) is in good condition. One is in poor condition; one in fair. The Recreation Hall is in fair condition.

*Figure 20: MAES Fort Assinniboine, East Guard House (Building #5418), as maintained in good condition by FAPA.*

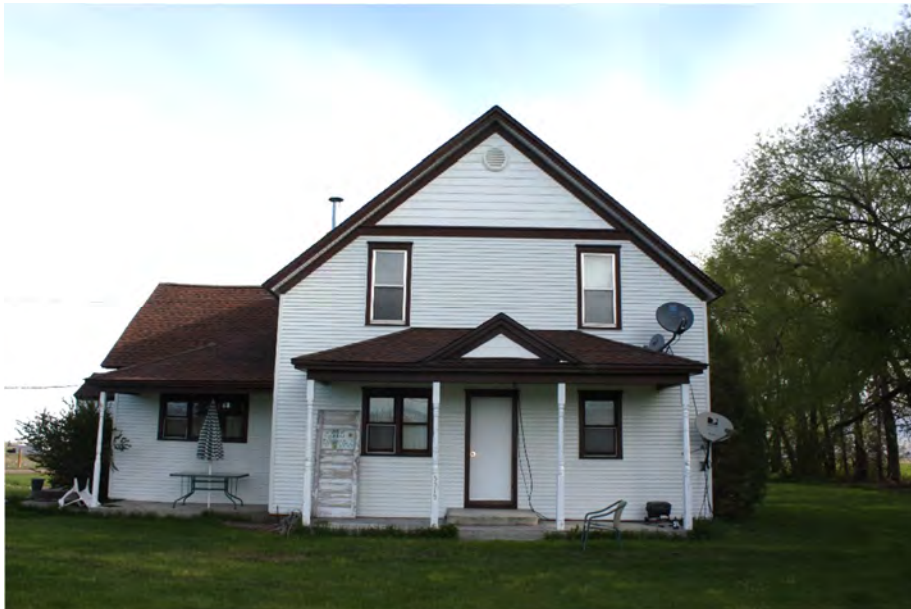
The 474-acres property includes the historic Stucky-Girvin Farmstead from the late 19<sup>th</sup> century, and more recent farm structures from 1968 through 2012. The Girvin farmhouse, garage, and barn were reroofed in 2012.

*Figure 21: MAES BART - the Girvin Farmhouse. May 3, 2012.*

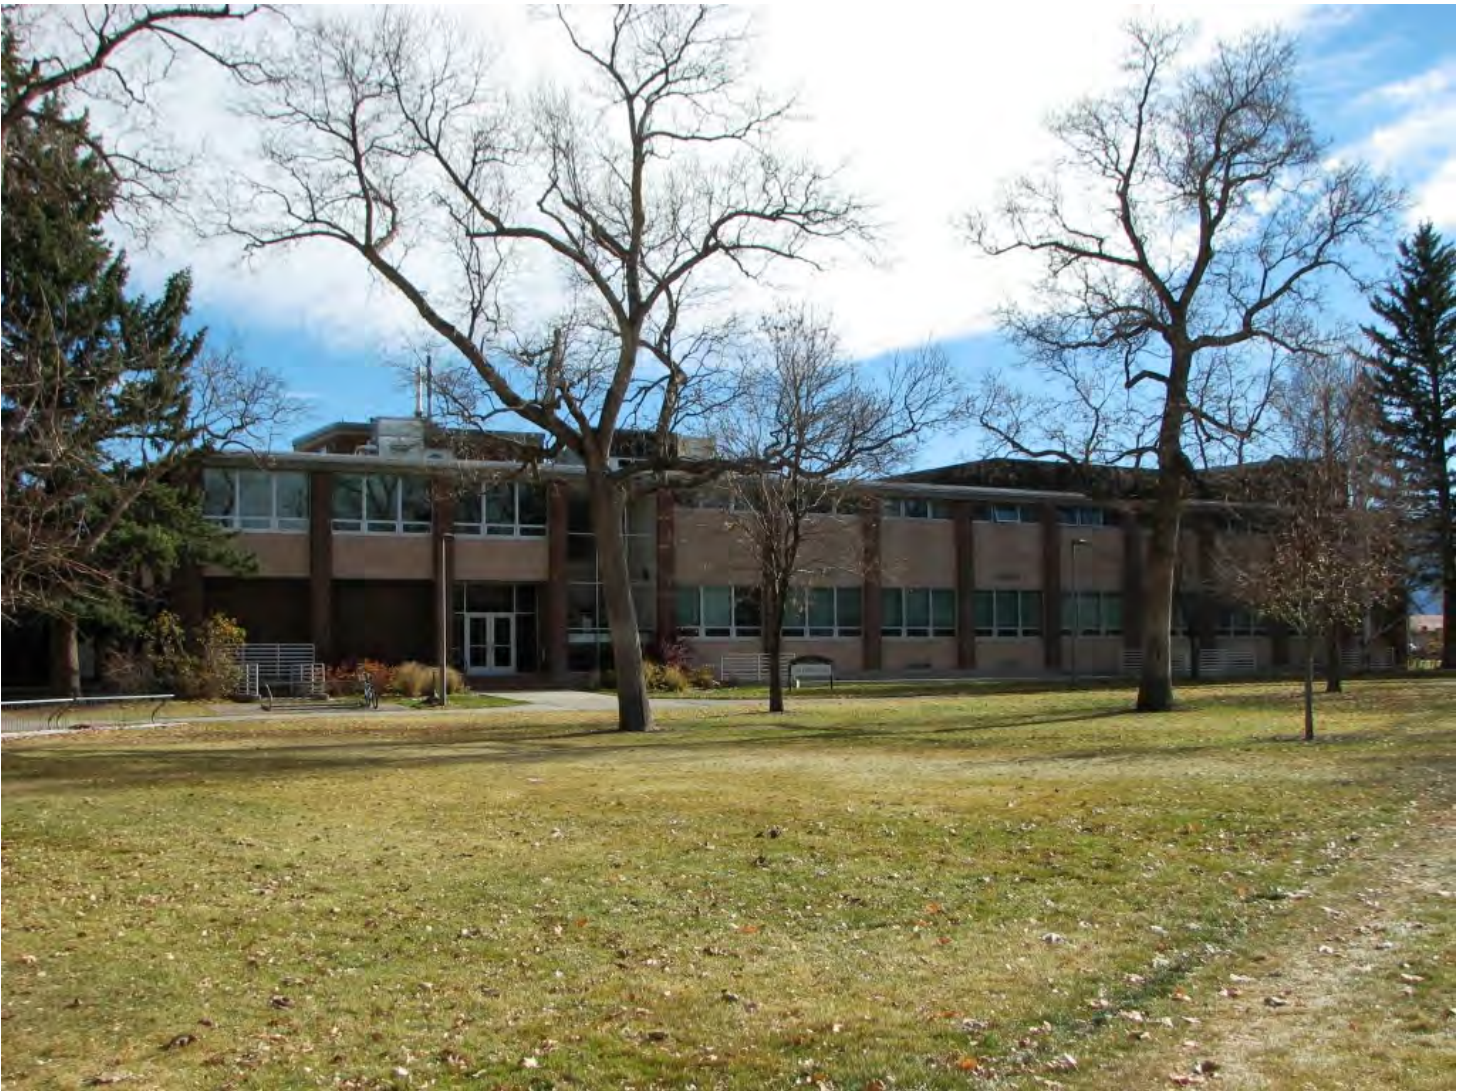
Site Number: **24GA1681**

**A.J.M. Johnson Hall  
West Façade, Facing: SE  
Montana State University  
Jessie Nunn, November 3, 2012**

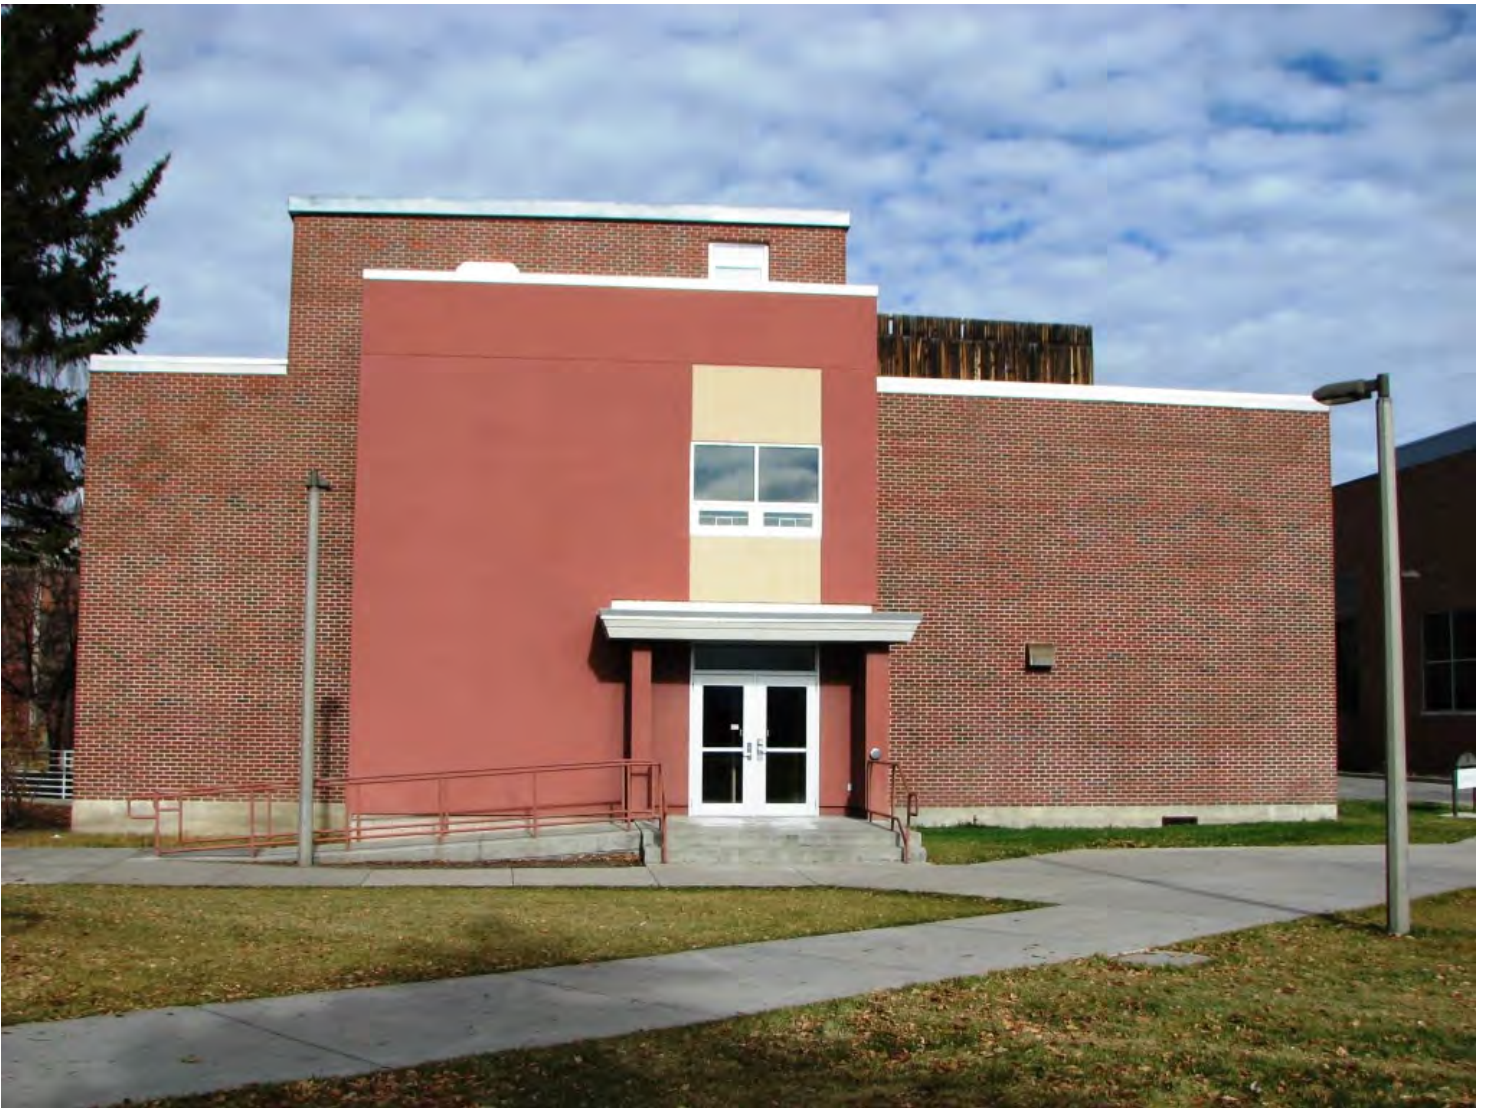
Site Number: **24GA1681**

**A.J.M. Johnson Hall**  
**South Elevation, Facing: N**  
**Montana State University**  
**Jessie Nunn, November 3, 2012**

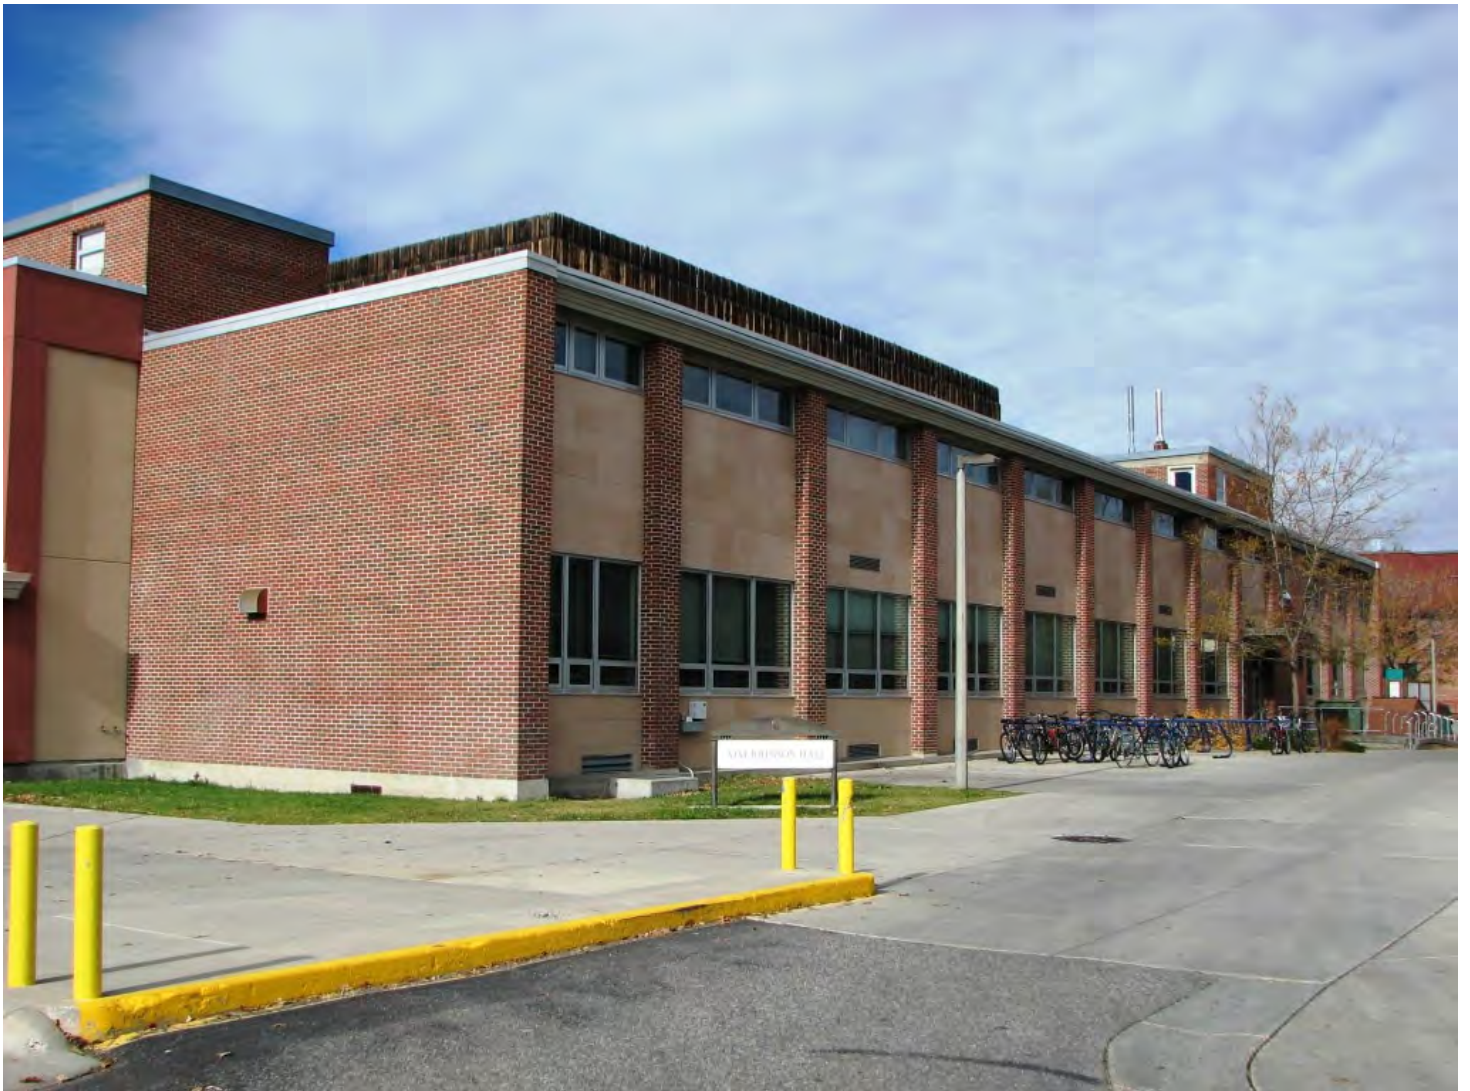
Site Number: **24GA1681**

**A.J.M. Johnson Hall  
East Elevation, Facing: NW  
Montana State University  
Jessie Nunn, November 3, 2012**

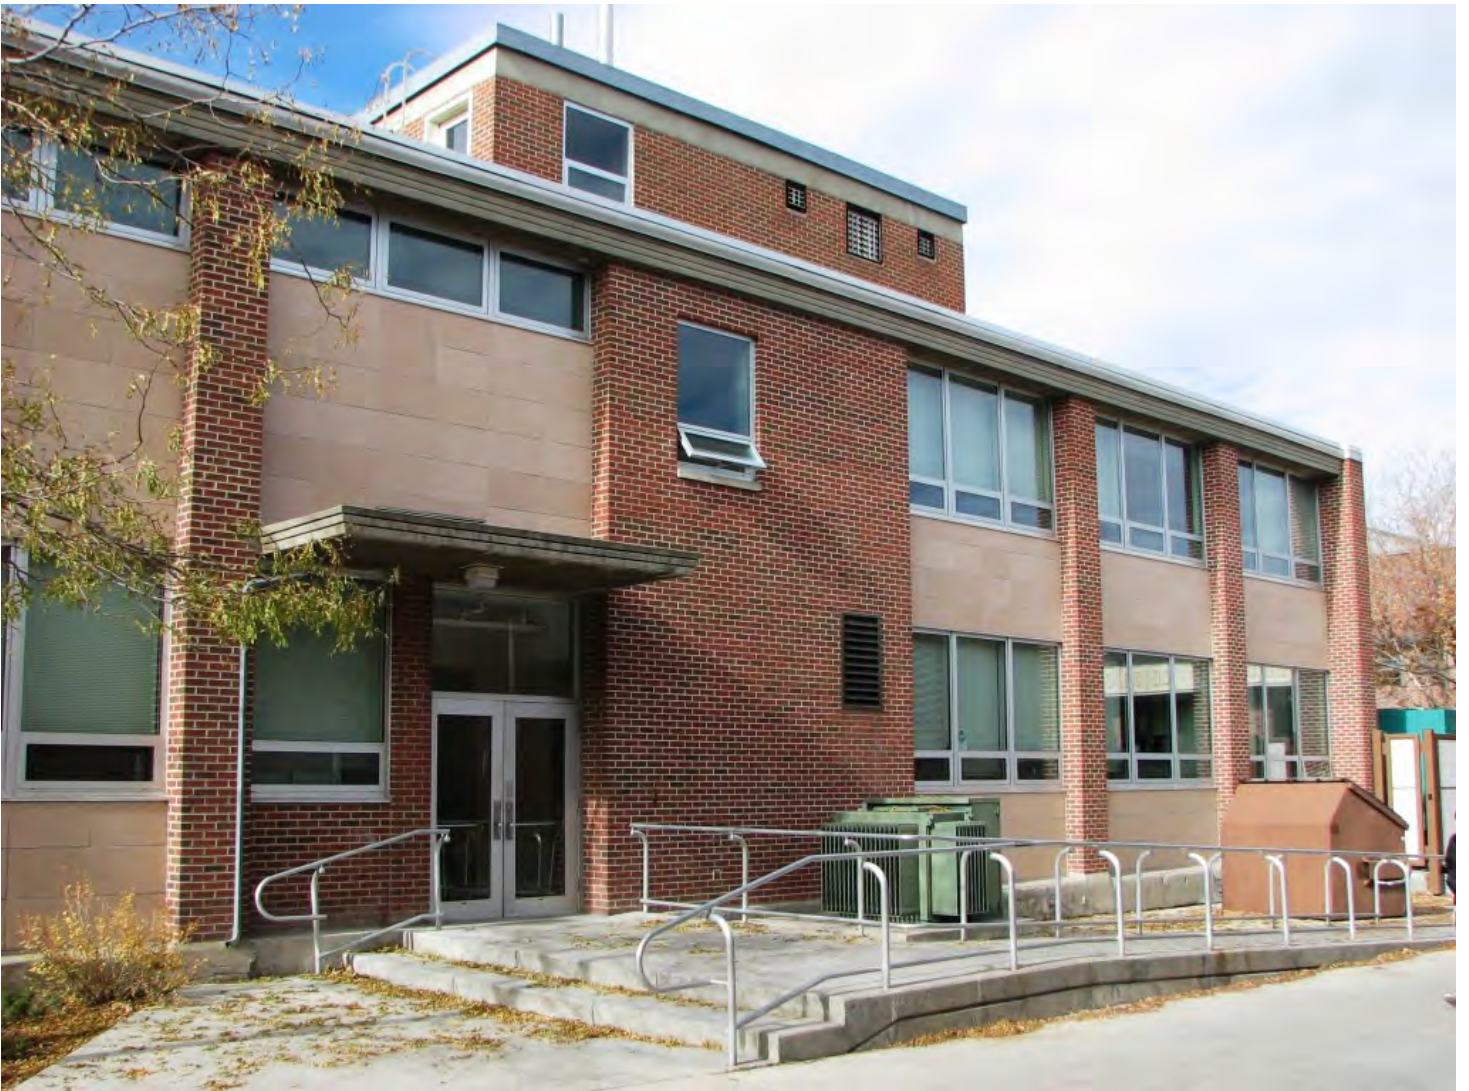
Site Number: **24GA1681**

**A.J.M. Johnson Hall  
East Entrance, East Elevation, Facing: NW  
Montana State University  
Jessie Nunn, November 3, 2012**

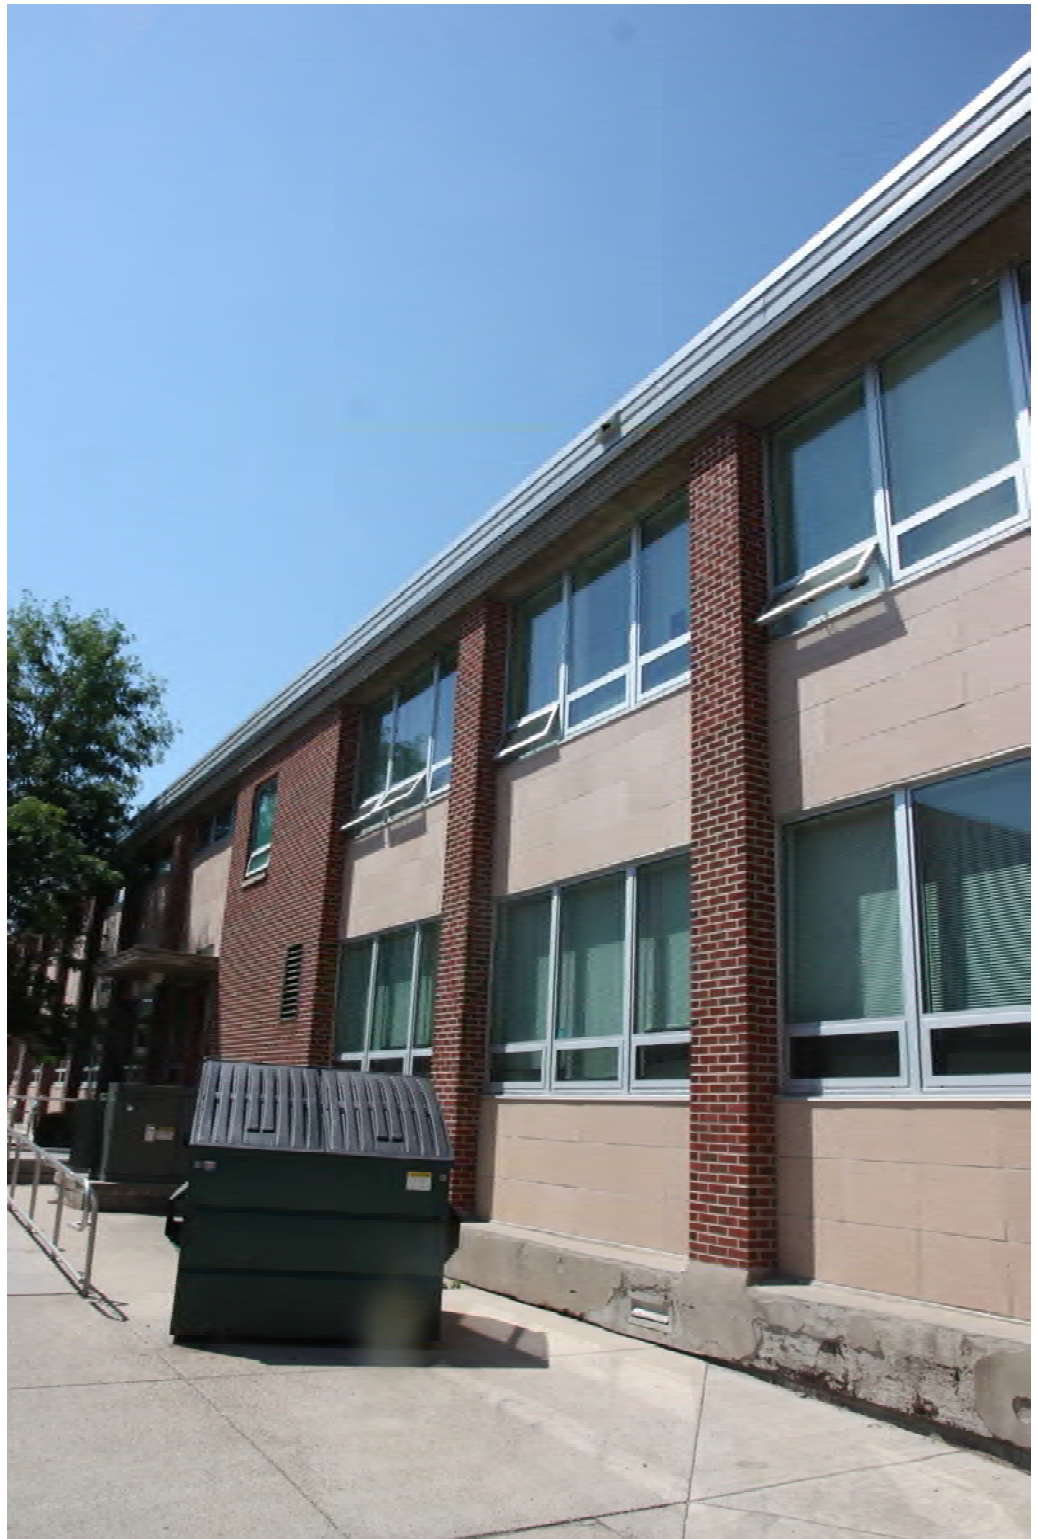
Site Number: **24GA1681**

**A.J.M. Johnson Hall  
East Entrance, East Elevation, Facing: SW  
Montana State University  
Lesley M. Gilmore, July 24, 2017**

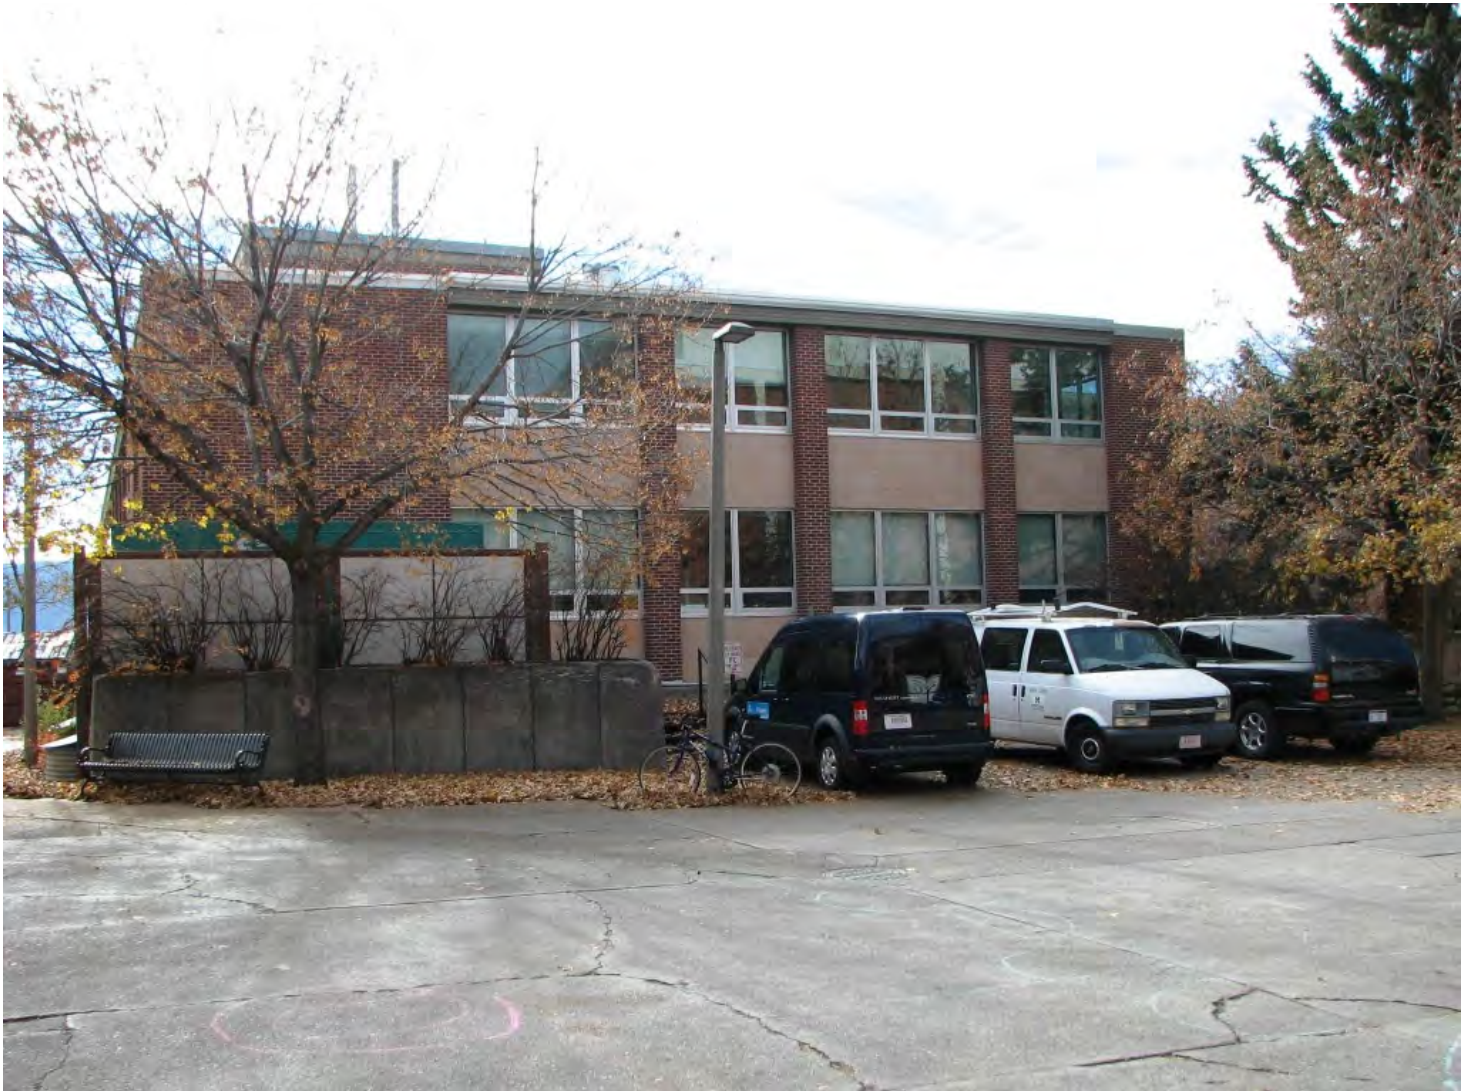
Site Number: **24GA1681**

**A.J.M. Johnson Hall  
North Elevation, Facing: S  
Montana State University  
Jessie Nunn, November 3, 2012**
