Montana State University

State-Owned Heritage Properties

Biennial Report 2014-2015

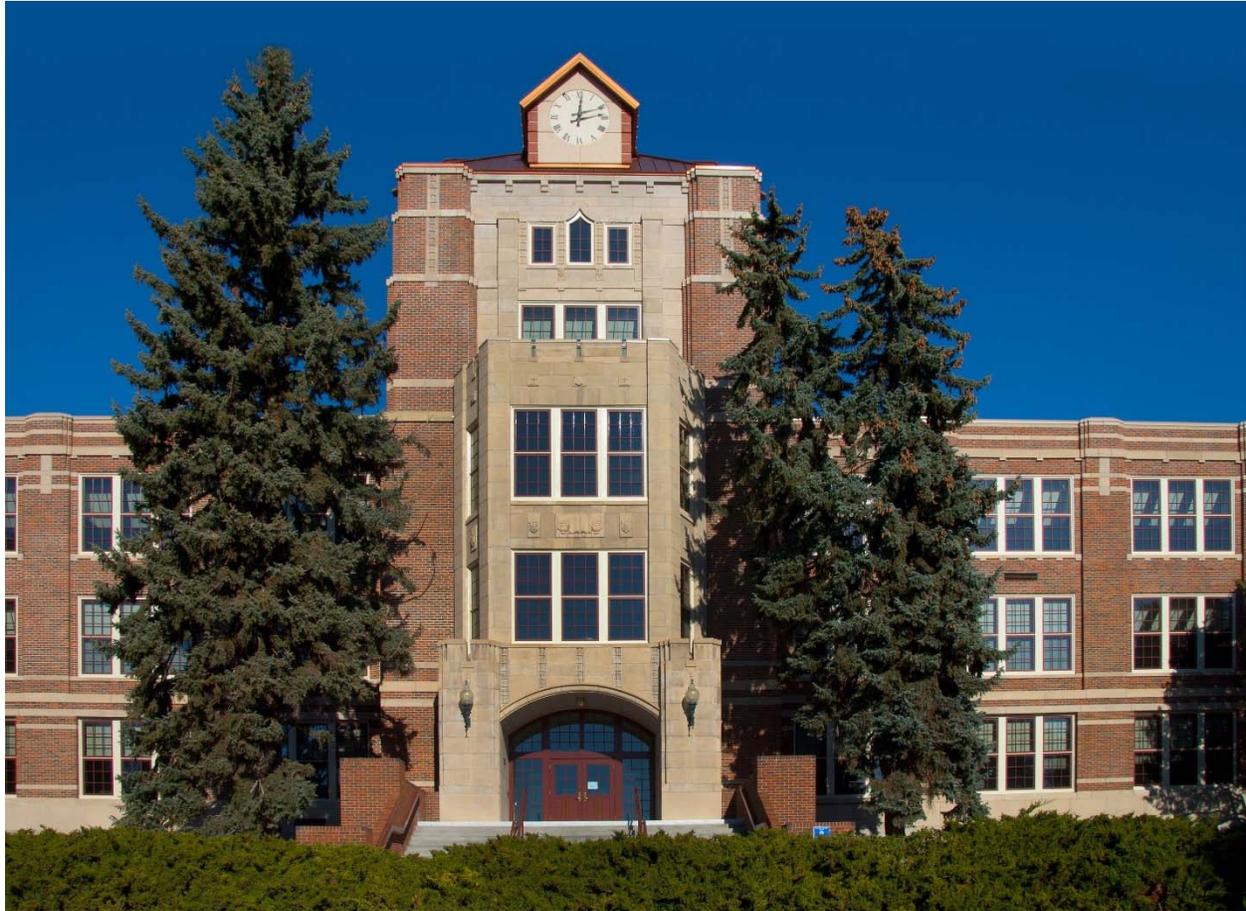
Photo 1: McMullen Hall (24YL2054). Source: MSU Billings University Relations, 2015

During this reporting cycle, **McMullen Hall (24YL2054)** was submitted for nomination and added to the National Register. Constructed in 1935, it is the first permanent structure for MSU Billings, when the campus was known as Eastern Montana Normal School. It rates "Good" for both historic integrity and overall condition. It is one of a few remaining examples of the school building style referred to as

Collegiate Gothic. In 1999, a clock was added to the tower but was not a change that detracted from the buildings original design and deemed reversibleⁱ. The building commands stature due to its geographical prominence facing south with the Rim Rock cliffs as its backdrop and its central tower. The building is distinguishable within the campus and local community.

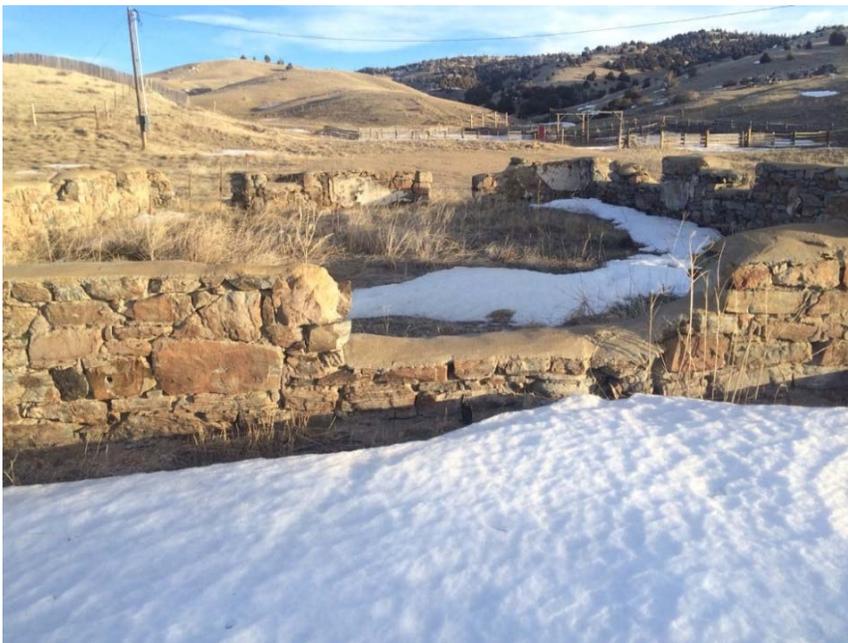
Photo 3: Rock foundation stem wall of Isaacs/Wann residence Red Bluff Stage Stop (24MA0262) lost by fire. Source: Corey Edmundson, 2016

Red Bluff Stage Stop aka Isaacs/Wann Residence (24MA0262) continues to report a “Failed” status due to the loss of the building following a fire caused by a natural storm event. A commemorative bronze plaque was installed at the site adjacent to the remaining rock foundation stem wall.

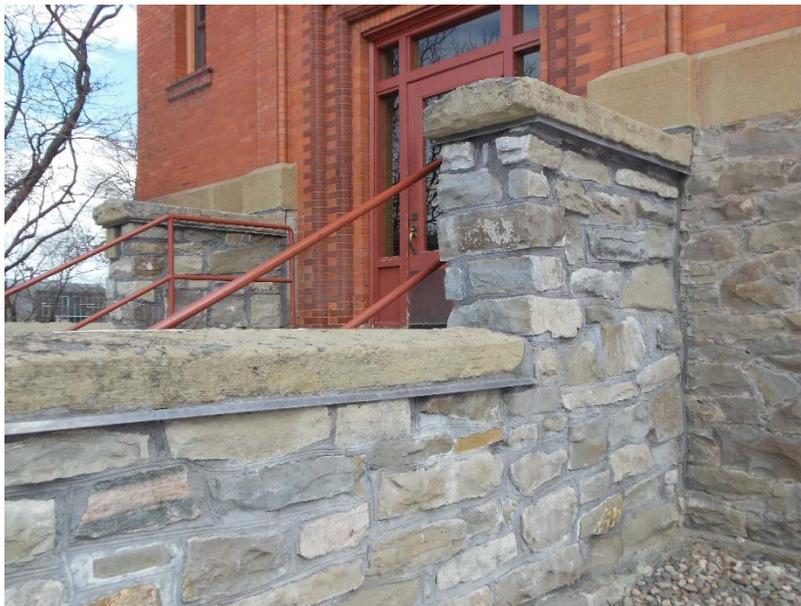
Photo 4: Montana Hall (24GA1879) west entrance exterior stairs. Source: Victoria Drummond, 2016

The west and north exterior stairs of **Montana Hall (24GA1879)**, the second oldest building on campus and the iconic symbol of the University, were restored. The restoration included the removal of the stone knee walls, repoint the stone base wall and related beltcourse on the west stairs, and clean and fill the joints between the stone and concrete of the north stairs. All original stone was preserved and reinstalled; rust was removed from the existing handrails and reused.

- **Montana Hall (24GA1879)** whole building renovation to improve code and life safety and insure another 100-years dynamic use of the iconic building. In the tier of the second highest priority.

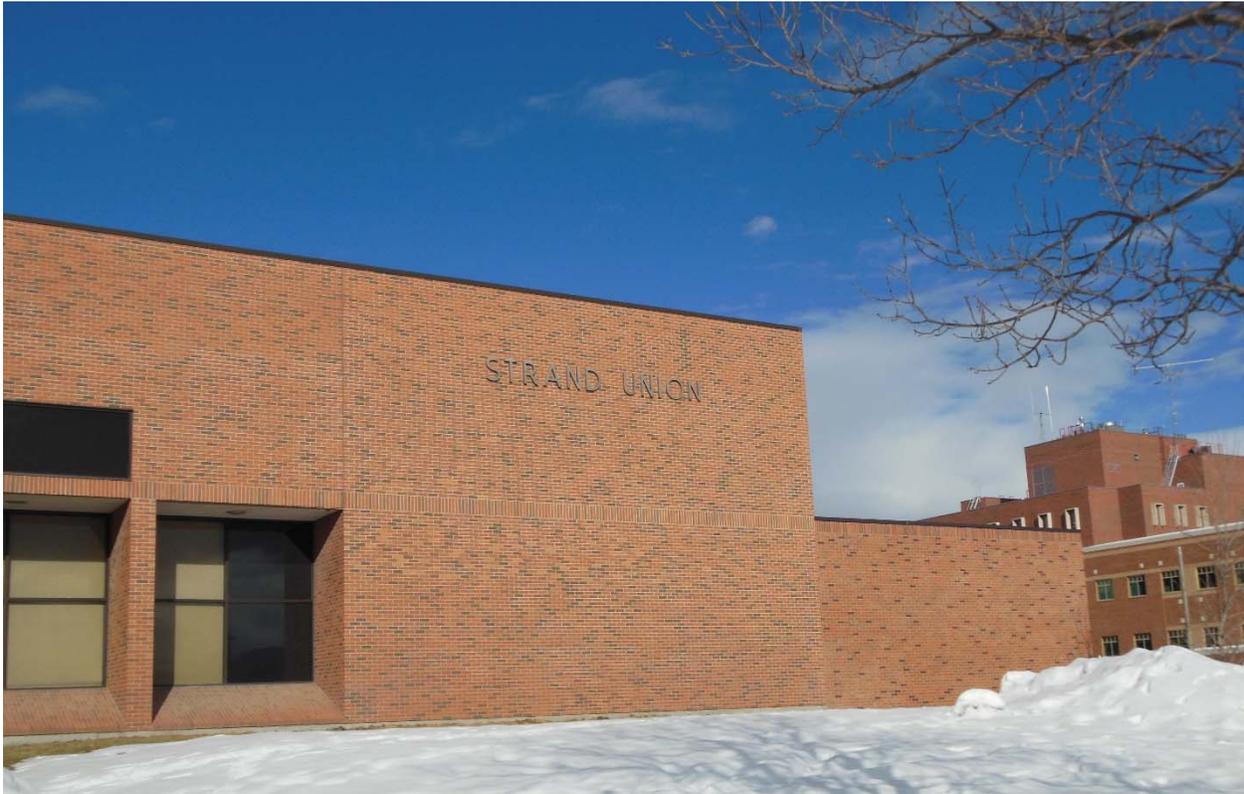
Photo 5: Strand Union Building (24GA1763), south east addition (right side of photo). Source: Victoria Drummond, 2016

Consultation with SHPO guided the selection of the most feasible option for an addition to the **Strand Union Building (24GA1763)**. The project added a windowless, brick clad rectangle building of approximately 2000 gross square feet to the south east portion of the building. The addition screens the back-door dock area, thereby improving the visual aesthetics of the building from the street while providing necessary storage space for the interior ballrooms. The addition does not detract from the architectural integrity of the overall building.
