SB3
State Agency Biennial Report on State-owned Heritage Properties
Montana Department of Commerce
(Montana Heritage Commission)
2010-2011

Prepared by:
Kathleen McCourt, Cultural Resource Manager
Prepared For: State Preservation Review Board and
Montana State Historic Preservation Office (SHPO)

January 2012

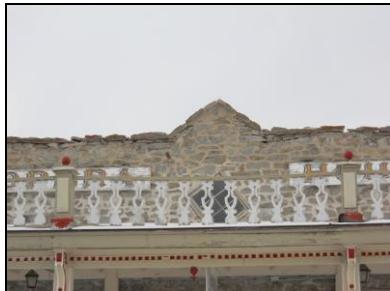
Opera House: Good

The Opera House, built in 1900 as a livery, is one of Virginia City's most utilized buildings as the home of the Virginia City Players. The façade of the Opera House is rapidly deteriorating. The mortar on the capstones and at least two courses of stone are visibly crumbling. This causes a danger to the pedestrians walking below, especially in the busy tourist season, when the Opera House is also very much a daily attraction. The loose mortar and stones need to be re-stacked from the stable level. The stones will be re-stacked using a compatible mortar to maintain historic integrity, as well as structural soundness. Any old mortar should be consolidated as needed. This project would either be completed by the in-house Preservation Specialists, or contracted out stone masons with knowledge of historic stone and mortar work.

Failing capstones on façade of Opera House might cause safety issues and look unseemly on one of VC's most popular attractions.

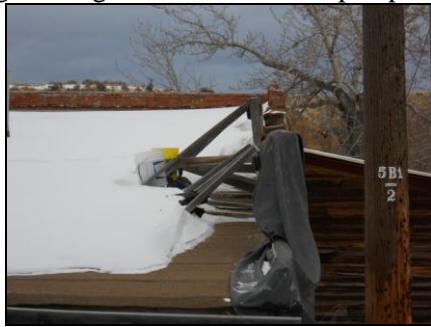
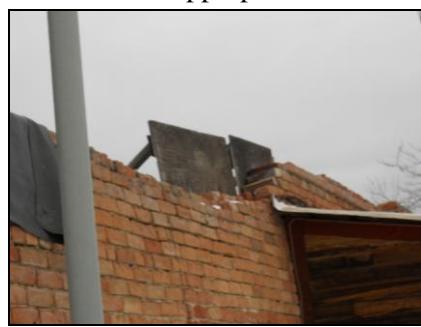
Buford Store: Fair

The Buford Store, built in 1875, is the first brick store in town. Unfortunately it is an un-reinforced brick structure. Two years ago the building was compromised when someone climbed onto the roof and pulled down six feet of the brick parapet, which needs to be stabilized and rebuilt. There has also been seismic activity which has further deteriorated the mortar which holds the building together, along with the wind, rain and ice. One wall is leaning treacherously towards the roof. The brick wall will need to be re-stacked, using the original bricks, and the parapet should be re-laid with appropriate historic mortar.

Rubber sheeting and plywood buttresses are employed to keep the brick parapet from collapsing all-together. These are temporary measures until the problem can be addressed with masonry.

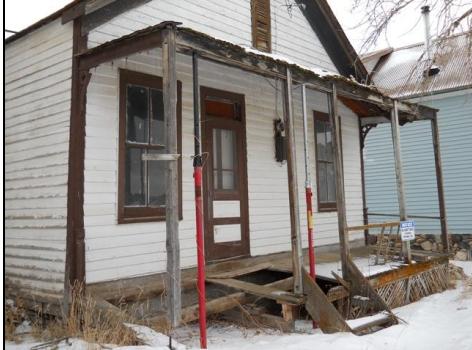
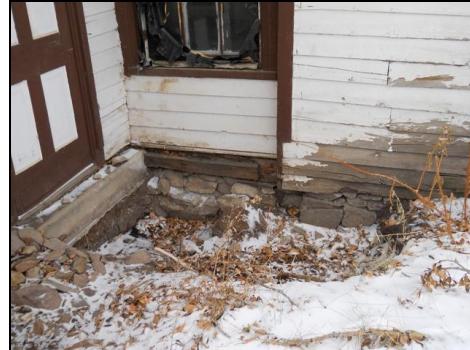
Hickman House: Poor

The excavation for the Hickman House was started by the MHC Preservation Crew but never completed. The historic building, built in 1869, would be extremely useful as housing for MHC seasonal workers, and needs to be completely excavated, jacked up for stabilization by replacement of rotted sill logs and sill plates, a new foundation poured, replacement of rotted floor framing and sheeting, gutters added, window and door repair, replacement of rotted porch, complete demolition of interior, and replacement and re-roofing of the accompanying outbuilding. Plumbing and electrical upgrades are also necessary.

The rotted porch and failed stone foundation of the Hickman House

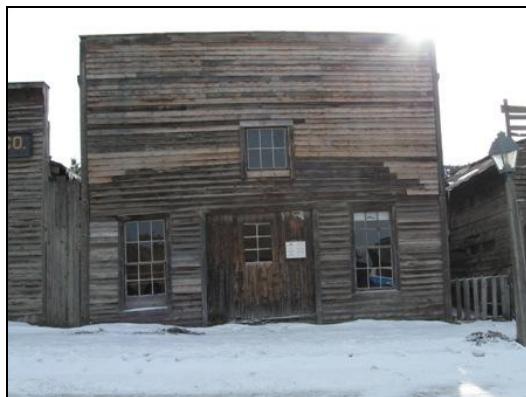
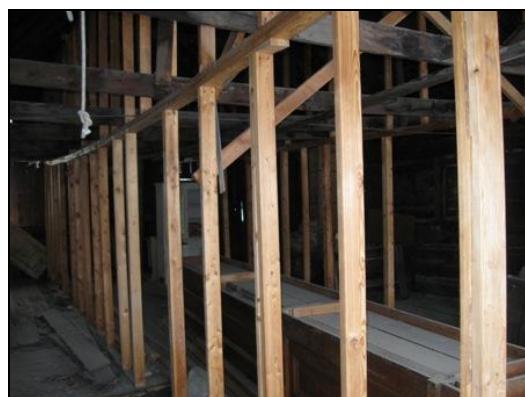
Prasch Blacksmith Shop: Fair

This building has appeared on the “never finished” list for a record amount of time: work began fourteen years ago. It is one of the many buildings on the main street with a fascinating history, having been a “hurdy-gurdy” dancehall when it was originally built, then converted to a blacksmith shop in the 1870s and used as such up to 1946. It needs footings poured (the holes have already been dug) and a timber-framed structure built internally to support the building. The floor itself needs replacement and the two forges need stabilization and chimneys in order for it to become a public display again. Gutters are also needed.

Though the clapboard false-front was preserved in 2009, the interior still retains the same temporary bracing that was placed in 2000 holding the roof up. This building was a display prior to the attempt at full stabilization, and the collections removed from the Prasch have put a strain on already overcrowded storage facilities.

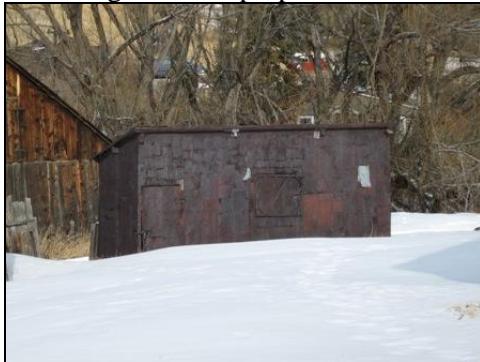
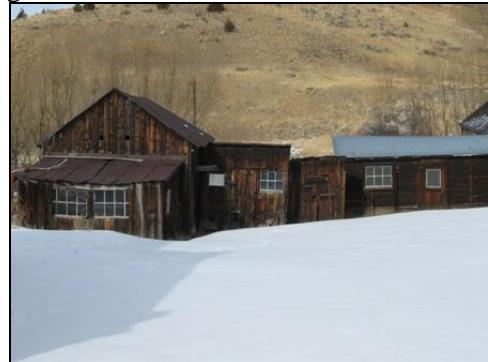
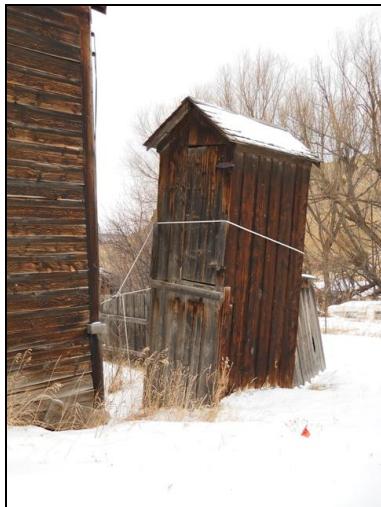
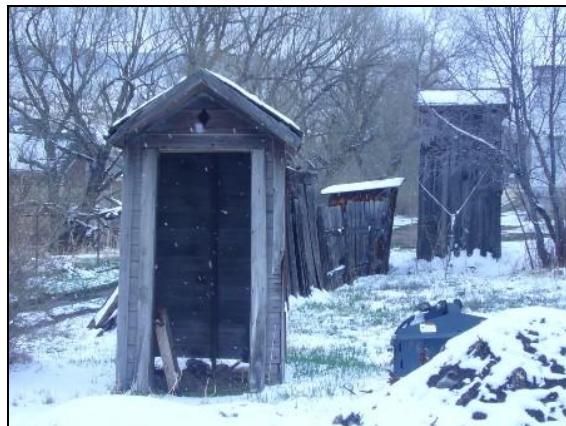
Cabbage Patch Buildings: Fair to Poor

The Cabbage Patch is a grouping of structures located with Block 154, one of Virginia City's oldest sections of town. It is a popular place for tourists to congregate, and it could be made into a small park area if it were cleaned up and stabilized. The buildings, though small in stature, need replacement of rotted sill logs and sill plates, replacement of floor framing and sheeting, new roofs, exterior walls repaired or replaced, new siding where needed, new fencing, and the stabilization and repair of outhouses, as well as window and door repair or replacement. The buildings sit directly on the grade, and need to be raised above grade with proper foundations and drainage.

These buildings sit on the ground, with the exception of the Toy Store 2 Story Outhouse pictured (bottom left), which has been held in place with a cable since 2004, to prevent it from toppling off its inappropriate foundation.

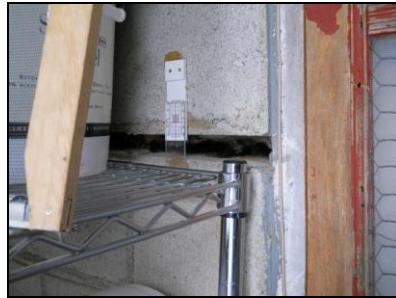
Figure 12: Crack monitor on the rear façade of the City Bakery shows the growing displacement of the building at an alarming rate.

The City Bakery is a Bovey partial reconstruction; as the original building had crumbled almost repair. It is currently being used by a concessionaire. The rear exterior of the building is in bad shape. The existing concrete block wall needs to be removed, excavated for footings and rebuilt. A crack monitor places on the building only five years ago shows a disturbing rapidity to its deterioration.

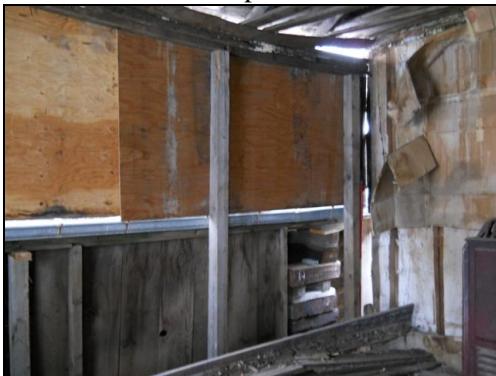
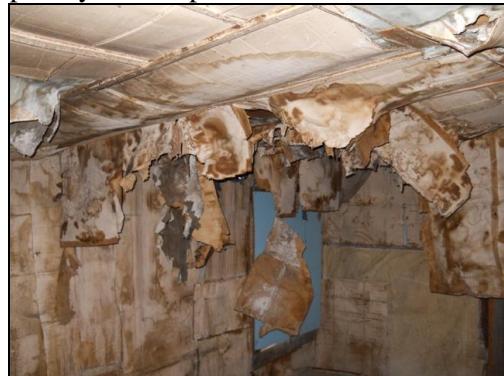
Coggswell Cabin: Endangered

The Coggswell Cabin is failing almost beyond the point of repair. It needs an entire new foundation system, and the roofing and framing stabilized and re-built, and a new roof. One log wall has completely rotted away, and all bottom logs need to be replaced. If we do not preserve this building in entirety it will collapse. It is extremely relevant to the social history of Virginia City, housing some of the earliest African American entrepreneurs in Montana and will hopefully be interpreted as such in the future.

No south interior wall remains in the Coggswell Cabin to shelter it from the elements, and the protective muslin covering what walls are left is clearly beyond repair with weather and water damage. This building is close to being classified as “Failed.”

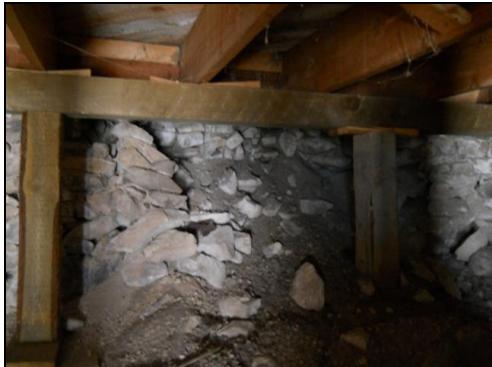
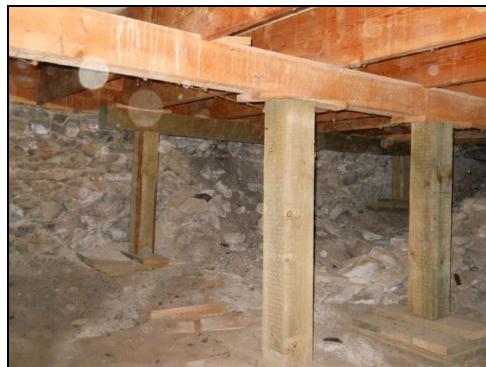
Montana Post (Print Shop): Threatened

The original portion of this important Montana building (1863) is in jeopardy below the ground level. It was built with no footing and we have already lost a section of stone. The only thing holding the building up are stabilization timbers placed over ten years ago. Drainage desperately needs to be addressed. In this crucial building, there needs to be a major excavation for the foundation, which includes jacking up and stabilizing the building, replacement of rotted sill logs and sill plates, a new concrete foundation, a repair of rotting floor framing and sheeting, a re-pointing of stone walls inside and out, addition of gutters, and window and door replacement and repair. The northeast corner of the exterior of the building is already showing signs of cracking. A seismic retrofit should also be considered, as with all stone buildings built without reinforcement.

Thought the stabilizing timbers are in good shape, this is a temporary solution to an eminent problem that will eventually arise within all unreinforced stone structures in Virginia City.

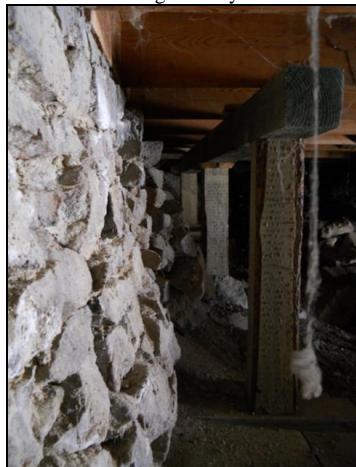
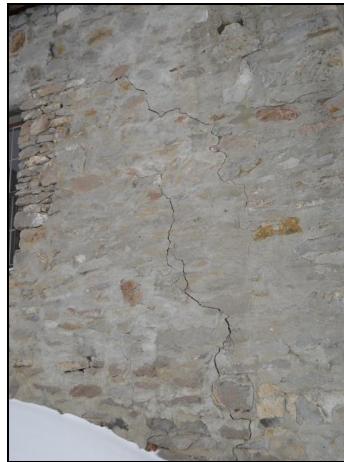
A view of the bowed out interior wall, and the exterior wall of the Montana Post building: Cracks are already appearing on the outside above where the section of stone has failed in the basement.

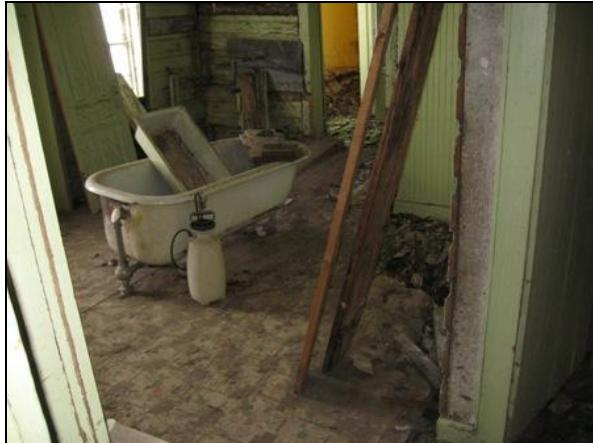
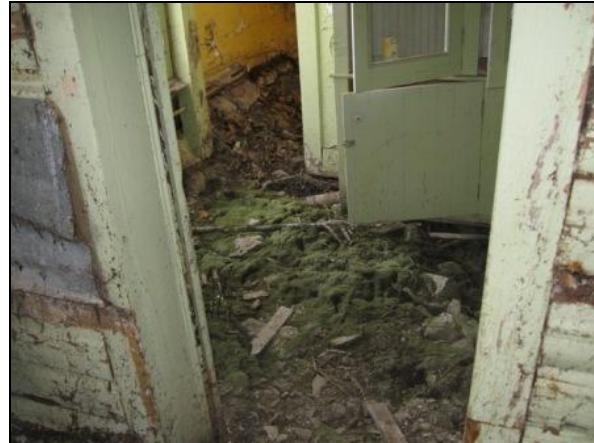
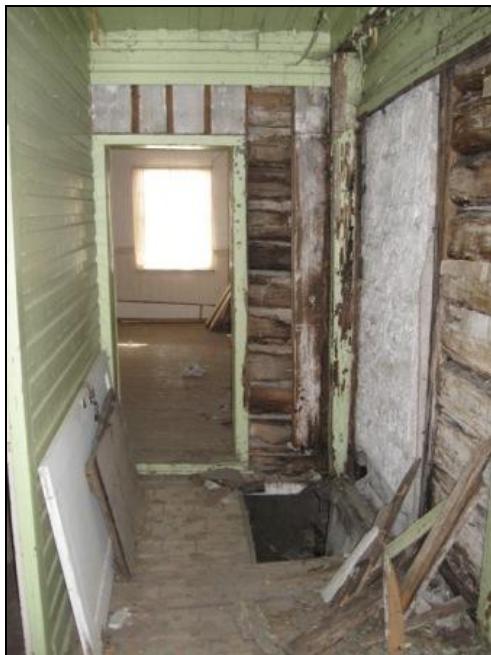
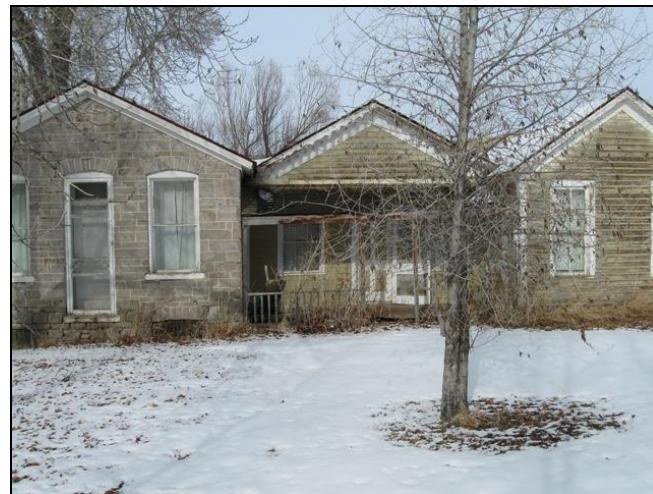
Gilbert House: Threatened

Built in 1864, this was the home of the Henry Gilbert family, who ran Montana's earliest standing Brewery in Virginia City. A \$100,000 grant was just awarded the MHC to stabilize the malting tower of the Brewery, which eased a dent in the building's preservation needs, yet no attention has been paid to the Gilbert home, a building which could serve many uses if preserved and brought up to code. It needs a major excavation both for drainage and a new foundation, replacement of rotted sill logs and sill plates, replacement of chimneys, replacement of flooring, window and door repair, and gutters. The interior has been neglected for decades and it appears that a natural spring, most likely an off-shoot of Daylight Creek, has opened beneath the northeast corner of the building, escalating its decline 18-20" below grade. This spring, along with a failing roof, has also caused extensive internal damage such as moss and mold growth in the roofing valleys, the floor, and all available surfaces. Also included in its preservation would be a complete electrical and plumbing upgrade.

The home of one of Montana's earliest Brewers is in danger of being beyond repair. The affect that the environment has had on this building could be an interesting lesson in adaptation, or lack thereof. It has as many problems on the outside as within, but the façade still looks attractive, and it still harbors treasures such as a claw foot tub (pictured, top left)

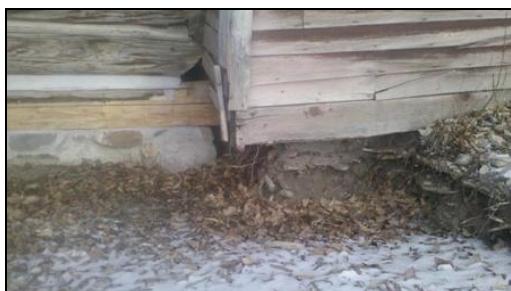
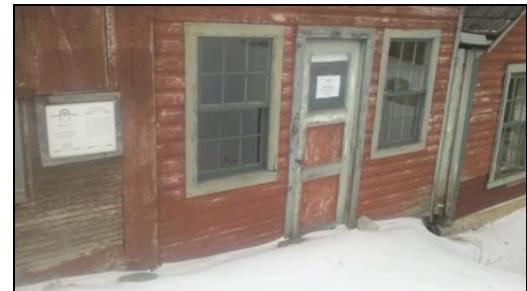
(Left photo) Rear corners of both Greenfront Buildings where they touch: the one on the left (V095) sits securely upon new sill logs and a new foundation, while the one on the right (V094) clearly needs to follow suit.

(Right photo) Front façade shows the preserved building on the right (V095) sitting high above grade, while the building on the left (V094) is still buried in the dirt (snow) and needs to be excavated and preserved.

The Green front cabins have been the primary focus of the Preservation team over the last couple of months. Excavation was started in early May focusing on the west cabin. The 3 sides of the cabin were excavated 3 ft. deep, removing the false foundation and rotten sill logs from the west side of the building. The front logs were removed as well. An 8"x16" footing was then installed around the 3

The team then set a row of cinder block on the footing and filled them with grout. A large rock was placed under each corner of the building. The building was lifted so the rock would fit, and the building was lowered back onto the rock. The large rocks are carrying the weight of the building. The team then started assembling the stone foundation. The rocks were set and pointed using a mortar formula of 2 parts Type S lime, 2 parts Portland cement, 10 parts sand.

The main focus on the Green front cabins during the months of September and October was to complete the exterior work before winter hits. The Preservation team finished the stone foundation around the three accessible sides of the cabin. The stones were set using a mortar formula consisting of 2 parts type "S" lime, 1 part white Portland cement, 1 part grey Portland cement, and 10 parts sand. After the foundation was completed, the area was back filled using big rubble stone on the bottom, and gravel to finished elevation to allow positive drainage around the building.

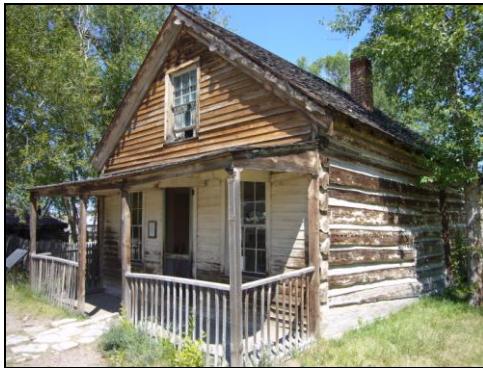
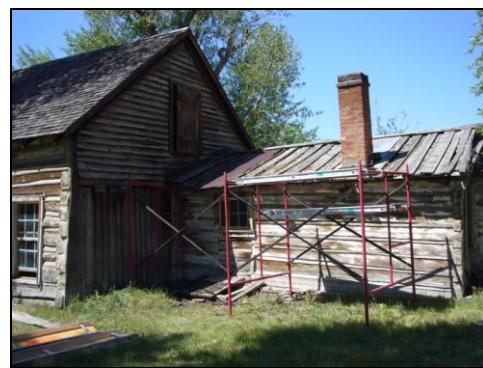
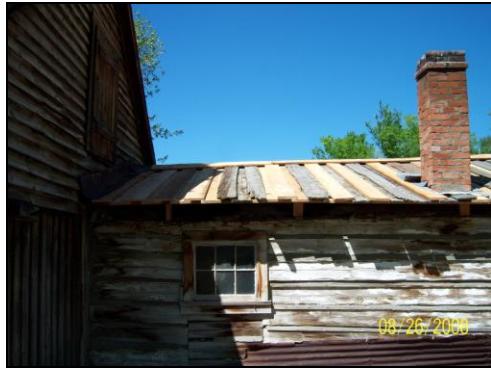
The Finney House kitchen roof, ca. 1912, received preservation treatment in the summer of 2008. The staggered plank roofing elements were also re-installed at their respective locations, with in-kind replacement of critically failed material conducted as necessary. However, there are other treatments that the building will need in the future.

Clockwise from top left: Finney House façade, the kitchen roof prior to stabilization, and the finished product.

The perimeter of the Finney House will need to be excavated in the future, the “Bovey Backfill” removed, and a new foundation placed beneath. Along with the foundation, new sill logs will replace the deteriorating ones. Re-grading and a new drainage system will be necessary. More attention needs to be paid to the (original) kitchen portion of the house. The south-facing log wall is noticeable deflecting due to the tilt of the chimney flue, which will need to be stabilized by providing lateral support for the flue, and the rear portion of the house (the stone “creamery”), is in need of re-pointing. Portions of the floor and sub-flooring in the front segment (the “main house”) were taken up during the assessment to see what the house was sitting on, and they have remained opened since 2008. The floor needs to be replaced and repaired, using original joists when necessary. Interior and exterior finishes will need to be treated, including daubing in the kitchen and plaster in the front and rear rooms.

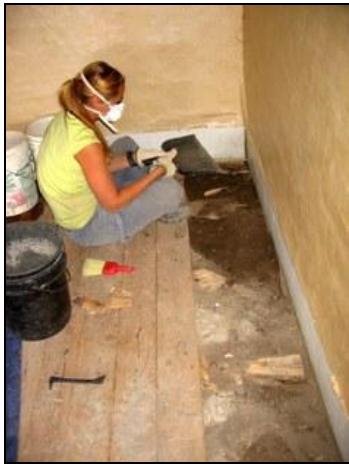
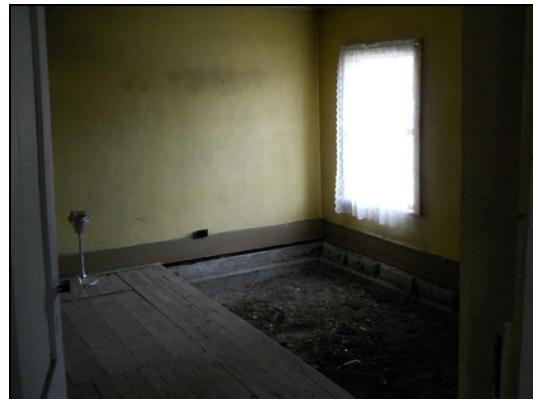
Above left and right: The author excavating soil beneath the floor for artifacts & building features in 2008, and a recent photo from 2012.

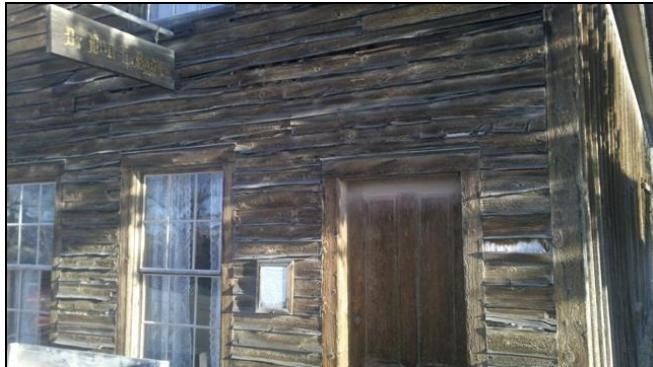
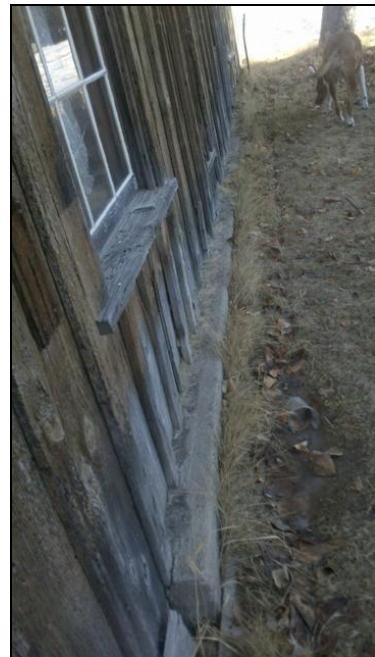
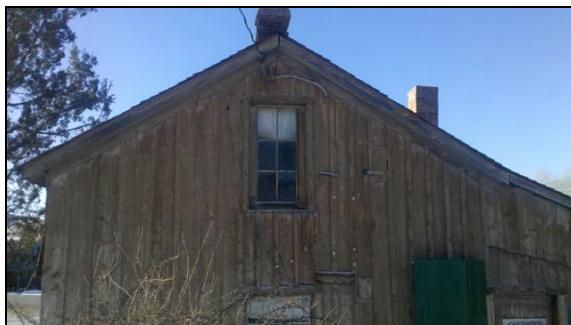
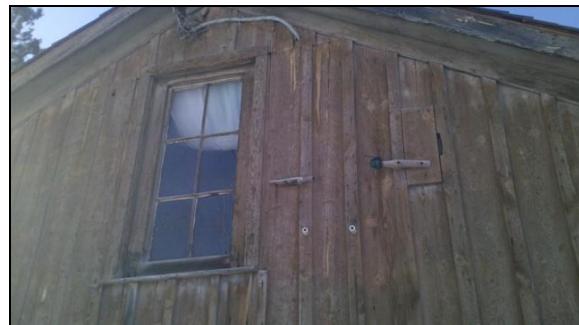
The Dr. Byam house is listed as Fair for several reasons. Firstly, it has foundation issues. It sits on a continuous poured concrete foundation that does not adequately lift it out of the ground. Due to this fact, it has drainage issues. The site needs to be re-graded to keep the lower wooden members out of the ground to prevent rot. The exterior clapboards and finish are in need of repair. The lack of paint has caused weather damage that looks unseemly and does not protect the building. The roof, replaced in 1997, needs to be monitored. The board and batten members will need to be repaired. It is sound, but needs to be monitored.

Clockwise from top left: The front façade needs clapboards replaced in kind. The windows are in good shape from recent preservation. Framings could use consolidation.

“Bovey Backfill” traps moisture around the base of the building, and does not allow the wood to breathe, causing rot.

Building has knob & tube electrical fixings hanging off of the rear façade. A bird nests just below the eave. Vegetation needs to be addressed.

The Dr. Byam House requires an excavation of the perimeter of the building, the removal of the “Bovey Backfill” encapsulating the foundation, removing the actual foundation and replacing it with more appropriate materials, the installation of a French drain on the east façade, and an appropriate drainage system to the west. The board and batten members that are failing need to be replaced, as well as the clapboards which diminish the appearance of one of Nevada City’s most important buildings, and a fresh coat of paint need be applied to protect the wood exterior and elongate the life of the structure.

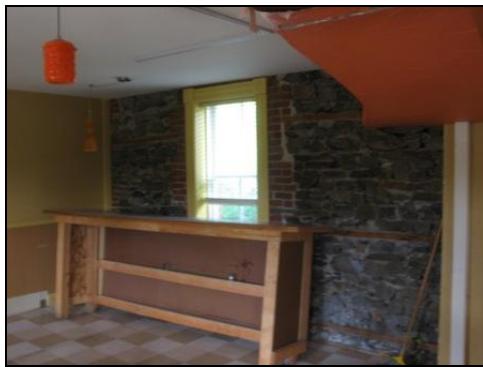
The stone and brick wall was preserved beneath a new wall.

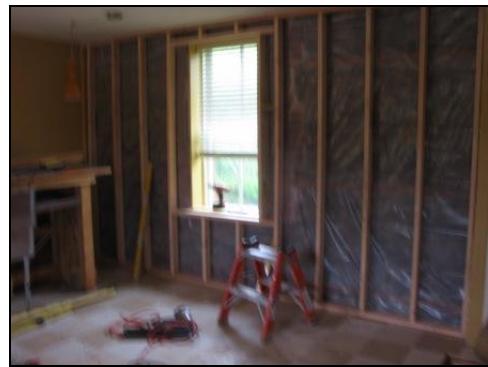
The plastic coating and stud wall before the sheetrock is placed.

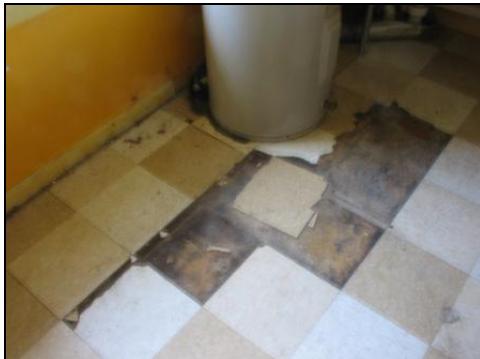
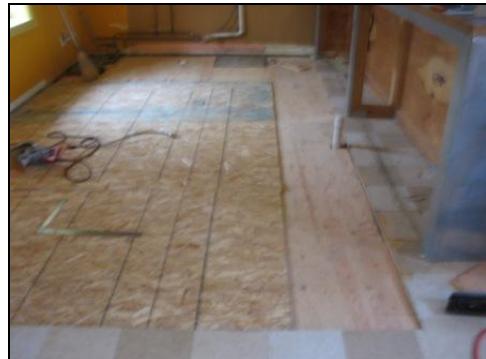
A broken hot water heater damaged the floor, causing the joists to rot. It was removed, and a new floor was put in its place.

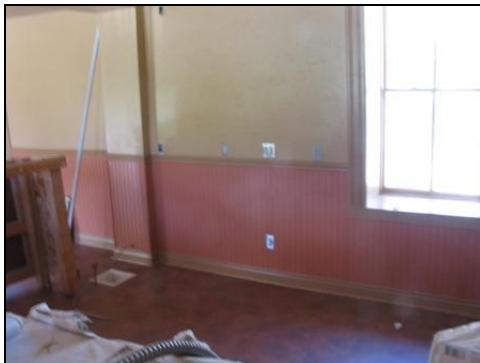
Wainscoting was installed along the base of the wall.

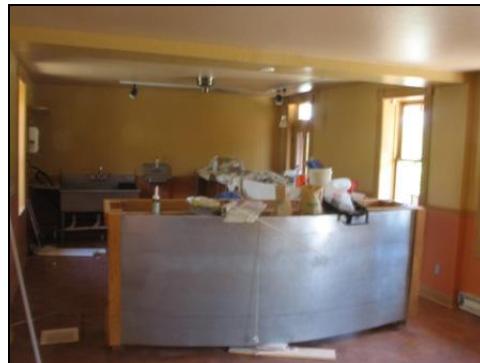
A view of the restaurant, almost complete.
