Biennial Report to the Montana Preservation Review Board

on the Stewardship, Status and Maintenance Needs of the Heritage
Properties of Montana State University

For the Reporting Cycle 2018 – 2019

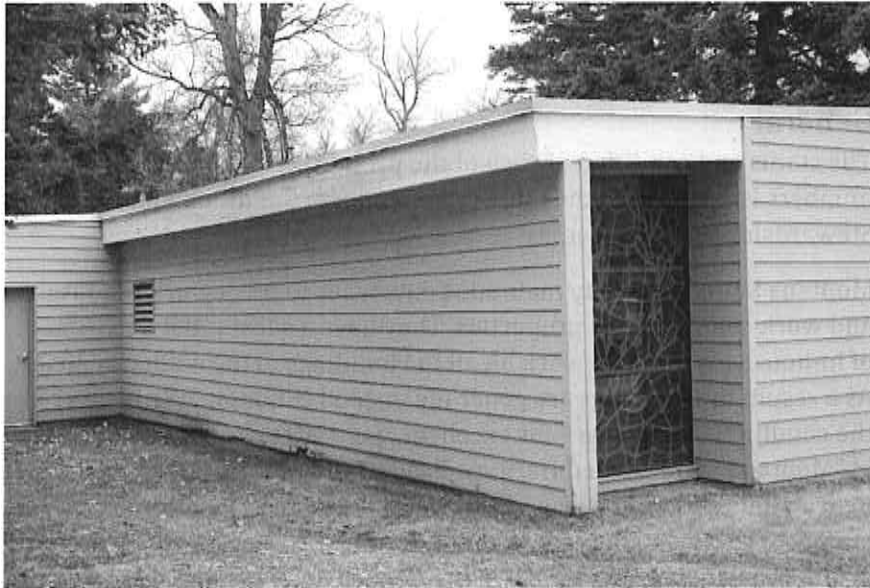
Danforth Chapel (24GA1796

Danforth Chapel has been downgraded from good to fair condition. Wood fascia and siding boards are rotting and causing the paint to flake off.

Figure 2: MSU-Bozeman's Danforth Chapel. Photograph taken January 16, 2020. The wood fascias and siding boards are rotten, causing the paint to flake off. This photograph depicts a common condition on this building.

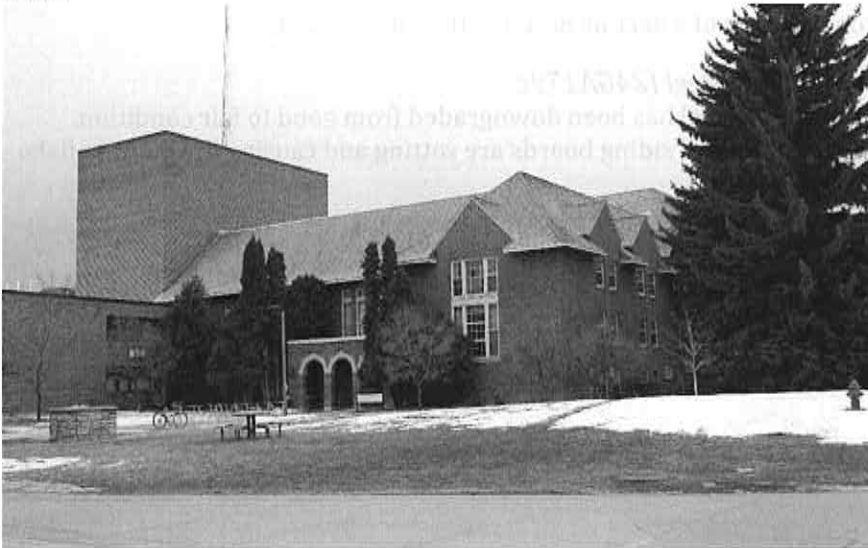
Strand Union Building (24GA1763)

The Strand Union Building has been downgraded from a condition of excellent to fair integrity. This correction reflects the impact of the overpowering additions to this once compact Jacobethan Revival building. The current building is approximately 7 times its original (1940) size, with additions constructed in 1957, 1967, 1971, 1983, and 2008.

Figure 3: MSU-Bozeman's Strand Union Building. Photograph taken January 26, 2020.

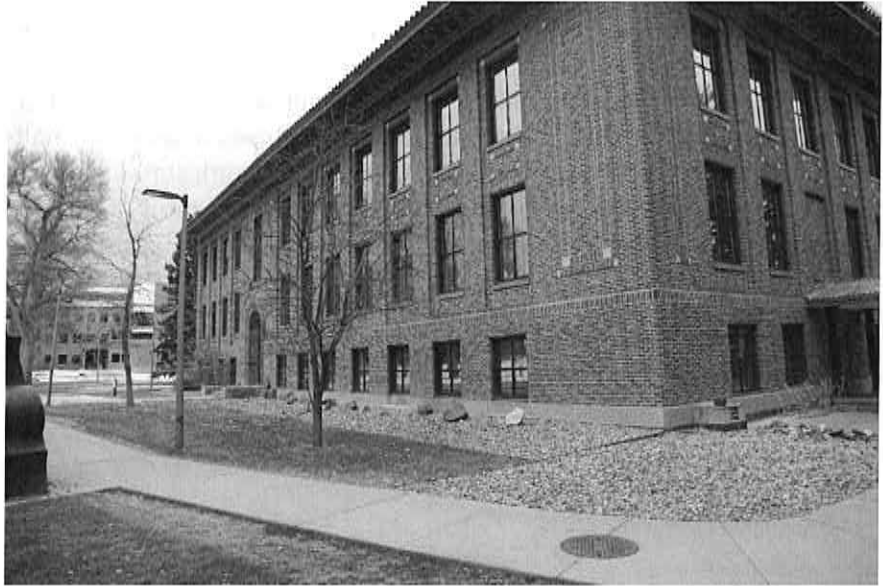
Traphagen Hall (24GA1889)

Figure 4: MSU-Bozeman's Traphagen Hall. The windows have been replaced. Photograph taken January 26, 2020.

Traphagen Hall has been downgraded from a condition of excellent to good integrity. This correction stems from the replacement of the original windows in 1986.

6. **Traphagen Hall (24GA1889):** Roof Replacement – Replace existing roof components including deteriorated underlayment, insulation, and flashing; and upgrade snow/ice fall protection.

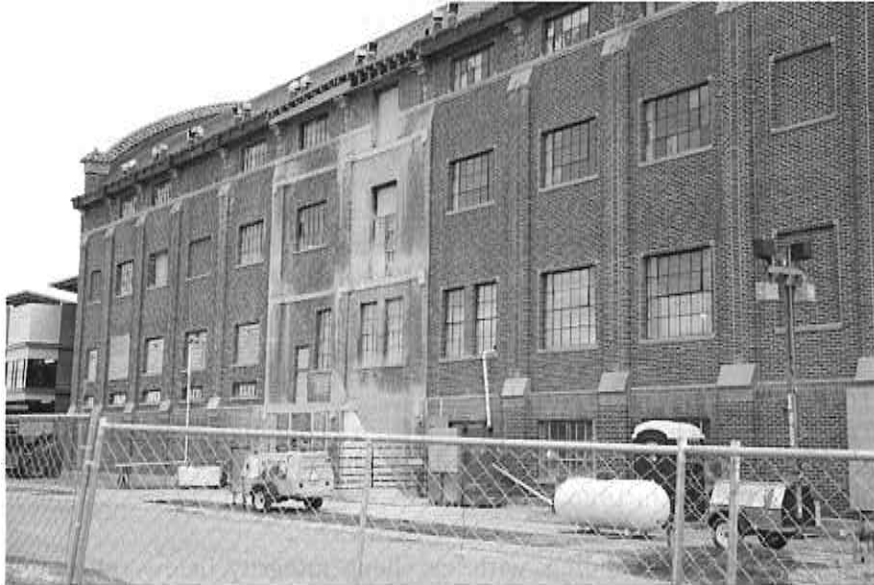
Romney Gymnasium/Hall's (24GA1884) integrity status has been changed to "Watch," to reflect the limbo of incomplete consultation with SHPO. During the early design stages of converting this gymnasium

building into a classroom building, MSU invited SHPO to participate in several review meetings held on campus. However, MSU did not initiate formal review with SHPO and has proceeded with the design and construction of the building.⁵ Much of the interior will be demolished to provide for handicapped accessibility in what had been a multi-and-half-layered flooring system, and the exterior (original) south stair hall has been removed. The primary concern at this point is the status of exterior integrity that would be supported by retention of the original steel windows.

Figure 5: Romney Gym, showing where the original south stairs and enclosure have been removed. Photograph taken January 26, 2020.

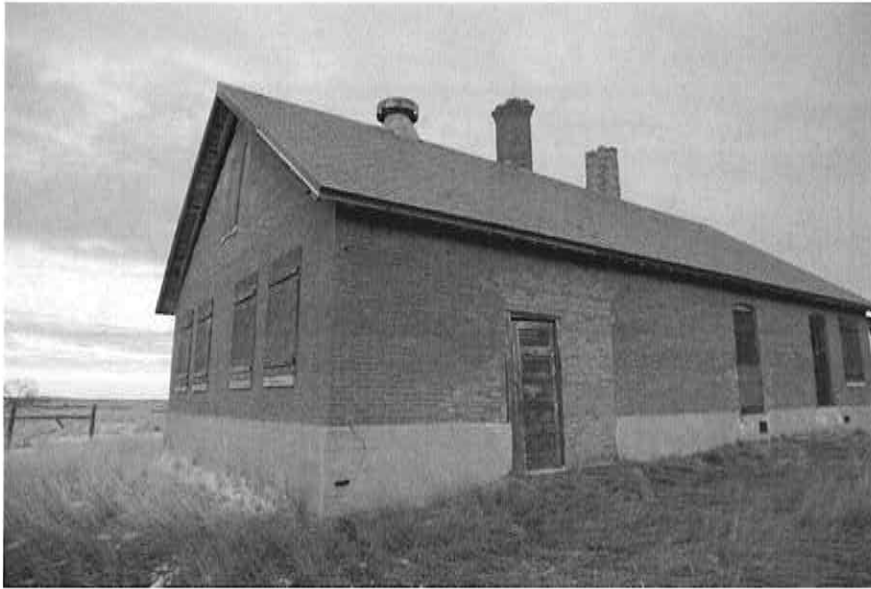
The integrity and condition of the buildings at the resources at Fort Assinniboine range from good to fair. MSU and the Ag Station no longer have offices or labs in the buildings, thus they use only a few of the barn buildings. A few of the Bachelor Officers' Quarters (Resource 1) and the Duplex Officers Quarters (Resource 2) are used as residences for the Ag Station personnel. The remaining fort buildings are used and monitored only by the Fort Assinniboine Preservation Association. The most recent

Figure 7: Fort Assinniboine's Double Cavalry Stable Guard and Shop (Rec. 10). Photograph taken January 22, 2020.

repair work performed on the buildings has been in response to weather-caused damage.

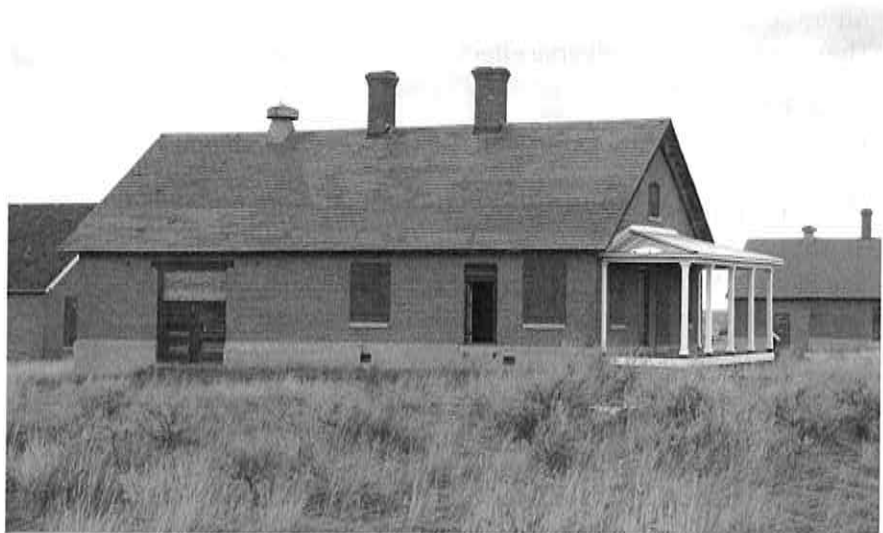
The Field Officers Stable #2 (c.1880), which weathered a 2015 storm that collapsed its roof and the top portions of the masonry walls, has since been demolished. After this 2015 storm, insurance settlements funded the reroofing of the three Double Cavalry Stable Guard and Shop buildings (Rec. 10, 11, and 12), constructed originally in 1905.

In addition to replacing the slate on the main gable roofs of these three buildings, the sheet metal roofing on the stable, extant front porch of Resource 11 was replaced.

Figure 8: Fort Assiniboine's Double Cavalry Stable Guard and Shop (Res. 11), constructed in 1905. Both the slate roofing of the front gable roof and the standing seam metal of the front entry porch roof were replaced. Double Cavalry Stable Guard and Shop (Res. 12) is visible in the background. Photograph taken January 22, 2020.

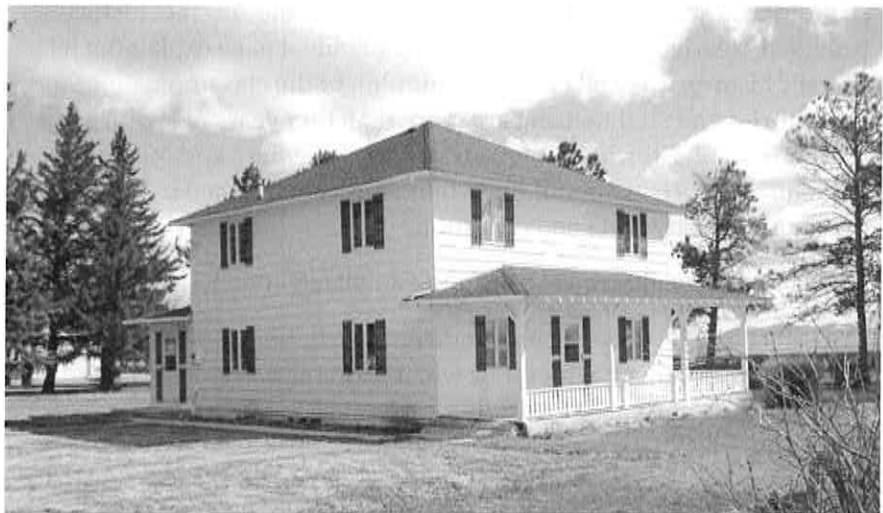
The Farmstead House, built in 1908 a year after the ag station was established, is in good condition. The rest of the buildings remain in fair to good condition. Both large barns (dated 1911 and 1922) were renovated in 2009.

Figure 9: Farmstead House (Building #4403) at the Central AG Research Center in Moccasin. Photograph provided by MSU (powerpoint), dated 2011.

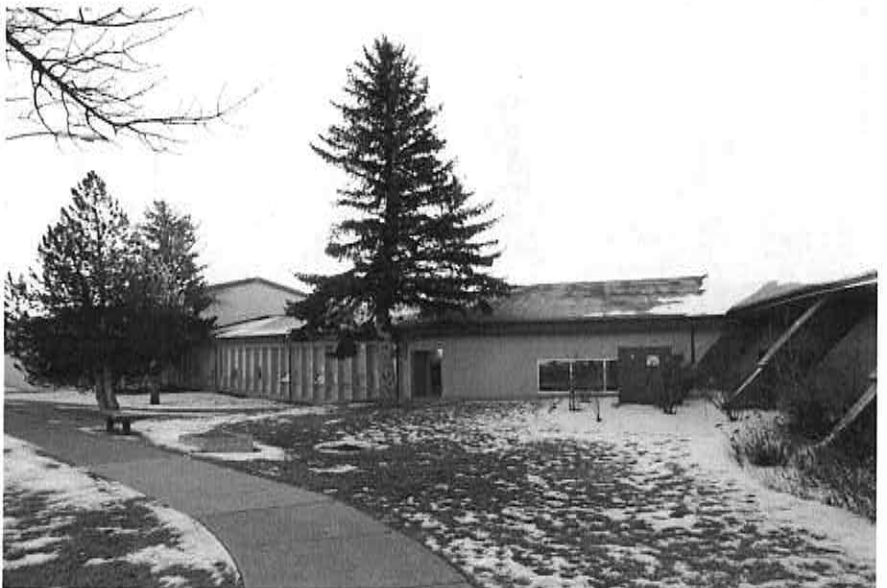
Figure 11: MSU-Northern's armory gymnasium, primarily at the right. The two left wings have been heavily modified. Photograph taken January 23, 2020.

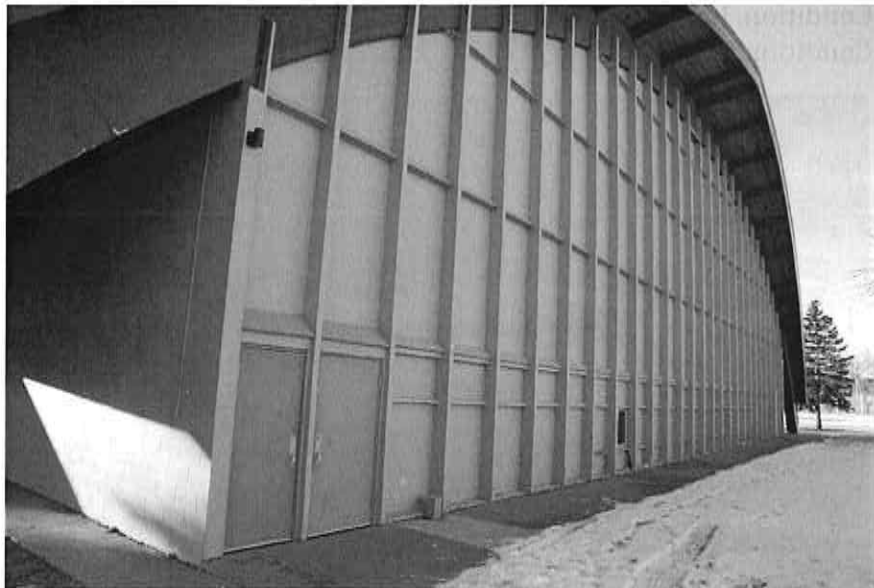
MSU-Northern's gymnasium is in good condition. The gym's roof has been repaired, yet needs to be replaced. The wood at the south wood curtain wall is becoming degraded in response to heavily worn paint; some of the wood is rotting. Pershing Hall is in fair condition; exterior preservation work is planned for this next reporting cycle.

Figure 12: MSU-Northern's gymnasium - south curtain wall of wood. Photograph taken January 23, 2020.

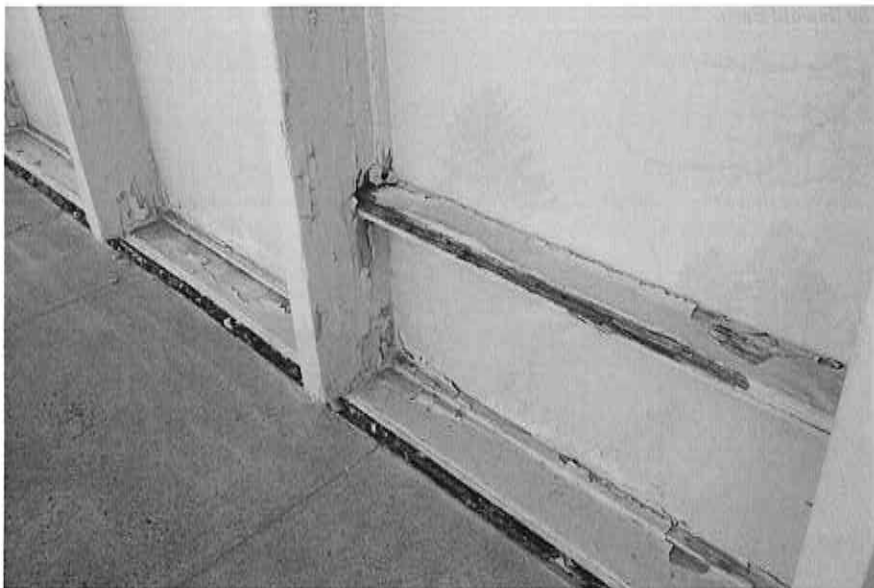
Figure 13: MSU's Northern gymnasium - close-up of rotten wood at south curtain wall. Photograph taken January 23, 2020.

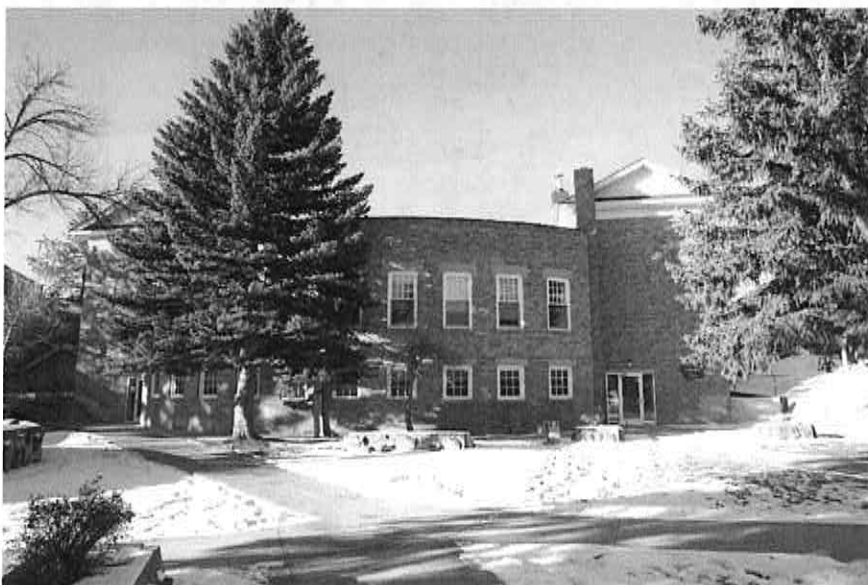
Criterion C for its design.⁶ Pershing Hall's good integrity reflects that while its massing and exterior are historic, the original windows have been replaced with vinyl windows, the brickmolds have been clad with sheet metal, and entry doors replaced with aluminum storefront units.

Figure 14: MSU-Northern's Pershing Hall, deemed a heritage resource in January 2020. Photograph taken January 23, 2020.

MSU-Northern Director of Facilities reports the intent to expend approximately \$160,000 on the exterior restoration of **Pershing Hall (24HL1654)**; \$350,000 for roof maintenance at **Cowan Hall (no assigned number for this 1949 iconic building)**, the **Metals Technology Building (1945)**, and another building. In addition, MSU-Northern has \$6m in authority for an interior renovation of Donaldson Hall (1936). Authority allows for MSU-Northern to raise the money to enact this project on this iconic campus building, located at the entry drive to campus. The building is currently off-line, due to code and accessibility-related deficiencies. In 2013, the exterior masonry of the building was restored for approximately \$400,000.

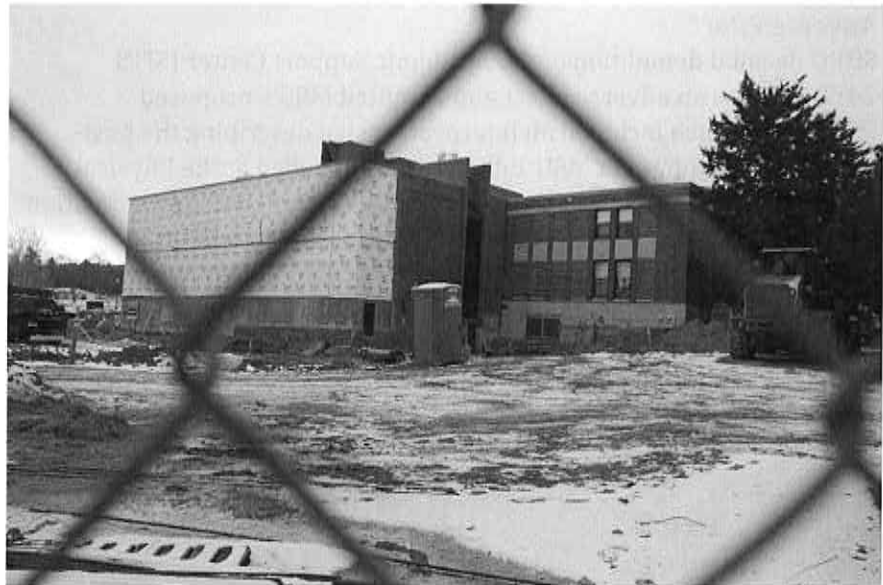
2. The 1947 Science Hall has been added to the heritage list. State A&E had the building documented in 2019 and SHPO assigned it a Smithsonian number. The original building is in good condition and has good integrity. The 1977 addition is currently being supplanted with a sizable addition, representing "...a nearly 70% increase in square footage..."⁷ Groundbreaking for this \$15m addition was concurrent with submittal of the drawings to SHPO. Thus SHPO did not comment of the design, because this action was considered foreclosure of the consultation process. The overpowering size and mass of the addition shifts the building into the endangered status.

Figure 16: MSU-Billings Science Building's addition under construction; view from the southeast. Photograph taken January 12, 2020.

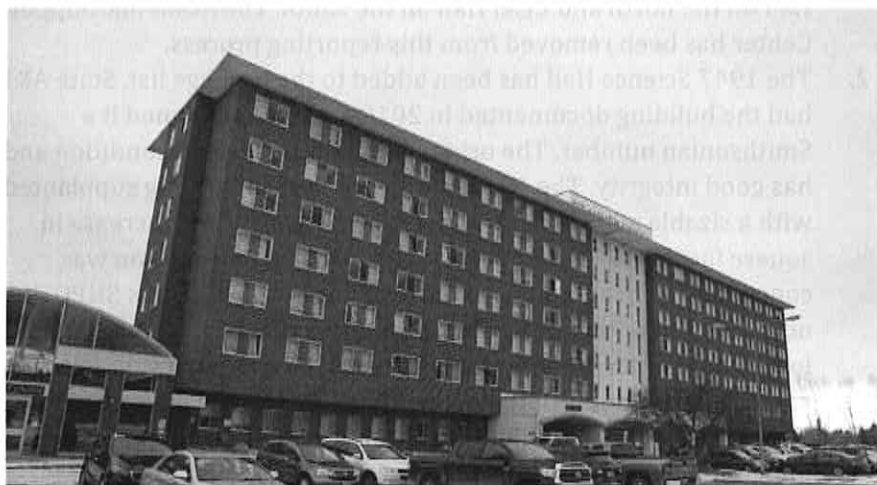
Figure 17: MSU-Billings' Petro Hall, constructed in 1966. Photograph (from the northeast) taken January 12, 2020.

Petro Hall, constructed in 1966, at MSU-Billings reached the fifty-year mark in 2016. Any work planned for this 147,664-square-foot dormitory should be preceded by SHPO consultation. SHPO can then ascertain if it is a heritage property. If so, a Smithsonian number will be assigned and formal consultation will be required for proposed projects. It is our understanding that no exterior changes are planned, but that “Interior finishes and floor-floor renovations as part of current Auxiliaries master plan” are being completed.⁸

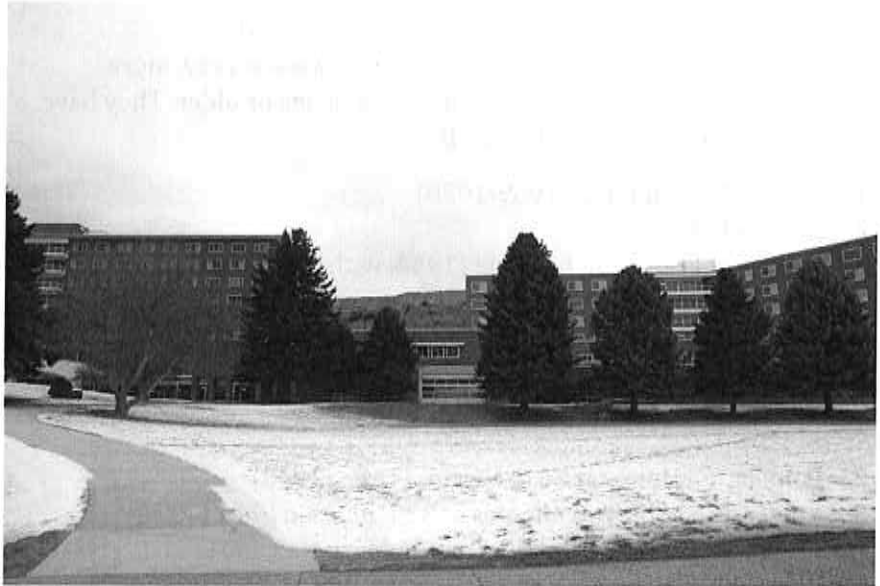
Figure 18: MSU-Billings, site where the Academic Support Center stood. Petro Hall is to the left and Rimrock Hall is to the right, flanking the Student Union Building. Photograph taken January 12, 2020.

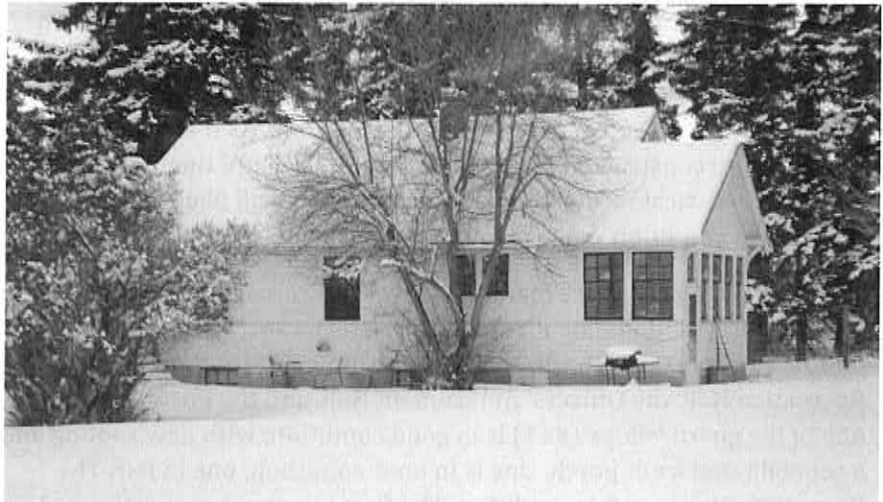
Fort Ellis Ag Experiment Station (24GA1894)

The 1931 residence (#1), designed by Shanley, Willson & Hugenin, benefited from SHPO consultation before the last reporting cycle. The planned demolition was cancelled and a historian documented – in a Montana Historic Property Record – the ag experiment buildings on site. The building remains on site and is used for storage until improvements can be made for habitation. A study was completed in 2017 to upgrade the residence for a station manager. The renovation of the building

Figure 21: Fort Ellis, Ranch House No. 1 (Building# 721), as designed by Shanley, Willson & Hugenin in 1931. Photograph provided by MSU (powerpoint).

occurred during the previous reporting cycle (September 2016 and June 2017), hence is not included in the Stewardship Costs for this cycle. Work included installing new storm doors, exterior windows, interior flooring, and restroom fixtures. Asbestos was abated from the flooring.

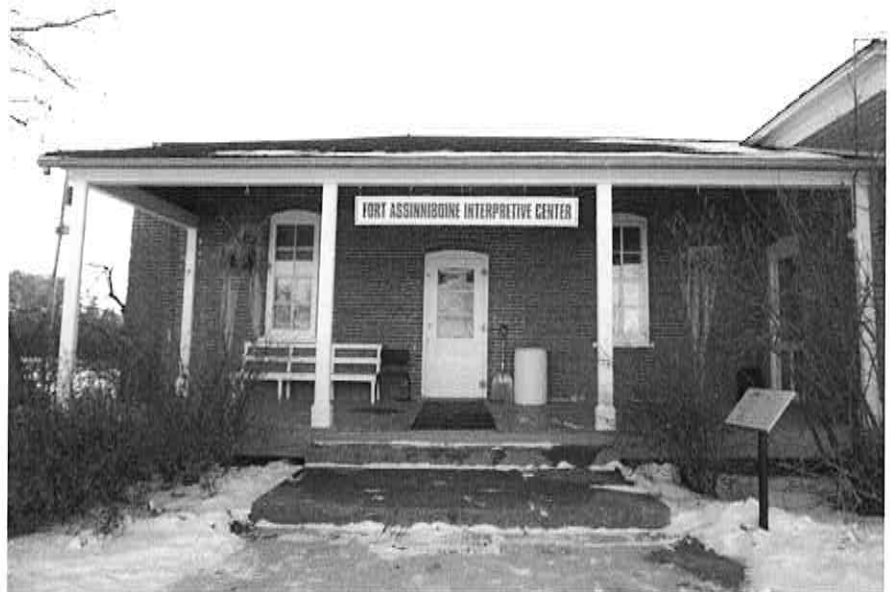
Figure 22: Fort Assiniboine, Post Library (c.1889), previously used for offices by NARC. The building is now used as an interpretive center. Photograph taken January 22, 2020.

Seven of the buildings are maintained by the Montana Historical Society and the Fort Assinniboine Preservation Association (FAPA): the three double cavalry stable guard/shops, the Ordinance Storehouse, Stable #4 Recreation Hall, the Officers' Amusement Hall, and the Post Library. Only one of the guard/shops (#11) is in good condition; with new roofing and a rehabilitated front porch. One is in poor condition; one in fair. The Recreation Hall is in fair condition. The Post Library is currently used as an interpretive center for FAPA; it is in fair condition.

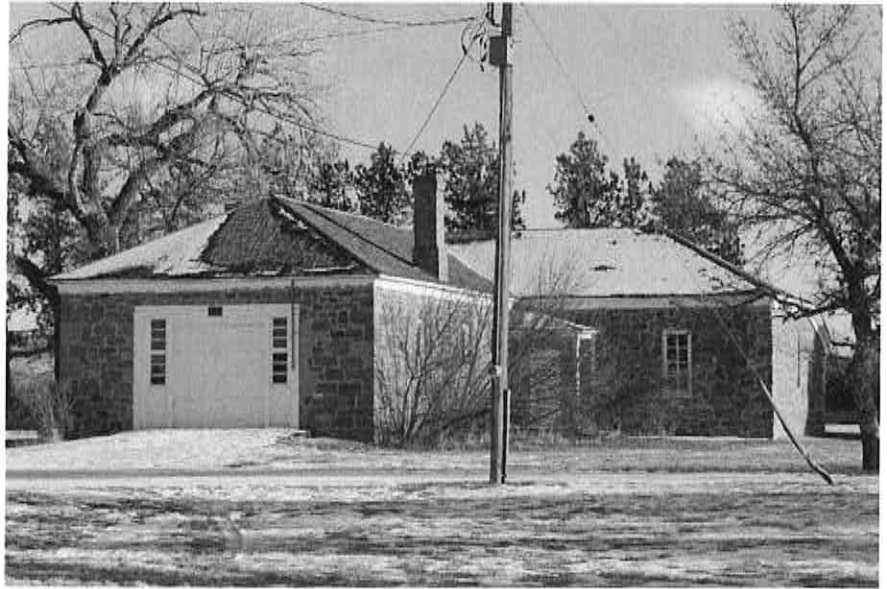
Figure 23: MAES Fort Assiniboine, Officers' Amusement Hall (Res. #6), as maintained in fair condition by FAPA. Photograph taken January 22, 2020.

As MAES vacates these buildings, a plan for shifting the care of them to the Montana Historical Society and FAPA should be investigated. Such an arrangement could include provision of some maintenance funding.

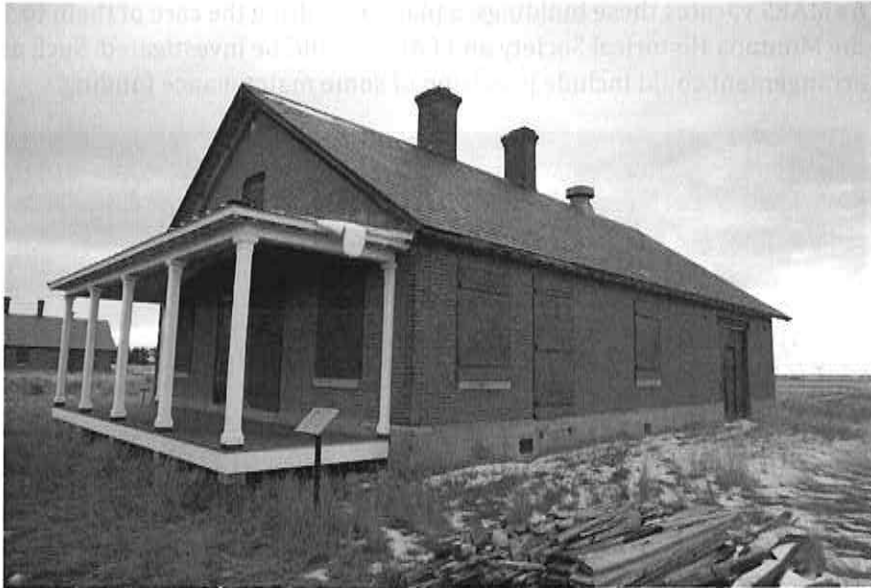
Figure 24: Double Cavalry Stable Guard/Shop #11, with new roofing and a rehabilitated front porch. Photograph taken January 22, 2020.

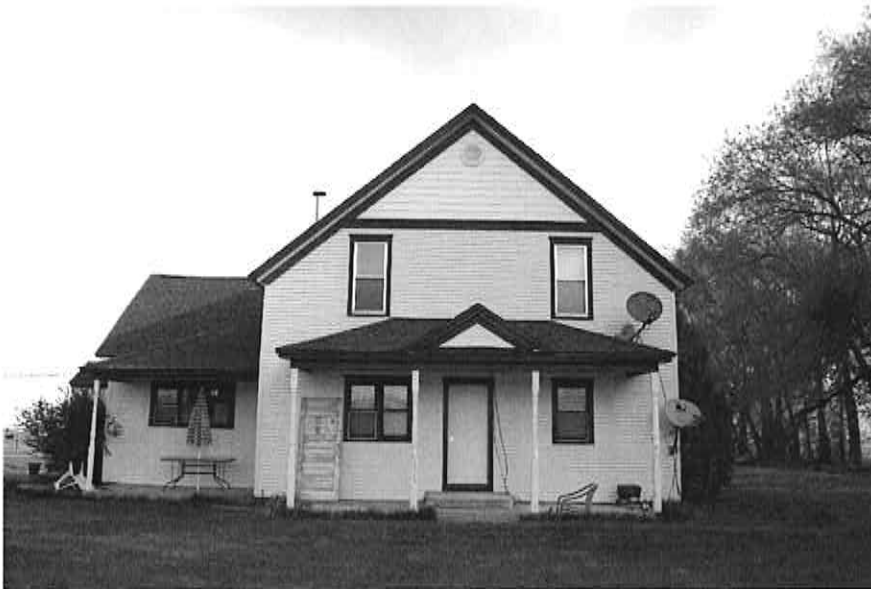
Figure 25: MAES BART - the Girvin Farmhouse. May 3, 2012.

The 474-acre property includes the historic Stucky-Girvin Farmstead from the late 19th century, and more recent farm structures from 1968 through 2012. The Girvin farmhouse, garage, and barn were reroofed in 2012.

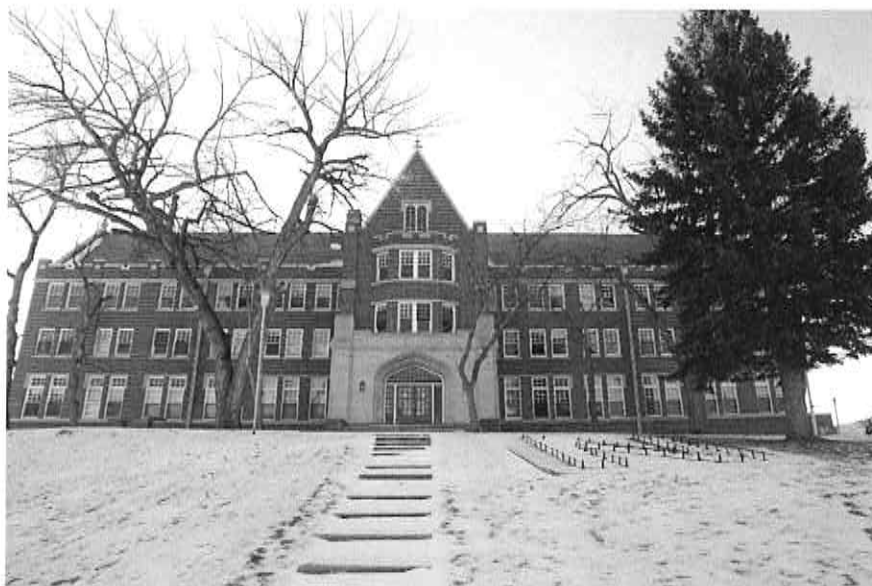
Figure 26: MSU-Northern's Donaldson Hall, constructed in 1936 as the second building on campus. The exterior of the building is in excellent condition and conveys a high degree of historic integrity Photograph taken January 23, 2020.

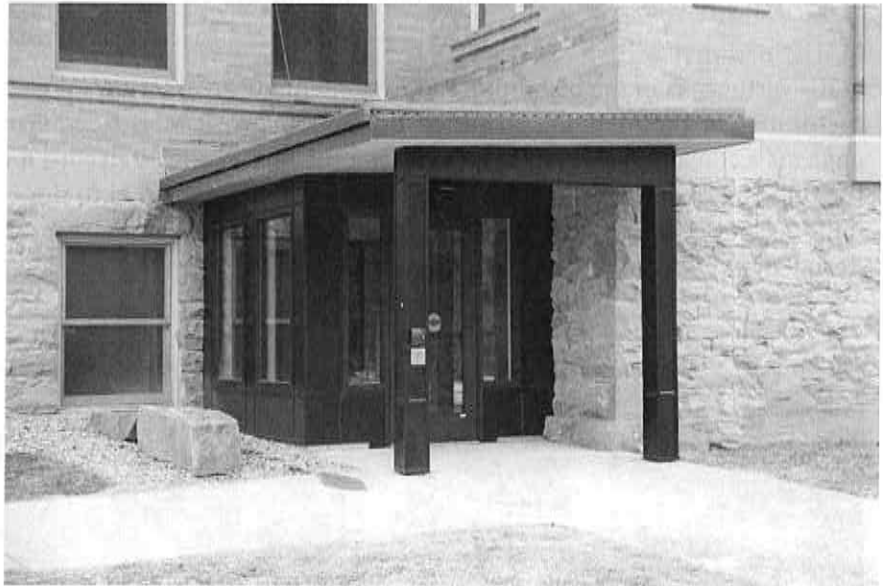
Figure 27: Montana Hall's newly constructed east exterior vestibule. Photograph taken January 26, 2020.

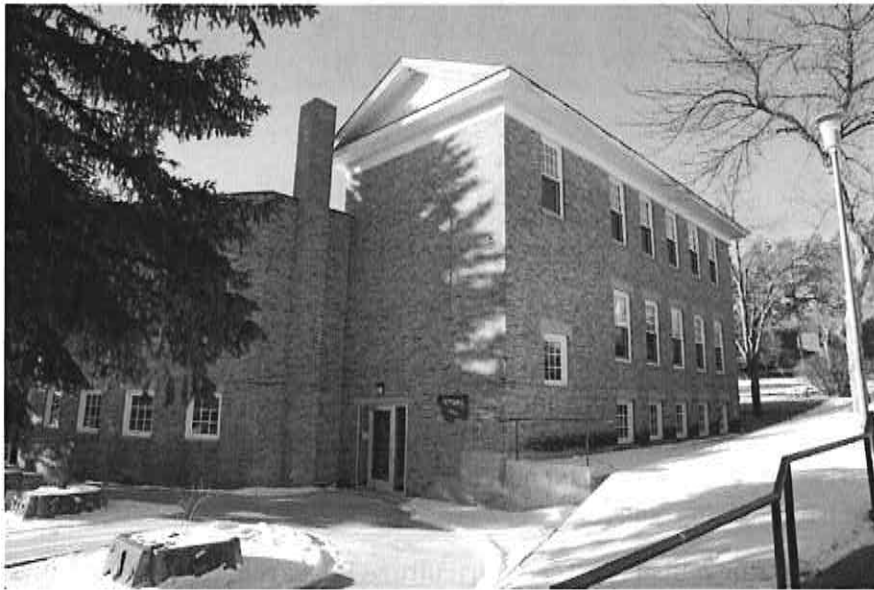
Figure 28: MSU-Northern's Pershing Hall, originally constructed in 1932. Photograph taken January 23, 2020.

MSU-Northern is in the beginning stages of planning an exterior restoration of Pershing Hall. In anticipation of this work, MSU-Northern engaged a consultant to prepare a Montana Historic Property Record for the building.¹⁴ SHPO conferred Smithsonian number 24HL1654 to the building. In December 2019, MSU-Northern submitted preliminary design drawings to SHPO, initiating formal consultation. *In process.*
