United States Department of the Interior  
National Park Service**National Register of Historic Places Registration Form**

**1. Name of Property**Historic name: Monture Guard StationOther names/site number: 24PW0047Name of related multiple property listing: N/A**2. Location**Street & number: Lolo National Forest, Seeley Lake Ranger DistrictCity or town: Ovando State: MT County: PowellNot For Publication: ☐ Vicinity: ☒**3. State/Federal Agency Certification**

Monture Guard Station Historic District  
Name of Property

Powell County, Montana  
County and State

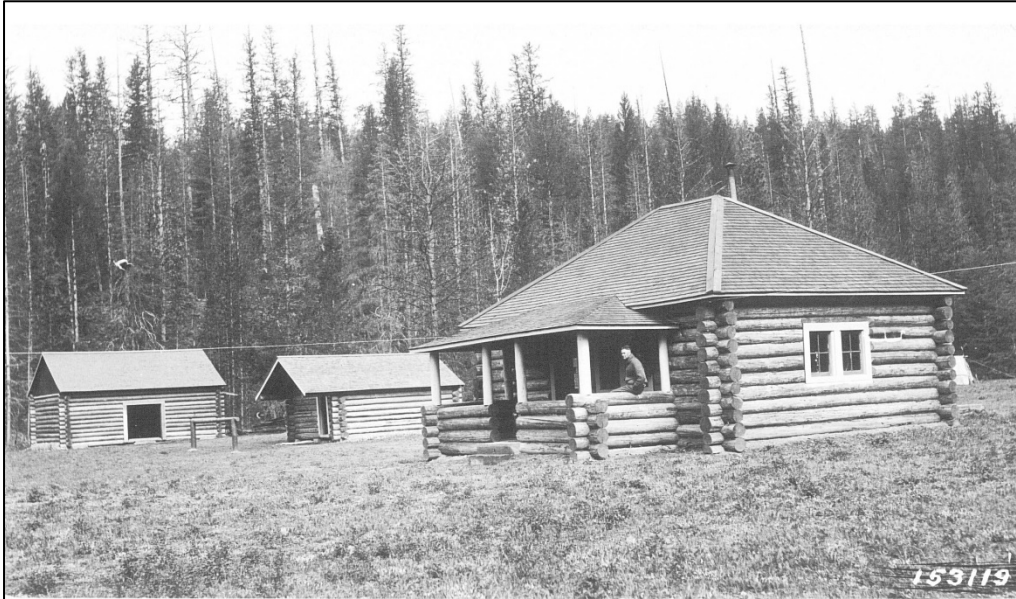
Photograph 001. MT\_PowellCounty\_MontureGuardStationHD\_001. Original residence, tool shed and barn, circa 1920. None of these structures are extant today. Courtesy of National Museum of Forest Service History.

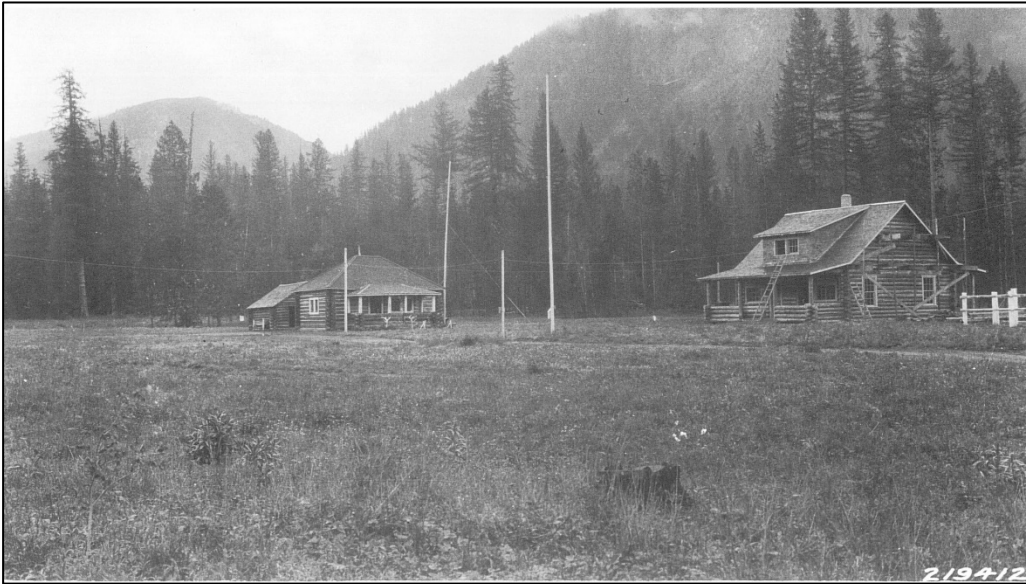
Photograph 003. MT\_PowellCounty\_MontureGuardStationHD\_003. Residence under construction, circa 1920. Courtesy of National Museum of Forest Service History.

Walter Robb, the Seeley Lake Ranger at the time, requested construction of a new residence in 1920 at the Guard Station (Bolton and Hubber 1990, p. 4). Historical photographs depict the residence under construction. The building has been subjected to several preservation efforts by the Forest Service over the past decade, including the replacement of rotting logs, replacement of the front porch materials, and applying new chinking between the logs.

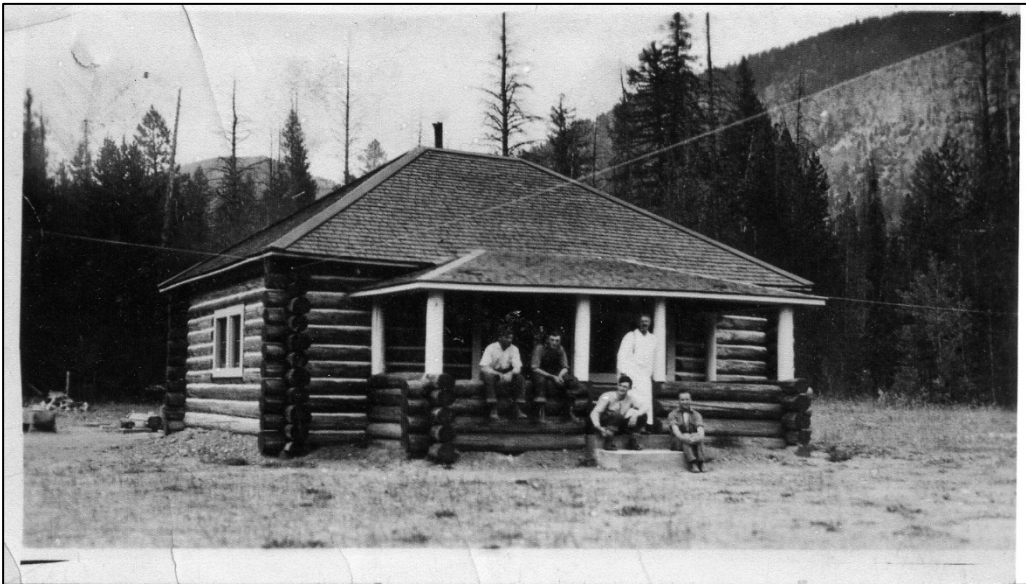
Photograph 004. MT\_PowellCounty\_MontureGuardStationHD\_004. Original Residence, circa 1920. Courtesy of Ovando Historical and Arts Society.

The Foundation under the dwelling was not done very well at the time of construction and the building is settling in a number of places. It is a rather good log structure and steps should be taken in the near future, when funds are available, to raise the building and put a good concrete foundation under it... when this is done it will be well to plan on the installation of a frost proof basement under the building for the storage of groceries for winter use and to provide access to the plumbing under the kitchen and bathroom... (MacLean 2014, pp. 53-55).

Despite the critiques, Fickes noted the quality of the residence: "It is a rather good log structure, and steps should be taken... to raise the building and put a good concrete foundation under it..."

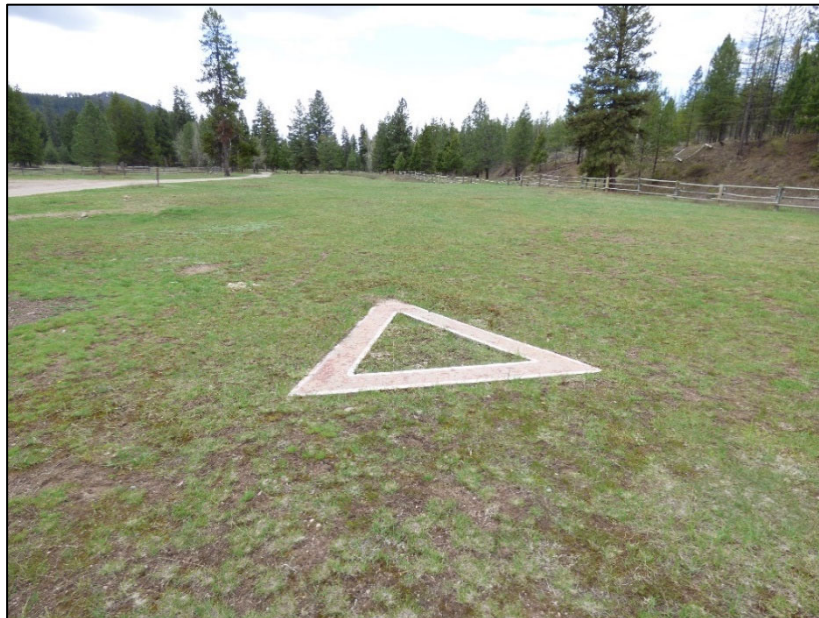
Photograph 015. MT\_PowellCounty\_MontureGuardStationHD\_015. Heliport, cement navigation aid, facing S.

**The Heliport (One Noncontributing Structure, 2003)** is a modern landing zone for helicopters used for firefighting. The flat area displays a concrete triangle that measures 9 feet by 9 feet by 9 feet used for navigation by pilots. The Heliport was constructed in 2003 (Tim Love, personal communication, 05/20/2022).

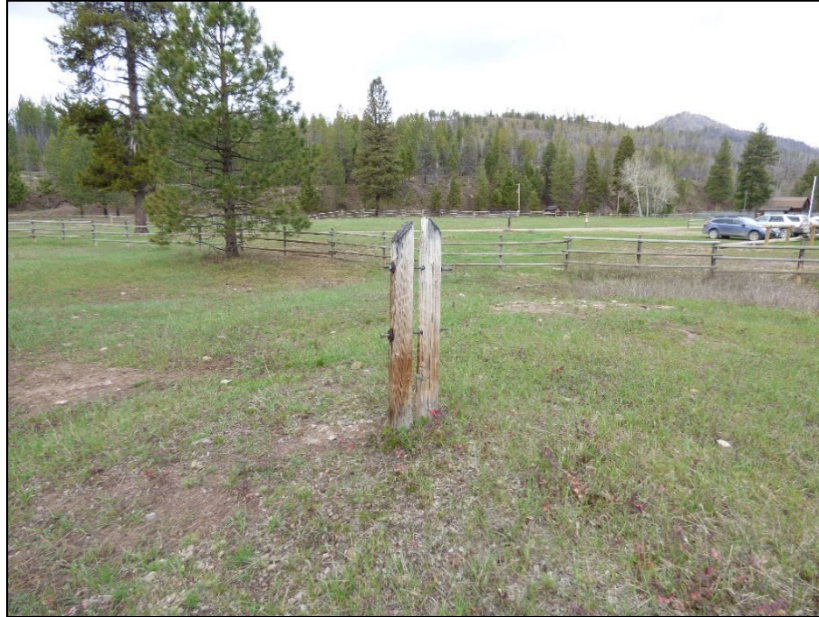
Photograph 024. MT\_PowellCounty\_MontureGuardStationHD\_024. Remains of the original flagpole, facing W.

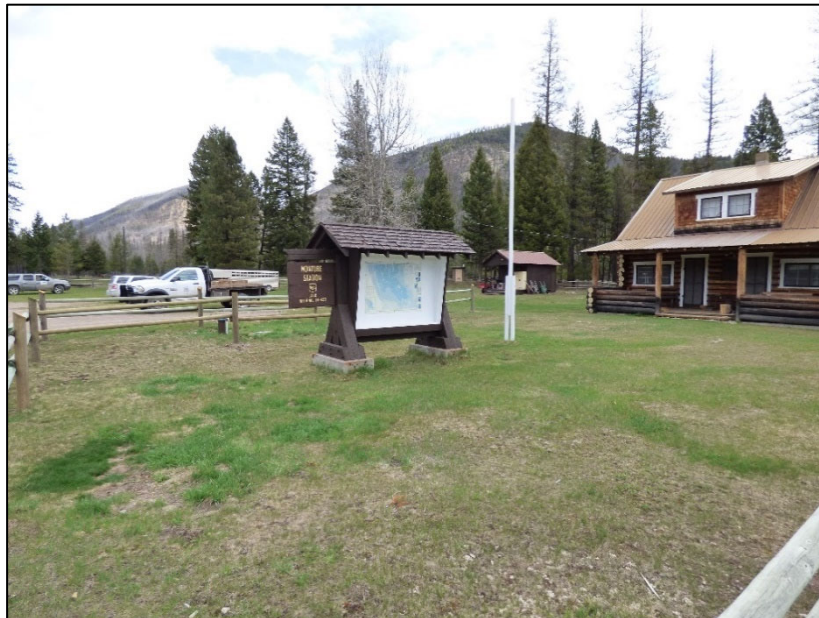
Photograph 025. MT\_PowellCounty\_MontureGuardStationHD\_025. Modern interpretive sign and flagpole, facing NE.

More recent additions to the property include the placement of a new flagpole and an interpretive sign that allows the public to better understand the Monture Guard Station's role. The Modern flagpole installed around the same time and near the interpretive sign stands more centrally located than the earlier flagpole. Another recent addition is a modern heliport that greatly assists the fire-fighting cause. The subtle and low profile of the heliport allows it to meld into the surroundings easily.

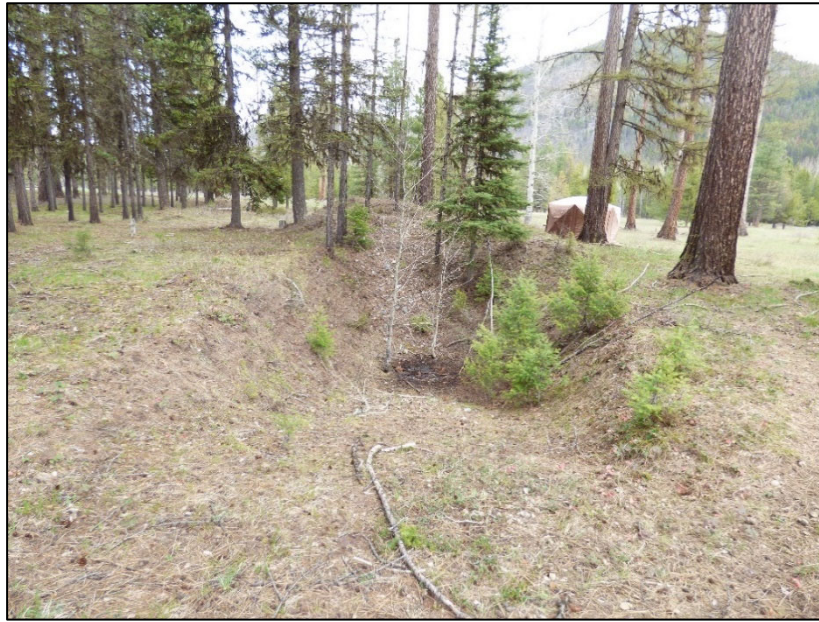
Photograph 026. MT\_PowellCounty\_MontureGuardStationHD\_026. Remains of reclaimed root cellar, facing N.

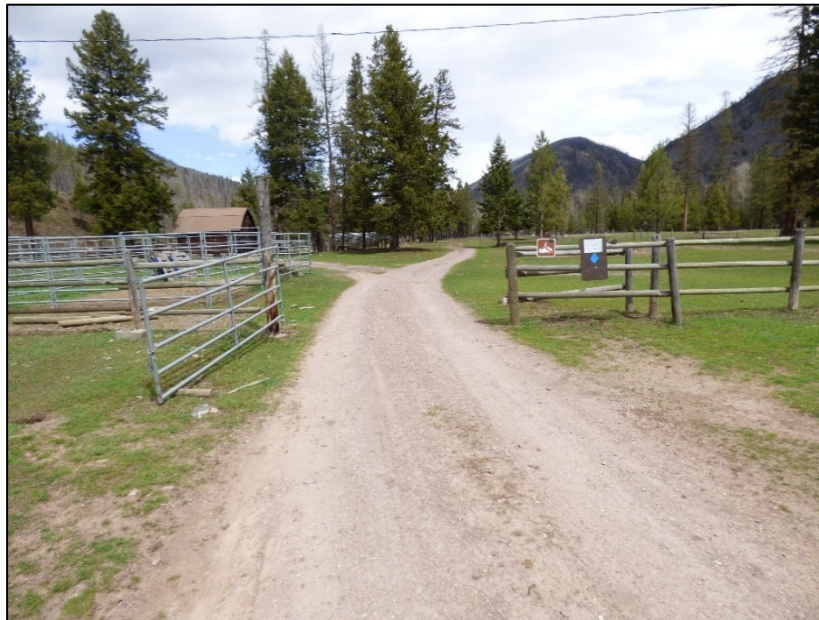
Photograph 031. MT\_PowellCounty\_MontureGuardStationHD\_031. Circulation network, road ends at the Barn, and the Forest Service pack trail #27 begins, facing N.

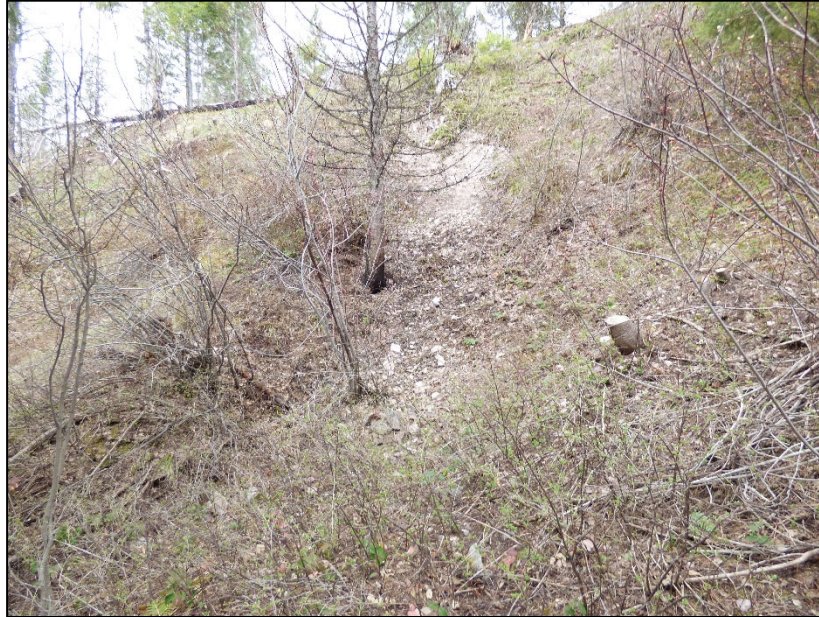
Photograph 32. MT\_PowellCounty\_MontureGuardStationHD\_032. Remains of the original root cellar, facing WSW.

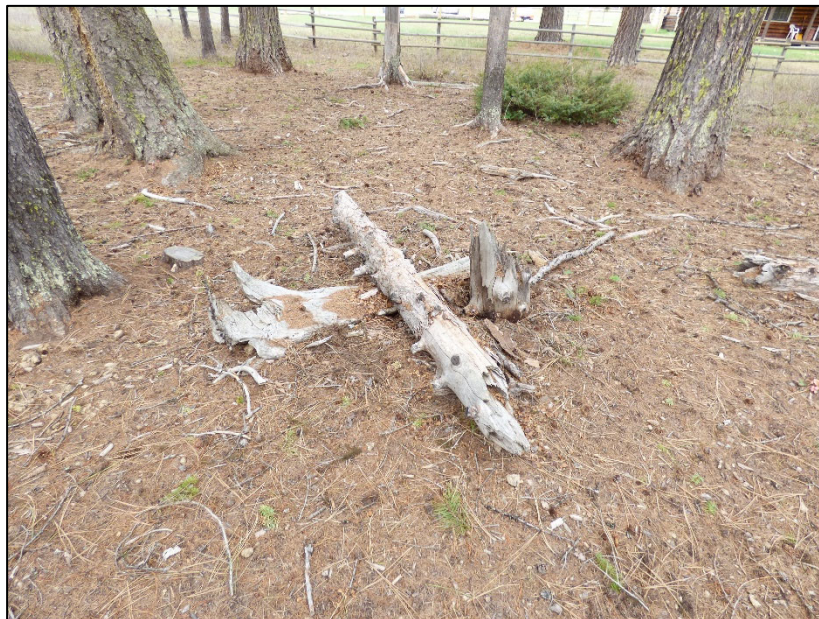
Photograph 33. MT\_PowellCounty\_MontureGuardStationHD\_033. Remains of the original cistern, facing. Years ago the Forest Service covered the cistern with a thick heavy plate of steel and logs to keep stock safe.
