University of Montana

State Agency Biennial Report 2016-2017 State-Owned Heritage Properties

Submitted February 6, 2018

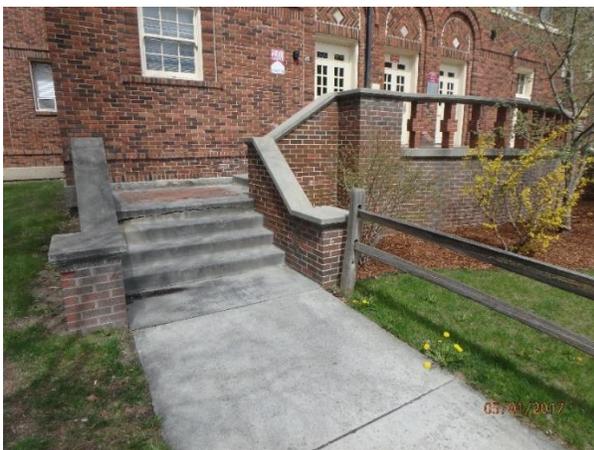
Picture 2: Elrod Hall steps: before – showing cracks in steps

Elrod Hall: the south brick entry stairs were in bad shape and leaking. Water was ponding due to lack of cross-slope. The brick stairs were removed and replaced with concrete stairs with brick inserts at the landings and handrails per code. The work was done by Reynolds Construction and designed by UM Campus Architect. SHPO was consulted on this project and approved the design. Project cost \$29,000.

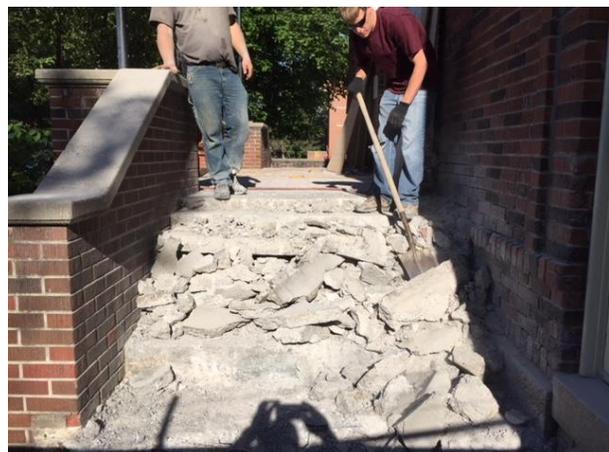
Picture 3: Elrod Steps: demolition work being done.

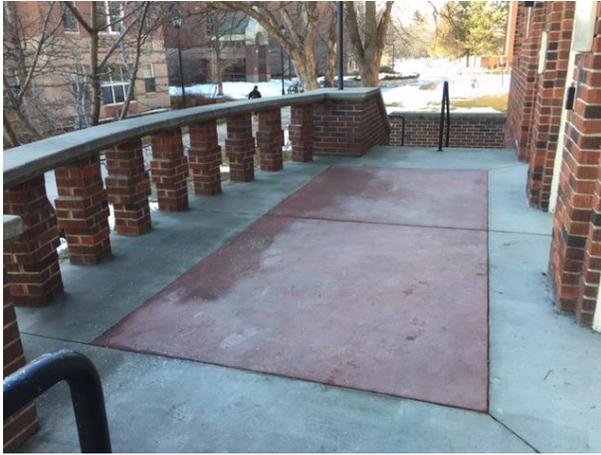
Picture 4: Elrod Hall steps: after. Upper landing

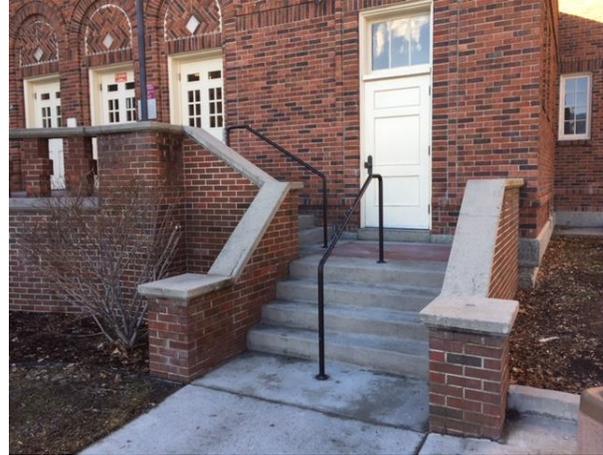
Picture 5: Elrod steps: new concrete steps & handrails

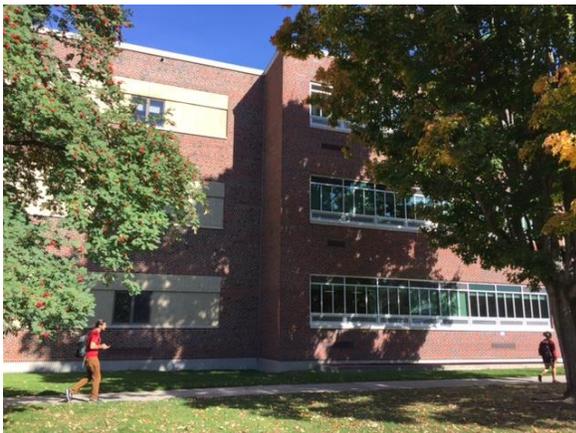
Picture 6: Liberal Arts: before Phase 2 remodel

Liberal Arts Building (24MO0471): \$2,200,000 have gone towards Phase 2 of maintenance and classroom enhancements in the South-central classroom portion the building that was designed by CommaQ Architects and constructed by Talcott Construction in October 2017. In consultation with SHPO, this project included the removal of plaster over rigid insulation board that covered the original windows within the rooms remodeled, and the replacement of those windows on the South-central portion of the building facing the Oval to recreate the look of a continuous ribbon of windows. The lecture hall 011 in the basement was also remodeled with the original plywood seats being replaced with new upholstered seats with better leg-room. The south windows were replaced with new storefront insulated windows that let in daylight to this basement lecture hall. A new curtain wall entrance was cut into the brick façade to allow entry directly off the Oval as well as student study lounges at each floor level. Funding for this came from a private donor & the academic wing of LA Building was named Dennis and Gretchen Eck Hall by the Board of Regents in September 2017 in honor of the donors. This follows on \$1,500,000 worth of classroom and audio-visual technology upgrades done in Phase 1 that was completed in August 2016, also from private donor funds.

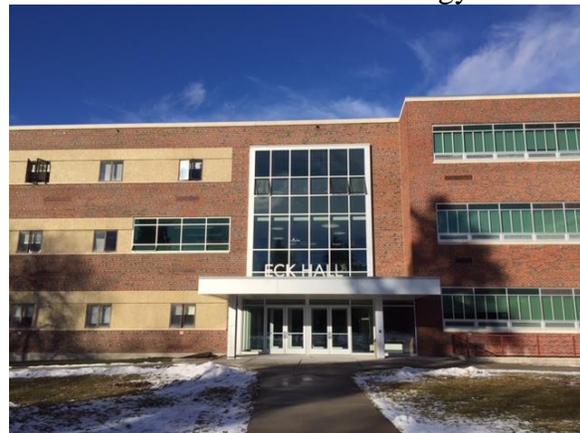
Picture 7: Liberal Arts: new entryway off the Oval

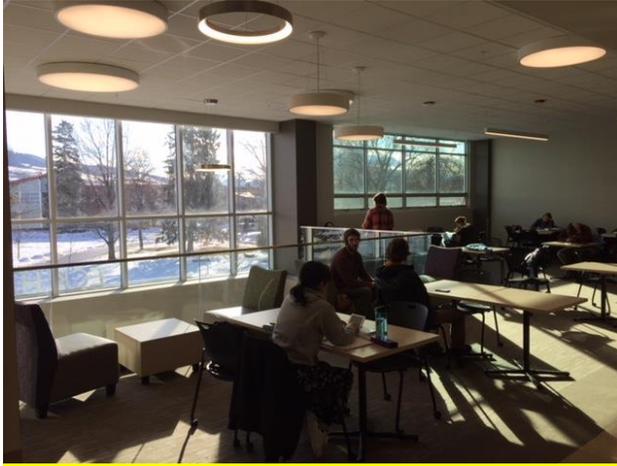
Picture 8: Liberal Arts: new 2nd floor student lounge

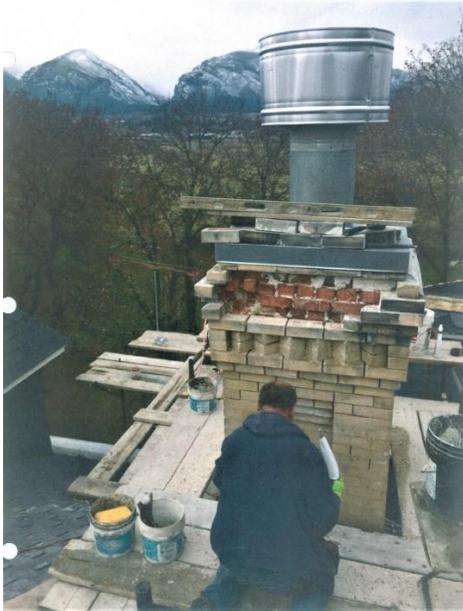
Picture 9: Daly Mansion: brick chimney being repaired

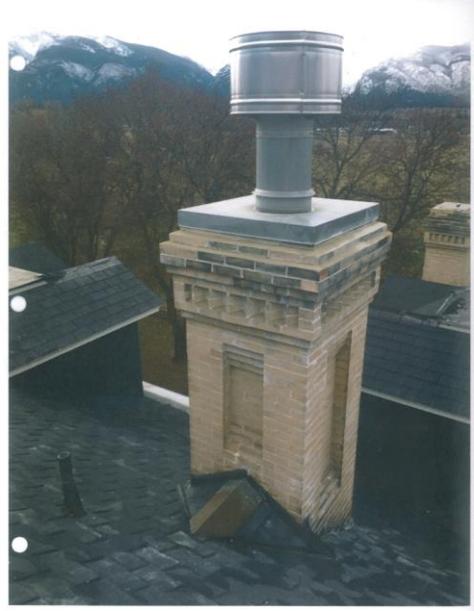
Picture 10: Brick chimney after repairs

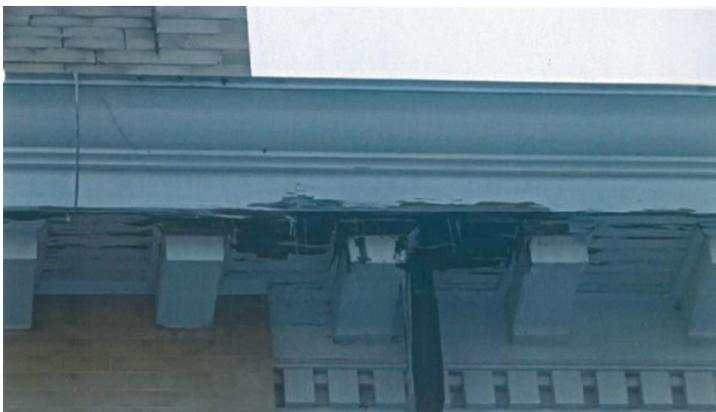
Picture 11: High roof trim & fascia before repair showing damage.

\$24,700: the Daly Mansion high roof fascia was restored and painted, including all dormer roof fascia's and painting dormer windows. Work completed in August 2016 and done by Reynolds Construction.

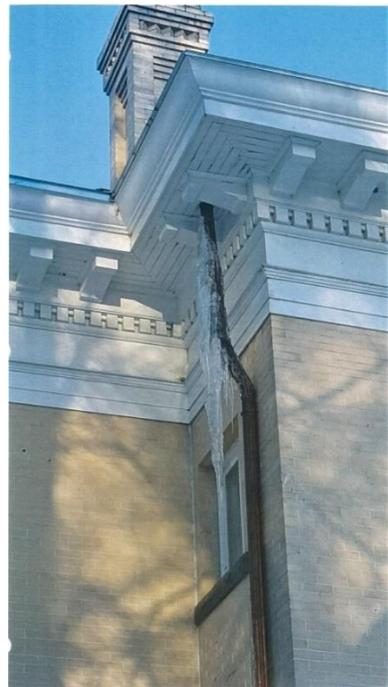
Picture 12: Before repair: Leaking gutters & downspouts

\$23,700: miscellaneous roofing repairs done on the Mansion roof consisting of gutter and valley cleaning, replacing built-in gutter lining from tar membrane to TPO membrane and correcting slopes to drain positively. Trophy room gutters refurbished and slopes corrected. Brick chimney tuck-pointed and repaired. Work completed by Reynolds Construction in March 2017.

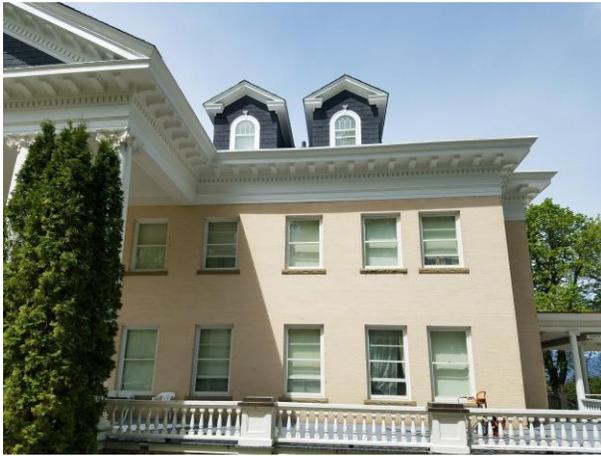
Picture 13: Daly Mansion high roof fascia repaired & painted.

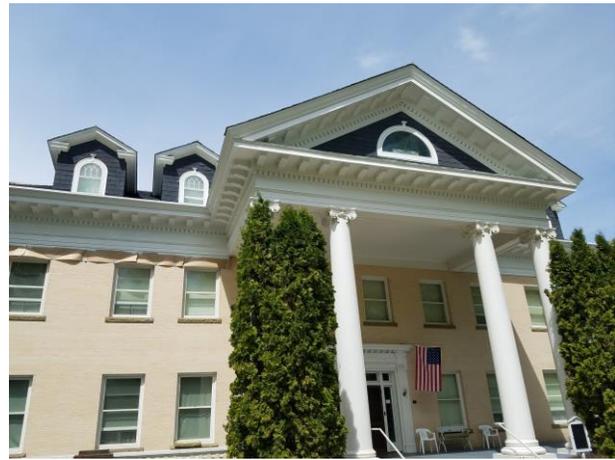
Picture 14: Daly Mansion roof & dormers repaired &

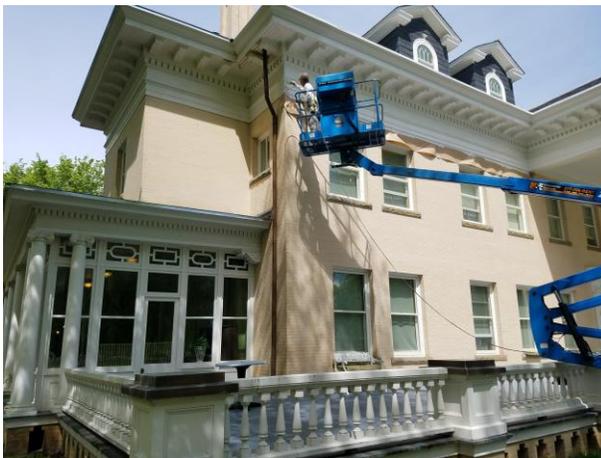
Picture 15: Roof trim being repaired & painted

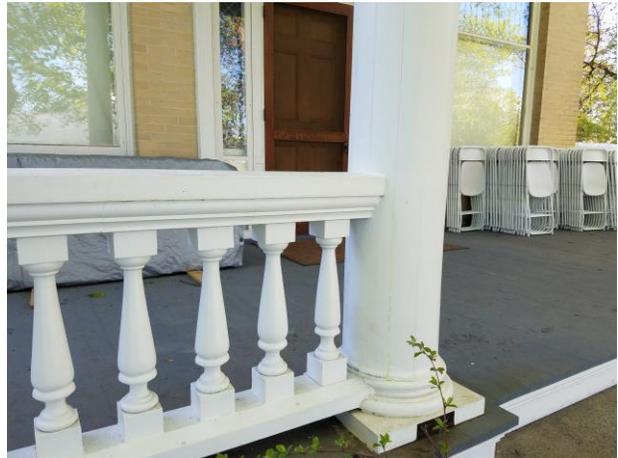
Picture 16: Porch balusters repaired, anchored &

Daly Mansion (24RA0241): Daly Mansion Grant activities and improvements are in partnership with the Daly Mansion Preservation Trust and the Montana Historical Society. \$17,100: the Daly mansion formal Dining Room porch deck railings & balusters were refurbished and painted. The deck sanded and painted. The Kitchen porch concrete steps were demolished and replaced with new concrete steps and painted railings. Work completed by Reynolds Construction in 2017. \$25,000: the Daly Mansion West Trophy Room Porch was refurbished by selective demolition of the supporting canopy, decking and defective floor structure. The structure was rebuilt, new VG fir decking installed, deck balusters, columns reset and anchored, deck trim and fascia restored and painted. Work completed by Reynolds Construction in June 2017 following plans from Jim McDonald of A&E Architects.

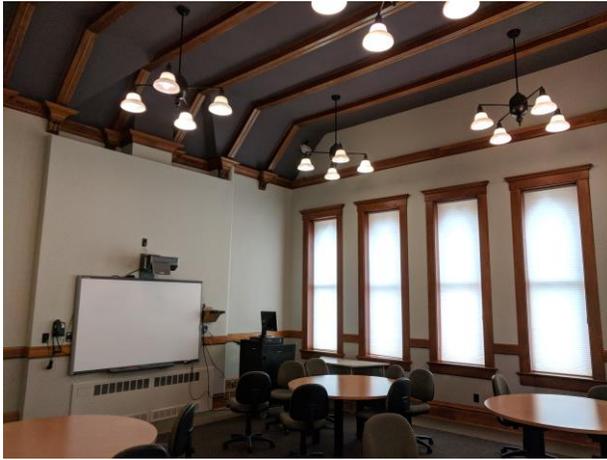
Picture 17: Restoration work at Main hall

Main Hall has recently undergone a series of renovations beginning in 2009 and completed in August of 2016. UMW partnered with Montana A&E and hired a third party historic architect to complete the projects under A&E# 27-04-01, A&E# 27-04-01-02, and A&E 27-04-01-03. The Montana State Historic Preservation Office was consulted during the design and planning of the Main Hall remodel. Phase I and Phase II of the renovation were completed in 2009 and 2011. The first two phases of the renovation addressed mechanical, electrical, and seismic stabilization concerns in the 1896, 1907, and 1951 buildings, along with rehabbing and preserving significant historic features. Original flooring, windows, and fixtures were refurbished and reused as much as possible. Great care was taken to return Main Hall's historic integrity during both design and construction. Phase III of the remodel was completed in the summer of 2016. The third phase of the Main Hall renovation addressed the 1924 Library building. Much of the ornamental plaster and historic aspects of this building were covered several years ago in an attempt to better utilize the space and increase energy efficiency. The renovation upgraded the mechanical, electrical, life safety code, and structural concerns within the existing building. Much of the historic, ornamental plaster was uncovered and restored using period appropriate materials and styles. Original light fixtures, mechanical grilles, and floor finishes will be rehabbed and reinstalled. The total renovation of the Main Hall complex has cost about \$15 million.

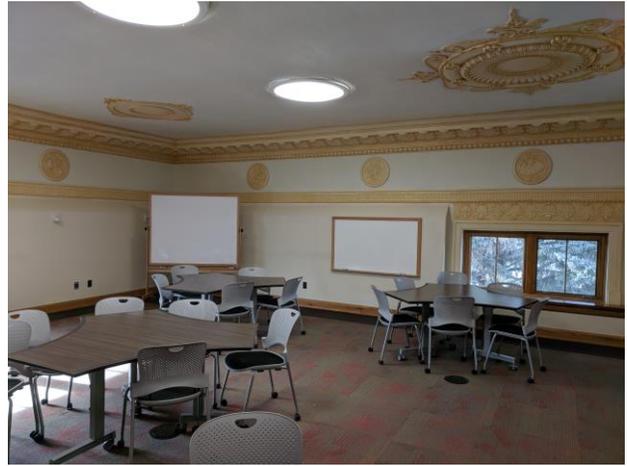
Picture 18: Decorative plaster restored at Main Hall

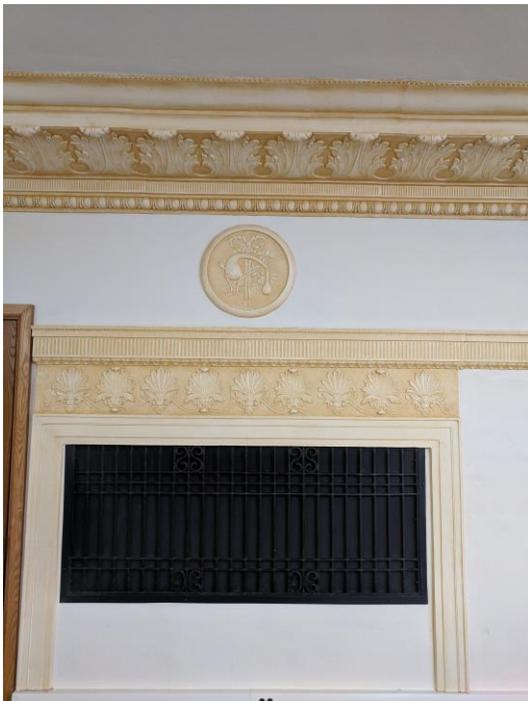
Picture 19: Decorative plaster, medallions & grilles restored.

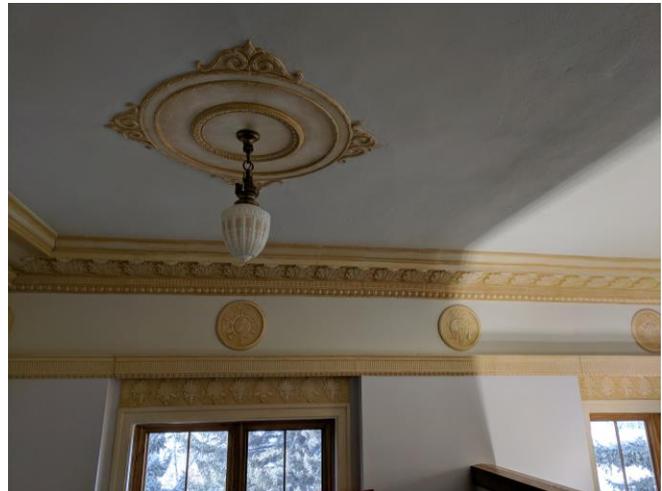
Picture 20: Restoration of decorative plaster, trim & friezes.
