State Agency Biennial Report on State-owned Heritage Properties

University of Montana 2022-2023

Submitted March 5, 2024

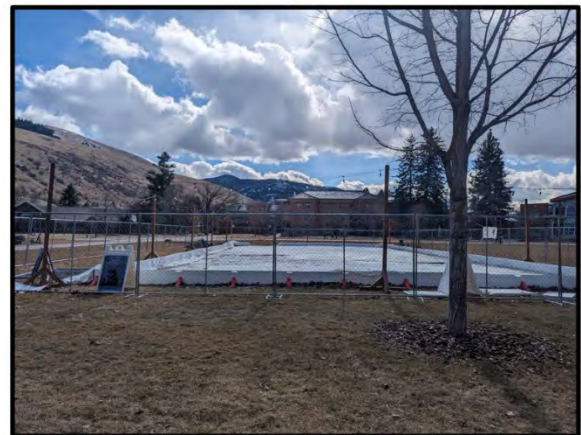
Ice rink on the UM Oval February 2024. Photo: Nikki Manning.

Due to failing brick the walkways were replaced in 2020 with brick stamped colored concrete. Unfortunately, the UM *Lux et Veritas* sidewalk medallion in the center of the Oval has still not been replaced. Overall, it has a **satisfactory** status and is in **good** condition.

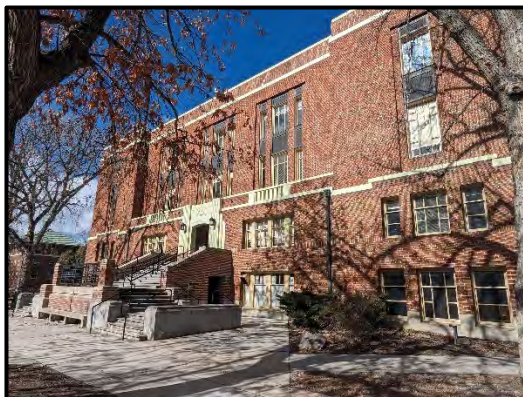
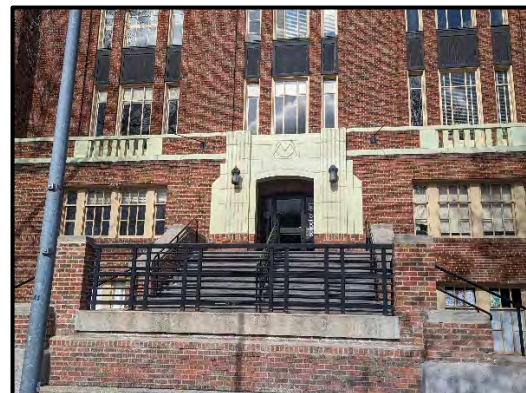
Originally constructed as the Student Union in 1935 after lengthy discussions about the need for one with then president of the university Charles H. Clapp and the state legislature. It was repurposed as the Fine Arts building in 1955 when the student population had outgrown the space. A roof replacement is in the planning stages as part of a \$2.42 million re-roofing project involving a few buildings. The Fine Arts Building has at some point received an unfortunate coat of paint on the door trim and connected detail that has almost a light fluorescent green tint (especially when the sun shines on it) and that does not match the more historic beige.

The Fine Arts Building in February 2024. Photos: Nikki Manning.

The Fine Arts Building is also slated to receive a new roof in the coming year or two and funds for this have already been approved from the state legislature. That status is **satisfactory**, and the condition is **good**.

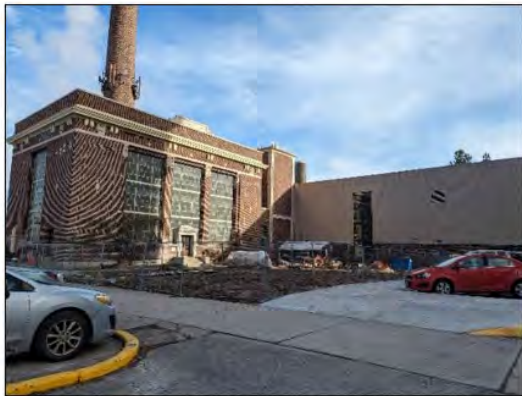
South Façade of existing heating plant and west façade of new CHP. February, 2024.

No significant work occurred in the heating plant during this construction. Assuming there were no extreme alterations made during the construction of the CHP, it is still being utilized as part of the system, so the status is **satisfactory**, and the condition is **good**.

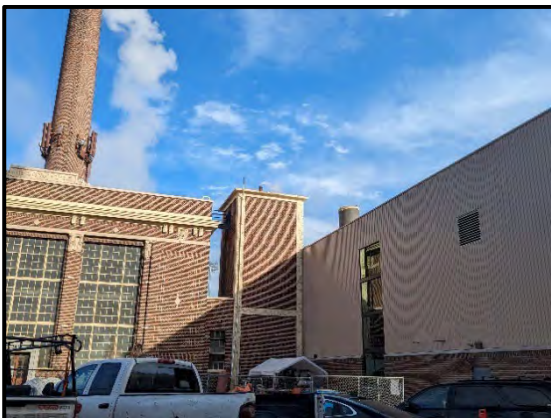
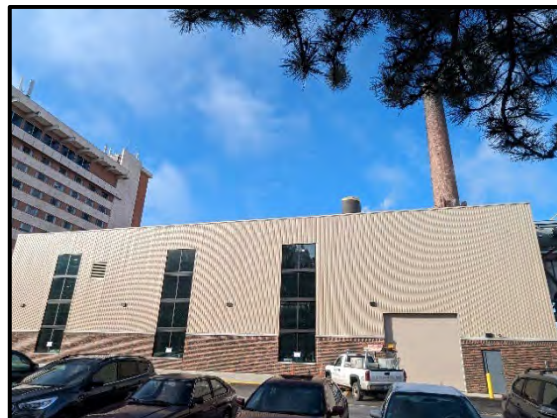
Existing heating plant and new Combined Heat and Power Facility, February 2024. Photos: Nikki Manning.

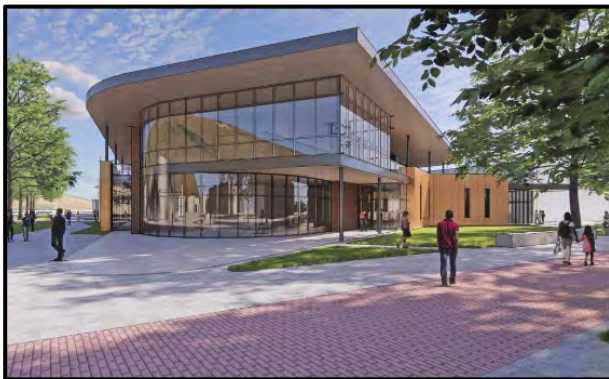
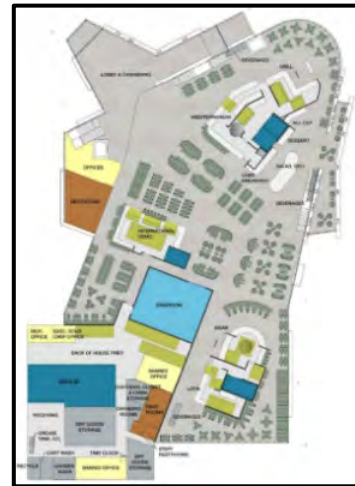
Originally called the “The Lodge” the Lommasson Center was built in 1955 after the post war population boom that necessitated a new and bigger student union and dining service on campus. The building has already been renovated and added onto multiple times over the years. Just to the east of Lommasson, Craig Hall was built as a men’s dormitory in 1953 with an addition in 1955. The university is currently constructing a new state of the art dining facility that will include gathering and meeting spaces in addition to the dining hall. Architect rendition and floor plan can be seen below.

Drawings from Facilities Services Projects Update website.

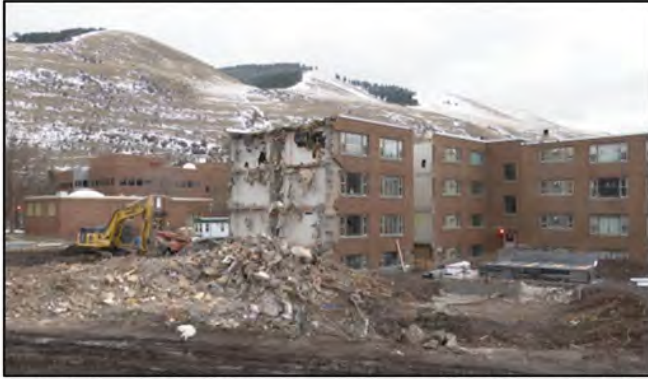
Craig Hall demolition and site of new dining facility. Source: MTN News.

For this new construction, the east third of Lommasson Center and about a quarter of Craig Hall on the north side of the dormitory were demolished. The open ends of each building were “enclosed with a frame of metal studs and rigid insulation covered with a metal panel system.” Student services located in Lommasson Center were moved to Aber Hall. The office renovations to Lommasson Center

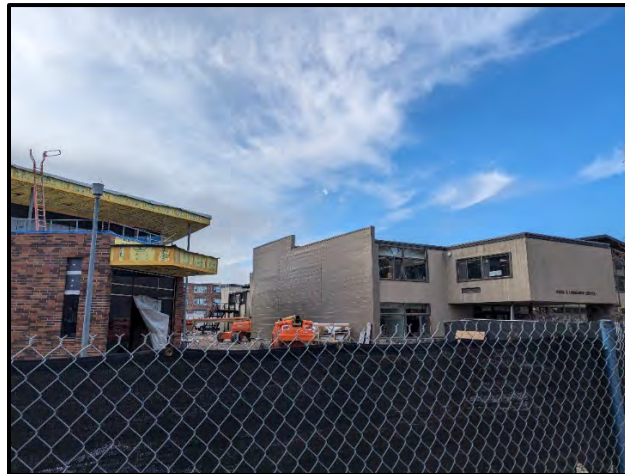
totaled \$36,000 and the corner store \$790,000. The status of both buildings is tentatively **satisfactory** – the historic integrity of Lommasson was impacted more than Craig Hall but if a full inventory/evaluation is ever completed at UM, they should be included in a re-evaluation. Condition is **good**.

East side of Emma B. Lommasson Center (right) where it was demolished and sealed. Portion of new dining facility (left), February 2024. Due to construction footprint and fencing it was not possible to get a current picture of Craig Hall. Photo: Nikki Manning

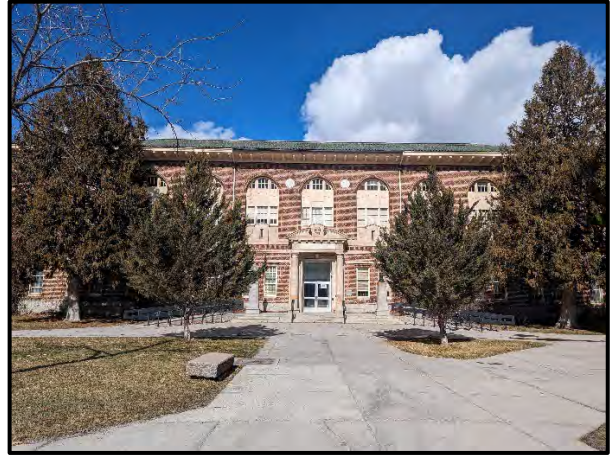
Designed by architects McIver & Cohagen and built in 1921, the Social Sciences Building was originally constructed as a new library for the campus when the first library in Rankin Hall outgrew its space. While the addition to the north in 1955 greatly affected the Renaissance revival aspect of the original building, it is located on the rear of the building which cannot be seen from the front. In 1979, the building was converted to house social science departments Anthropology and Sociology, Computer Science, and Information Technology Offices.

University Library date unknown (pre-1970s) (left). Courtesy Mansfield Archives and Special Collections.
Social Sciences Building, February 2024 (right). Photo: Nikki Manning

In the past year a new elevator was installed at a cost of \$450,000 and several classrooms on the second and third floors of this building were renovated within the past year. The cost of these renovations was \$740,000. Because most of the work on this building has been interior, the status could be considered **satisfactory**, and the condition is **good**.

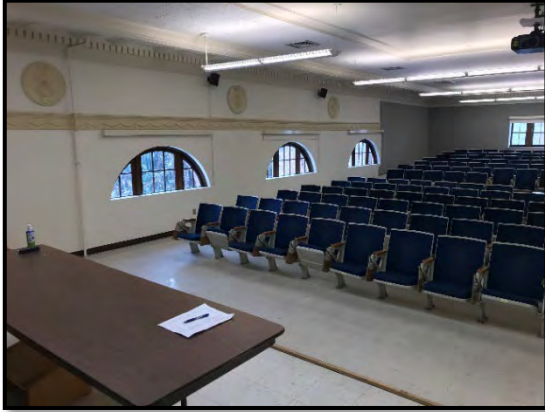
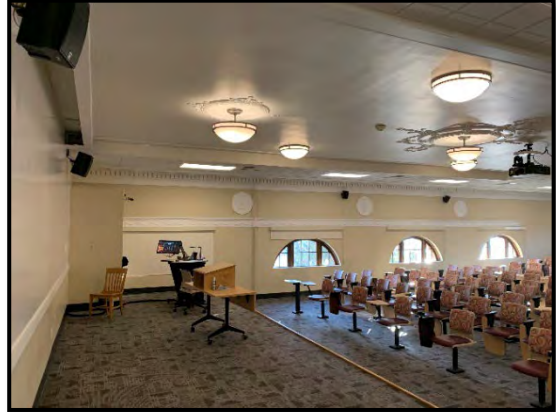
The original reading room of the library was part of the massive conversion from library to academic departments. It was basically cut into various squares including being converted into two separate floors. Some of the original details of the reading room are still visible in the current classrooms, particularly in the windows, trim, ceiling and wall medallions, and the intricate detail around the ceiling lights on the third floor.

Third floor classroom 2023 (left) and 2024 (right). Photos: Facilities Management.

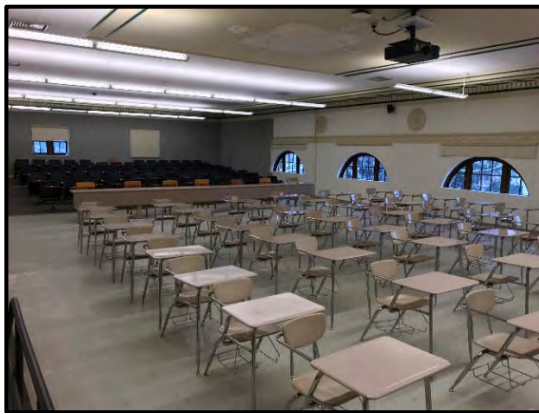
Third floor classroom 2023 (left) and 2024 (right). Photos: Facilities Management.

The very top of the original reading room windows can be seen in the third floor classrooms and continue down into the second floor as seen below.

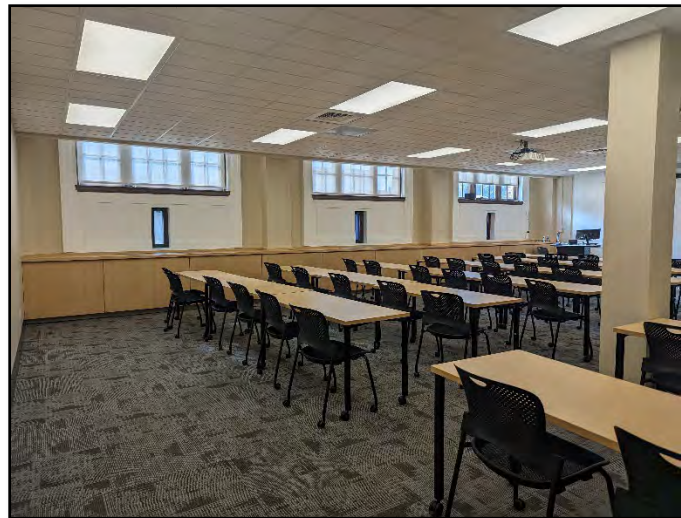
Second floor classroom, 2024. Photo: Facilities Management

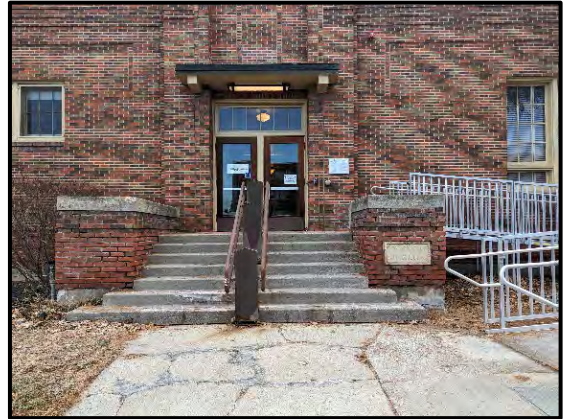
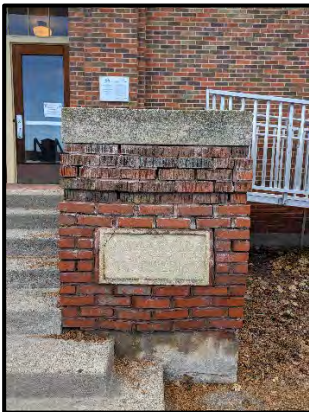
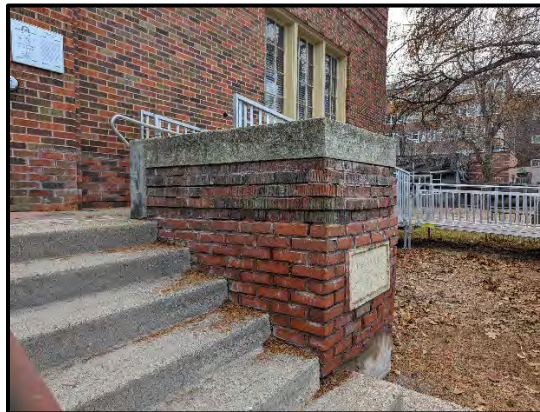
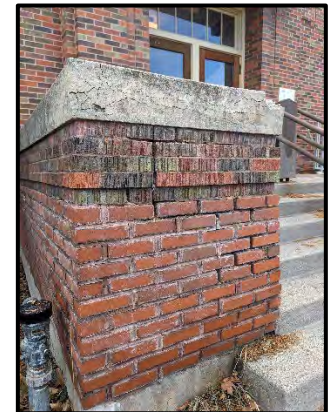
However, the brick piers at the front entrance are cracking, crumbling in some areas, and bulging in others. Plans are complete for pier repair and a new ADA ramp. The university is seeking a funding source for this.

International Center west entrance and brick pier damage, February 2024. Photos: Nikki Manning

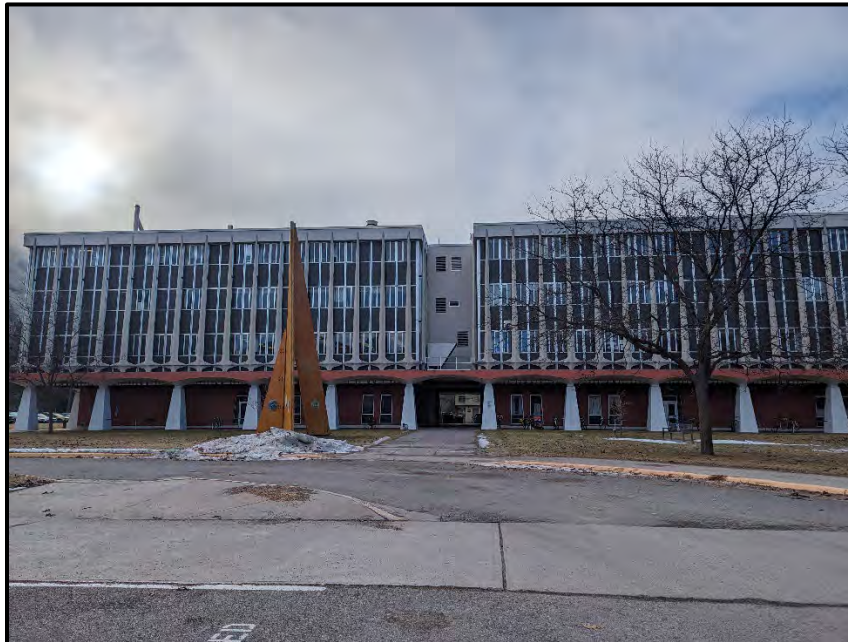
Charles H. Clapp Building, February 2024. Photo: Nikki Manning

Critical renovations are needed to address a myriad of issues that affect campus community health and safety. While asbestos removal was completed in 2006-2007 on the 3rd and 4th floors, the basement, 1st, and 2nd floors still require abatement. There is a list of mechanical, electrical, and plumbing issues, fixtures that need updated or replaced, and the building elevator is in dire need of replacement. Multiple updates are needed to bring the building into ADA compliance. There are currently conversations taking place with faculty and staff about temporary or permanent relocation to prepare for a major renovation. \$27 million was authorized by the state legislature and the university has committed \$10 million. With the extensive renovations planned this building would be on the **watch** list. The condition is **fair/poor**.

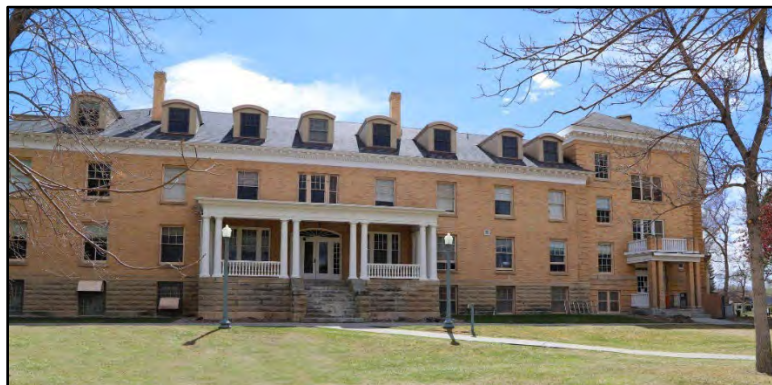
The 2022 stewardship listed the building as **satisfactory** status and **fair** condition which was a slight improvement from years past when listed in watch status. It is unclear whether any major work had been completed during this reporting cycle beyond routine maintenance and care.

UM-Western Mathews Hall. Source: umwestern.edu/student-life

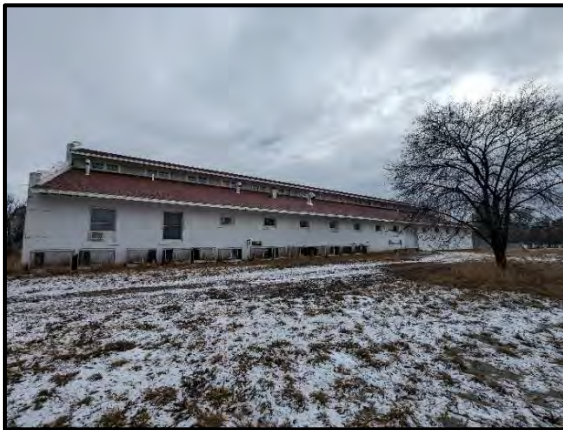
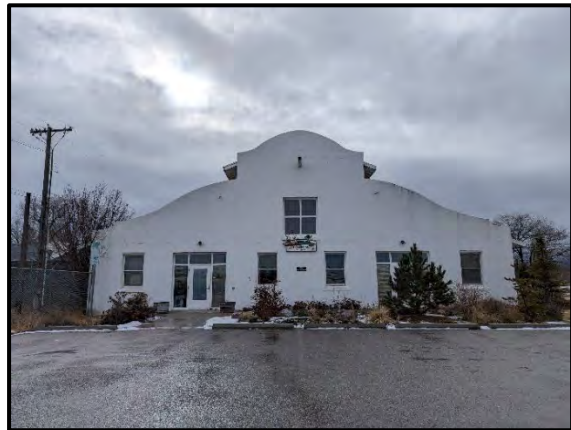
There have been no major changes or threats to the stables during this cycle. The overall condition of the building is **good**. The entire building has modern heating, plumbing, and electricity that is in great functioning condition. Additional funding and support were provided by UM Facilities Services for basic maintenance, janitorial services, heating, plumbing, electrical, sewage, landscaping, and snow removal.

This building is currently used regularly as laboratory, office, and animal housing space for the Division of Biological Sciences. Per communication with the site director, Bret Tobalske, the split rail fence that runs along the west side of the property was replaced with \$16,500 private foundation funds from the Drolinger Family Charitable Trust and administered through the UM Foundation. This fence also abuts West Cell Block T-156. The carpeting on the ground floor of the building was removed and the floor renovated. The carpet was replaced by polyaspartic flake, a patterned form of epoxy coating, at a cost of \$13,055.

West elevation of stable building (left). North elevation (right), February 4, 2024. Photos: Nikki Manning

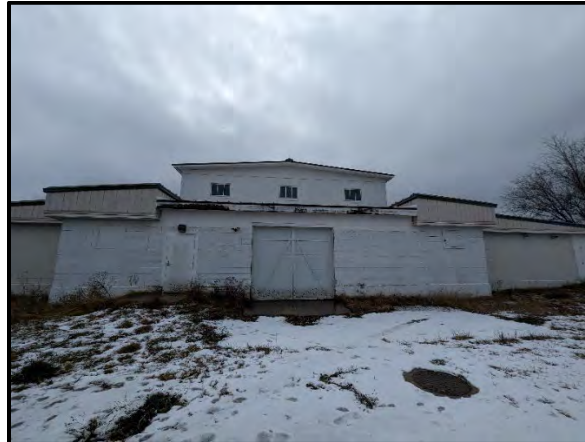
Department of Geosciences at UM. This side of the building also has heating, plumbing, and electricity. The rest of the building is currently used for storage by the Departments of Geosciences, Wildlife Biology, and Ecology. Currently, the most pressing preservation need for the building is some minor wood rot in wooden soffits on the east exterior eaves of the building.

North elevation T-156, February 4, 2024. Photos: Nikki Manning

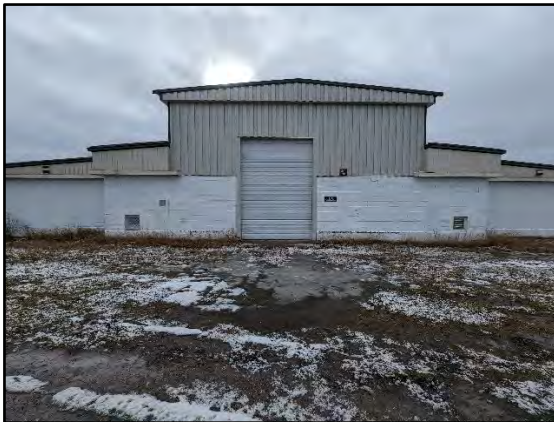
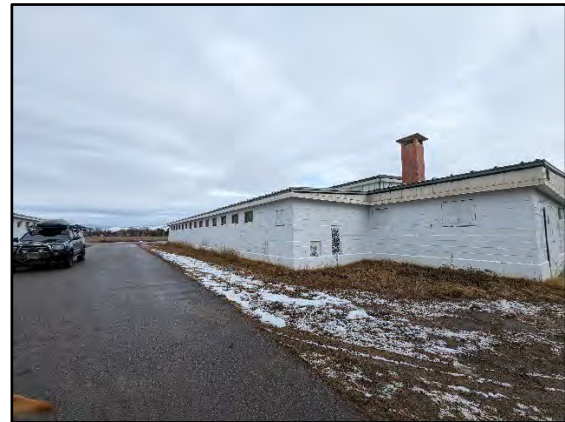
This concrete structure is like T-156 except there has been some remodel of the roof area (not in this reporting cycle) and the interior has not been modernized like T-156. This building is used by the UM School of Theater and Dance for storage. The cell layout inside has not been modified so each cell is used to organize the items in storage. The department is careful to use only temporary storage platforms, shelves, etc.

North elevation T-157 (left). West elevation T-157, February 4, 2024. Source: Nikki Manning

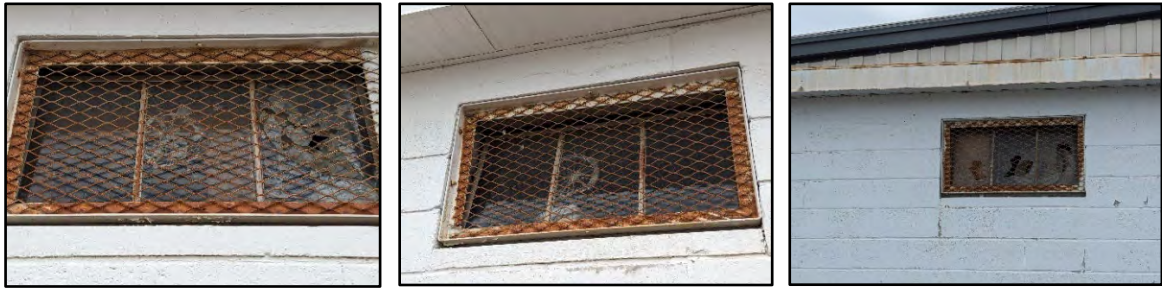
No work has been done to this structure during this cycle and is in **fair to poor** condition. Almost all the windows are broken, some worse than others. There has been discussion about taping insulation to the walls to cover the windows to at least keep out the weather, animals, and insects. There is often an ice dam at the front garage door in the winter causing damage to the concrete pad around the door and allowing water to seep inside.

Selection of windows of T-157, February 4, 2024. Photos: Nikki Manning

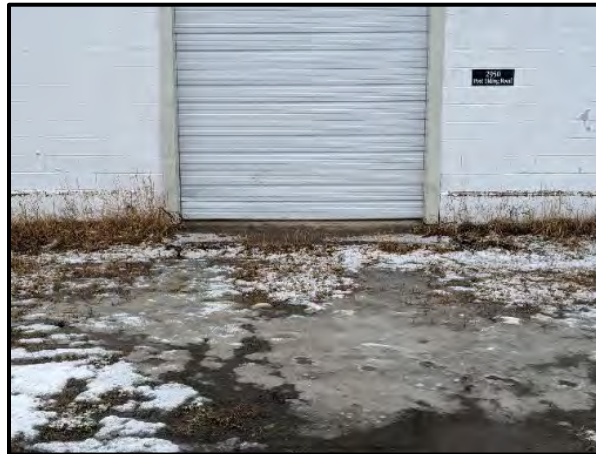
Garage door entrance of T-157 on north elevation, February 4, 2024. Photo: Nikki Manning

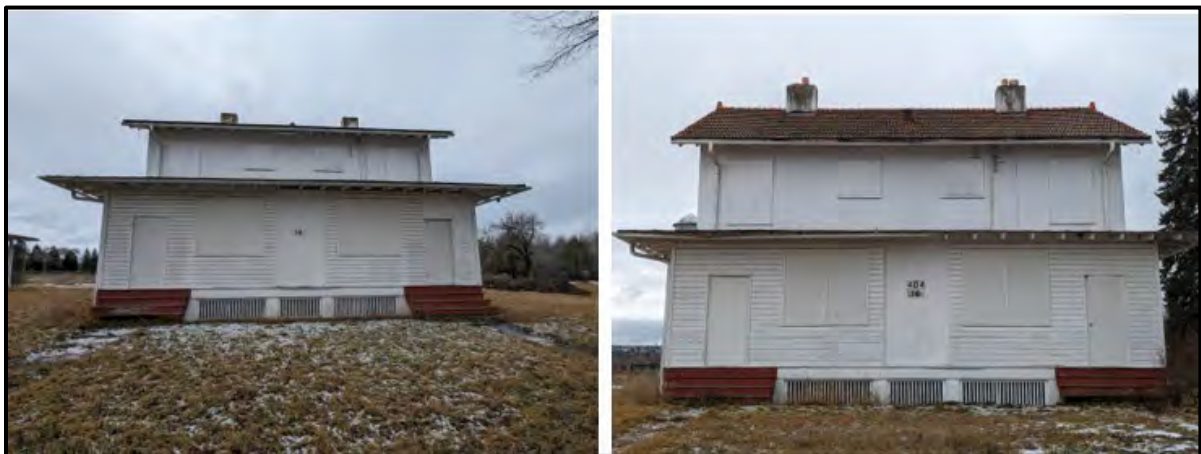
NCO Quarters T-14 (left) and T-16 (right), February 4, 2024. Photos: Nikki Manning

No work has been conducted on the buildings in a while, let alone during this reporting cycle. The 2016 stewardship report mentioned that it was “uninhabitable when acquired by the University of Montana” but that the historic integrity was intact. As seen in the photos, all windows and doors are boarded up and no one has been inside for a while and the buildings remain in poor condition. Wood is sagging in some areas, but the structures are believed to be solid. It would need to be evaluated. Significant lead and asbestos abatement would be required. Estimates for renovation acquired by Bret Tobalske in 2010 were in the range of \$450,000-\$500,000.

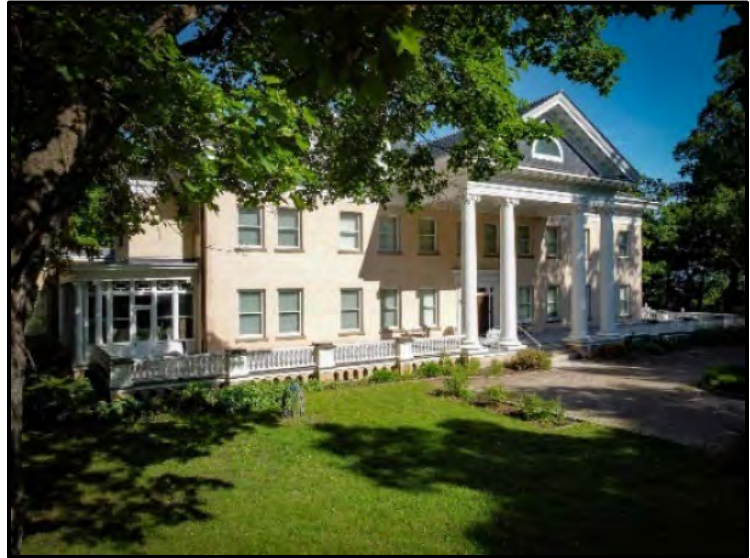
The daily on-site management of the site is overseen by the Daly Mansion Preservation Trust with guidance from the UM Facilities Services office and the Montana Historical Society. The Trust opens the mansion grounds to the public seasonally and for both public and private scheduled events and does an exemplary job taking care of the site. The integrity is **excellent**, status is **satisfactory**, and the condition is **excellent**.

The Daly Mansion Preservation Trust is in the process of a public fundraising campaign to replace the water line on the grounds. The current water line is over a hundred years old and being crucial to the mansion's operations it urgently needs replacing. Through a Montana Historical Preservation Grant, they have already procured \$100,000 but they need to raise an additional \$20,000 to match this grant. Not only will it support the water supply replacement but the continued restoration of the mansion's third floor.
