# Montana Department of Corrections

## Biennial Report on Heritage Properties

2018 - 2019

The Montana Department of Corrections  
Biennial Report on Heritage Properties  
2018 – 2019

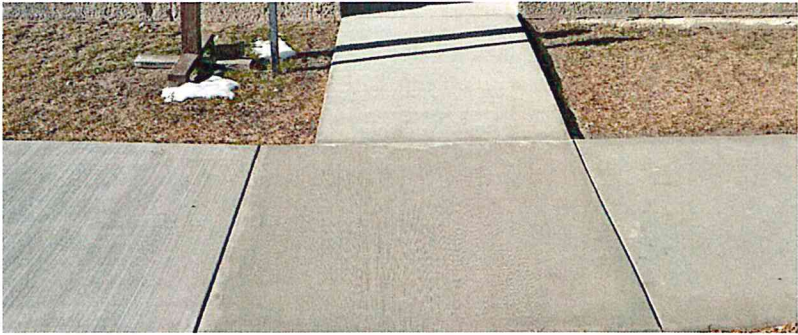
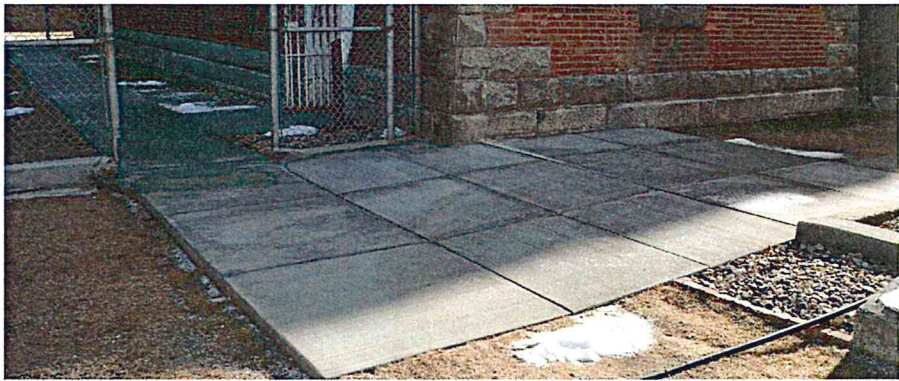
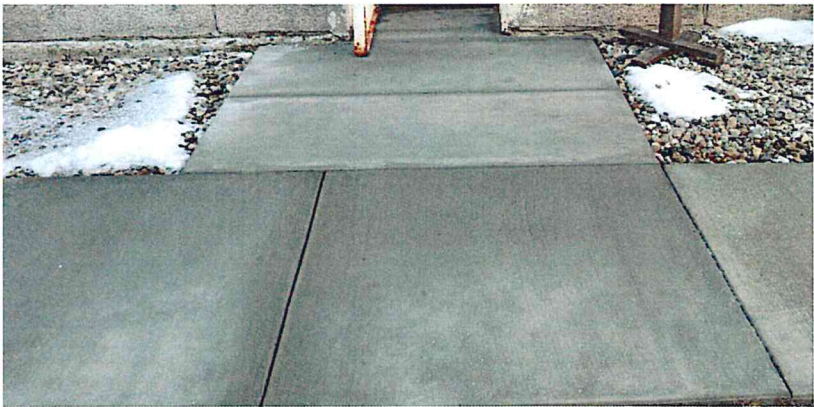
Sidewalk repair examples  
2019

3. **265' of 4' wide x 4" thick sidewalk was replaced throughout the complex. In addition, replaced a section of the concrete stairs entering the Administration Building (HS8) were replaced.** The sidewalk replacement began in June of 2019 and was completed in September 2019. The work was performed by the Powell County Museum (Museum) maintenance staff, the DOC Fire Crew and the DOC Community Workers assigned to the Museum. The total cost of materials was \$4,000. Pictures of the sidewalk and step replacement are provided in Attachment B.
