**DEPARTMENT OF
ADMINISTRATION'S
FOURTH BIENNIAL REPORT ON
STATE-OWNED HERITAGE
PROPERTIES
PRESENTED TO THE
PRESERVATION REVIEW
BOARD
PURSUANT TO MCA 22-3-42 (4)**

January 2018

Introduction

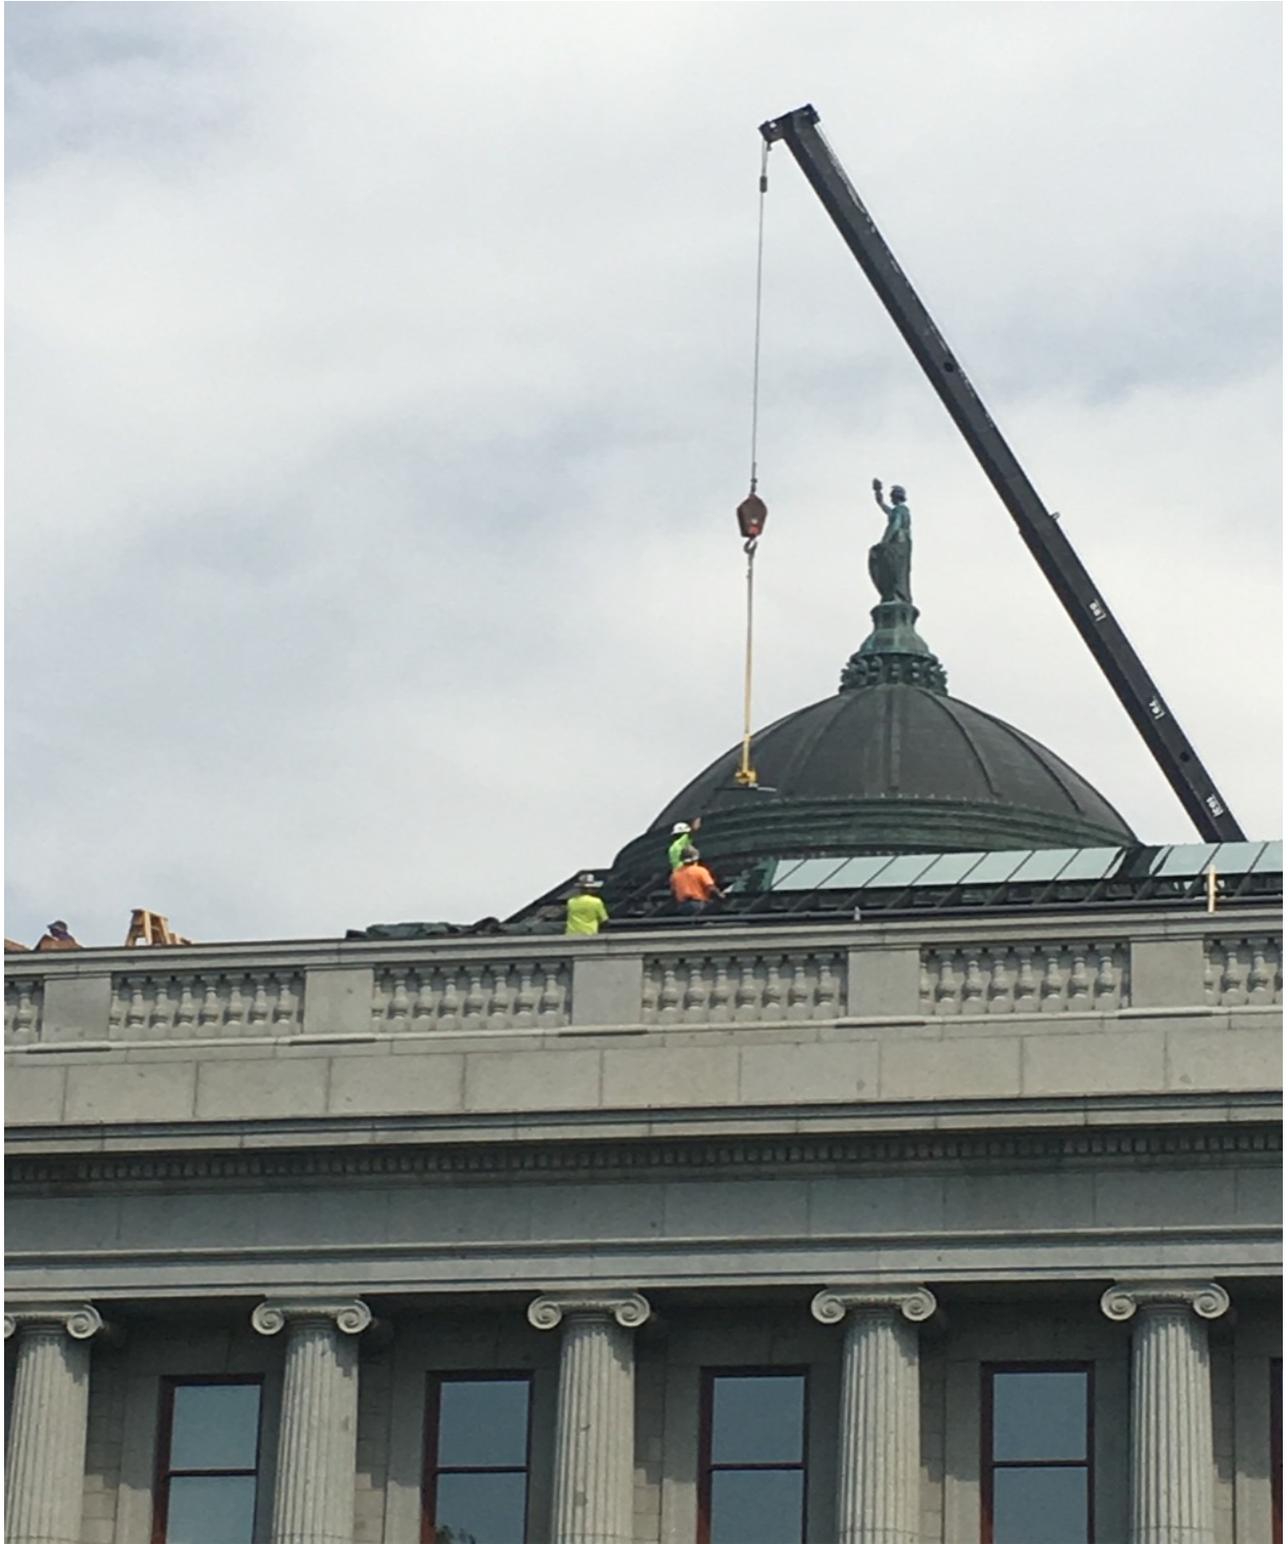
The original 1912 Capitol skylights were replaced over the Old Supreme Court, Senate and House chambers, and the Old Law Library in the summer of 2017. The photo shows a skylight panel being placed above the House Chamber.

The skylight project was triggered by the many leaks, the extreme temperatures that their utilitarian spaces were exposed to and the ultimate relating damages to the spaces below especially to the delicate stained glass lay lights, plaster work, and scagliola (imitation marble). Through a professional evaluation, it was determined that the deterioration level of the skylights was such that maintenance repairs alone were not able to address the long-standing materials failure and deterioration.

After extensive research and consideration, the team including the design team, GSD, and SHPO, it was concluded the need to replace the skylights was too great. The new state of the art glazing and cladding system of the new skylights will provide the same light quality to the stained glass lay lights as before but with the added benefit of better temperature control and a more sophisticated system of weather protection.

The project is in the final stages and the total expected costs are \$981,000.00. These costs break down into approximately \$ 875,000.00 of (all-encompassing) construction costs and \$ 106,000.00 of design and professional assessment (all-encompassing) costs.
