National Register of Historic Places Registration Form

Historic name: River View Dairy Barn

City or town: Cut Bank State: MT County: Glacier

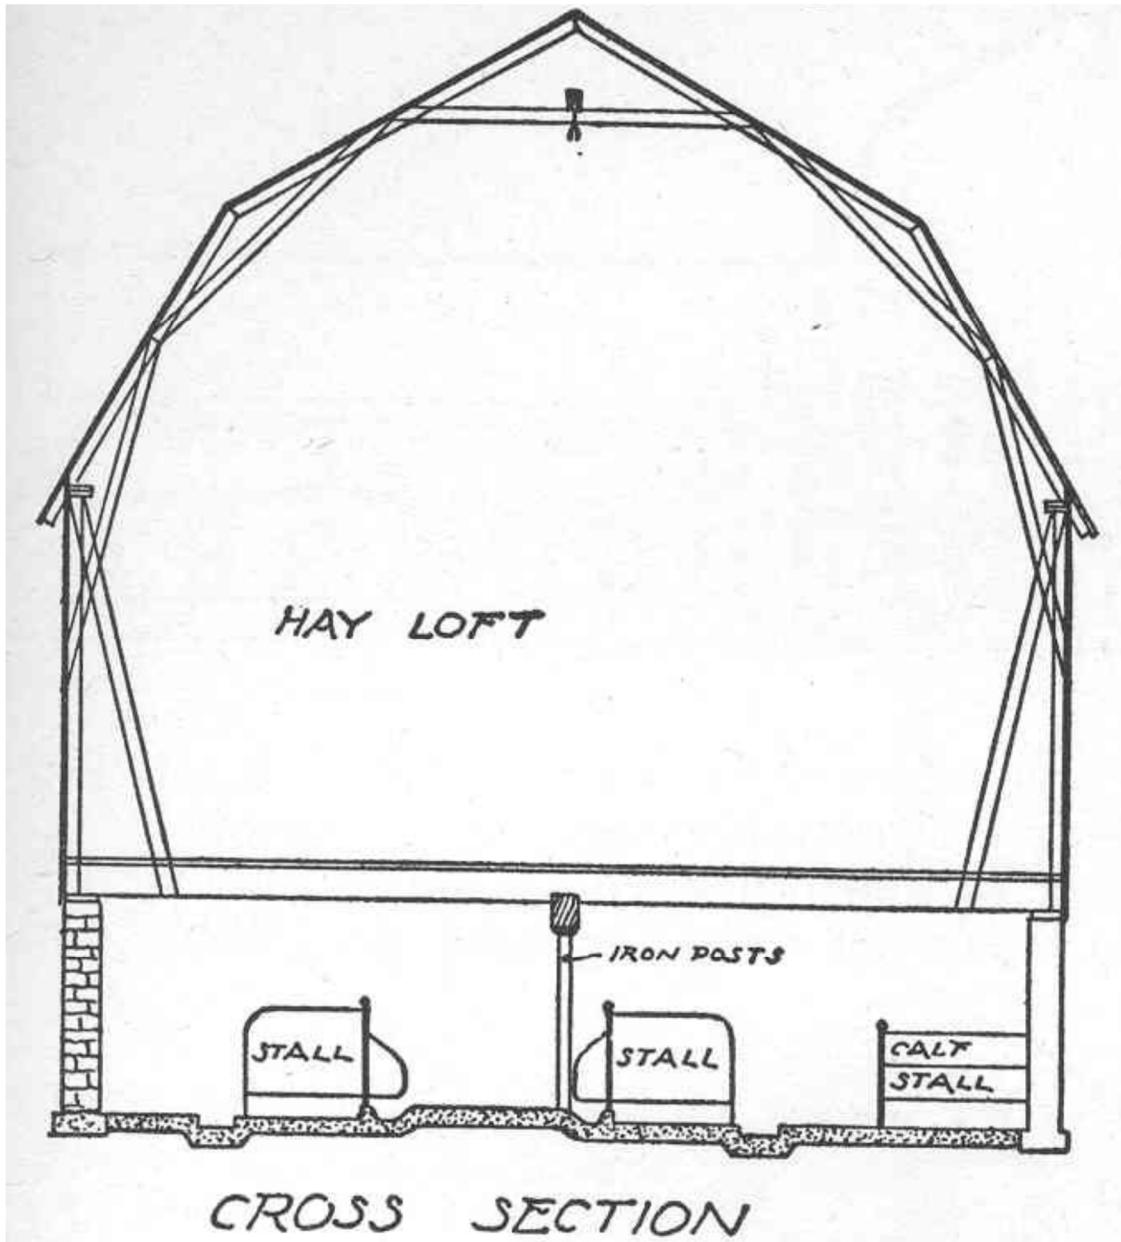
Representative illustration of basic interior roof system design. William A. Radford, ed., *Radford's Combined House and Barn Plan Book*, (Chicago, IL: The Radford Architectural Co., 1908), p. 143.

An elaborate truss system supports the roof of the River View Dairy Barn. As the elements have taken their toll, additional bracing and support has been added, including a four-beam internal frame with the vertical beams passing through the second story floor and sunk into the ground below surface. Additional cross bracing has also been installed on the barn's end walls. The

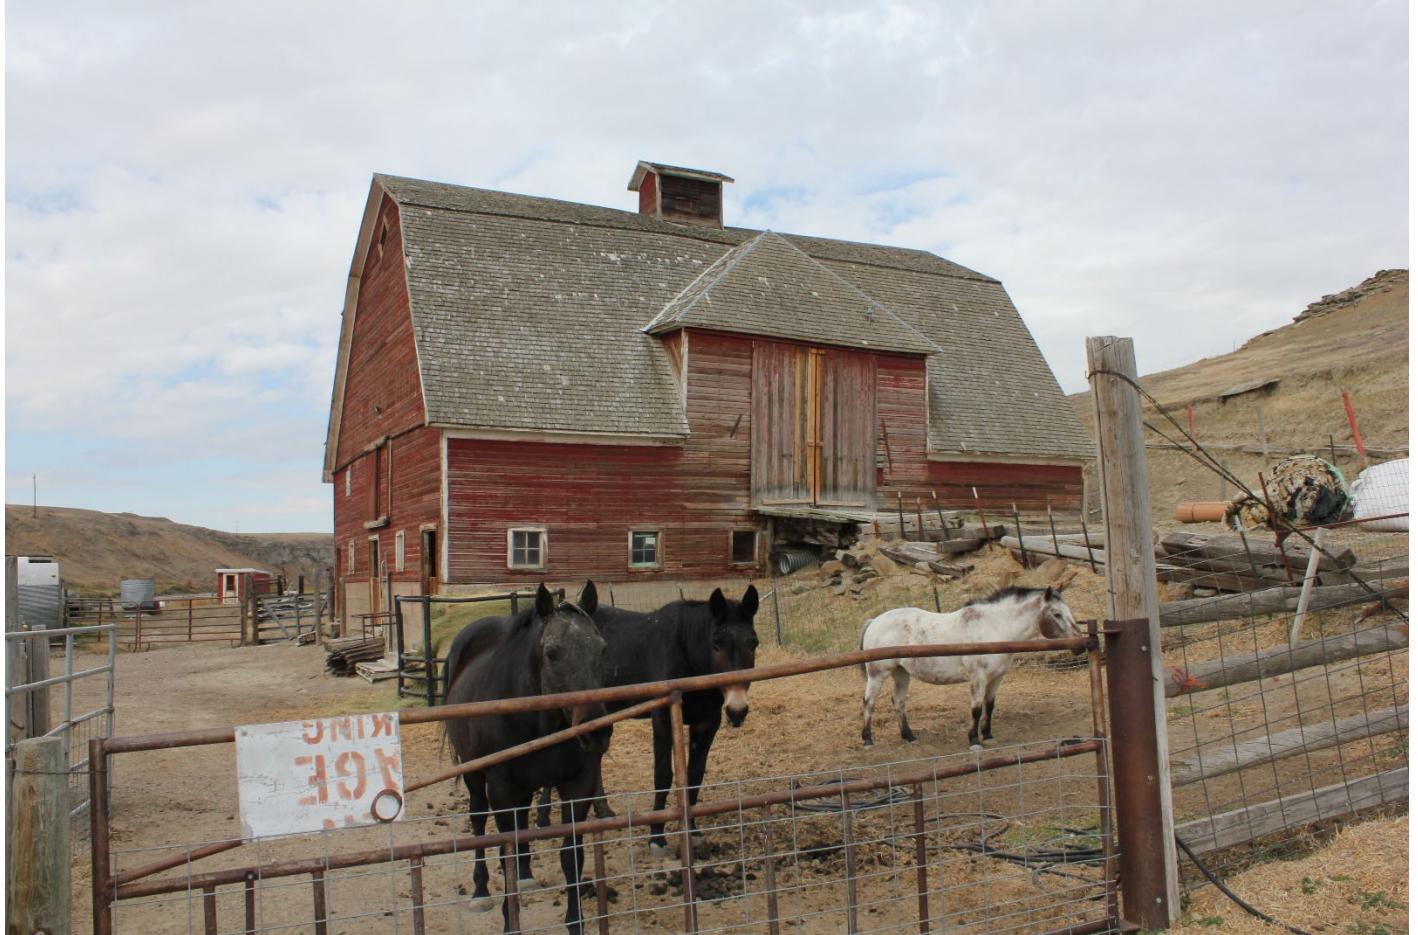
MT_GlacierCounty_RiverViewDairyBarn_0001, East elevation of River View dairy barn and Corral, view to the west.

The north and south gable ends of the barn hold a single diamond window. A row of horizontal boards that roughly divides the lower portion of the barn from the upper gable portion serves as a beltcourse on the north elevation. East elevation fenestration includes oversized, paired, vertical board doors below the dormer, and two square, four-light fixed windows in the south end of the barn immediately above the concrete foundation. The west elevation is the same as the east, however, the two square windows lack interior framing. The paired double doors on the east and west are approached by large boards and planks that serve as a bridge to span the distance between the interstice below and the entry to the barn. This design that positioned the doors and approaches opposite one another allowed for the passage of vehicles straight through the building negating the need for a wagon to back up.

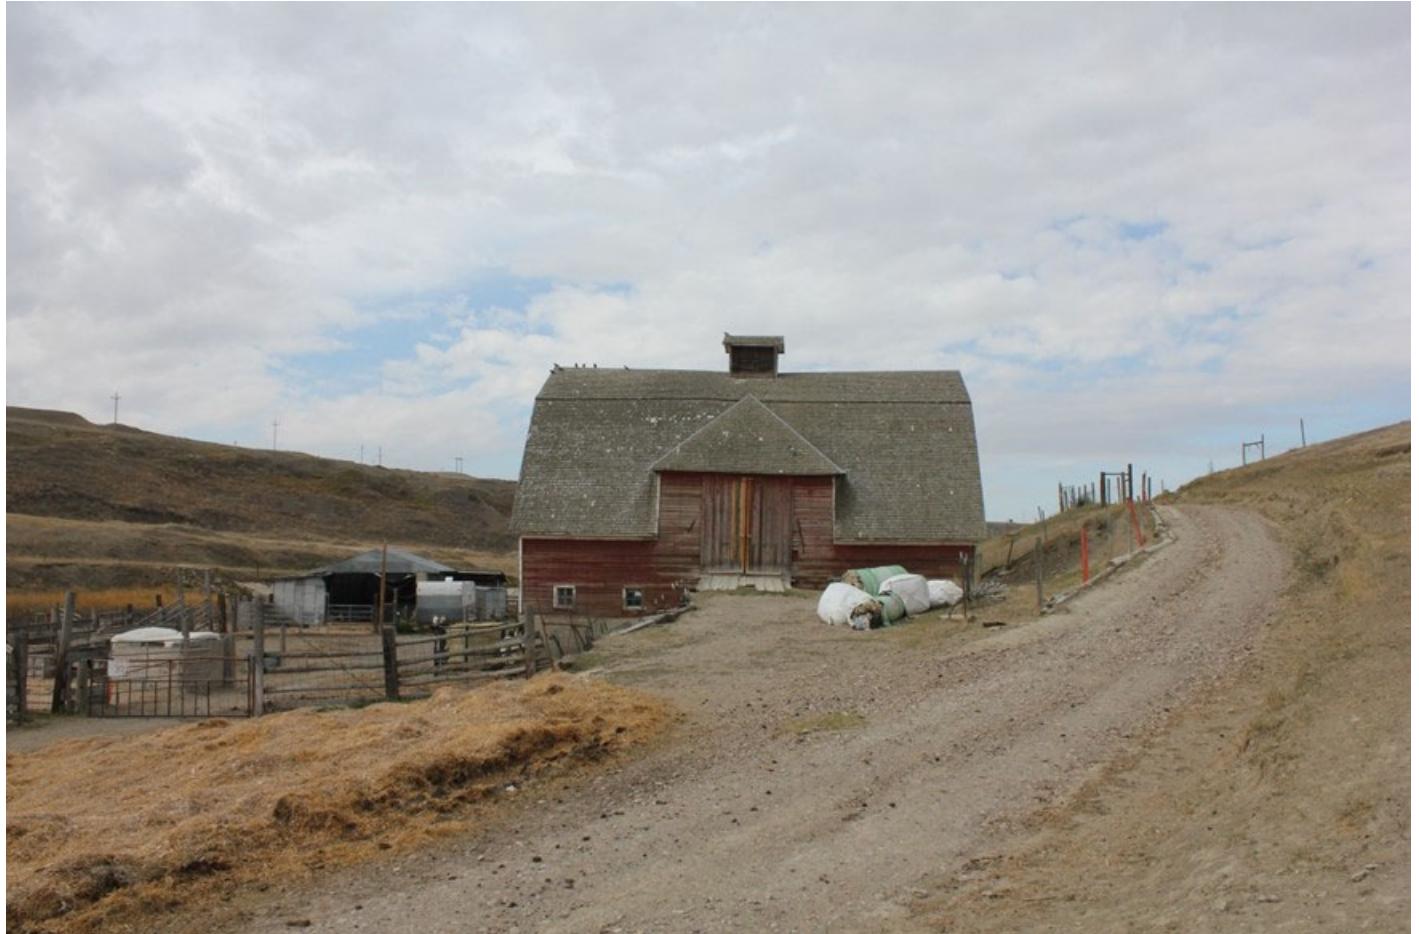
MT_GlacierCounty_RiverViewDairyBarn_0002, East elevation, corral, and approaches/drives, view to the west.

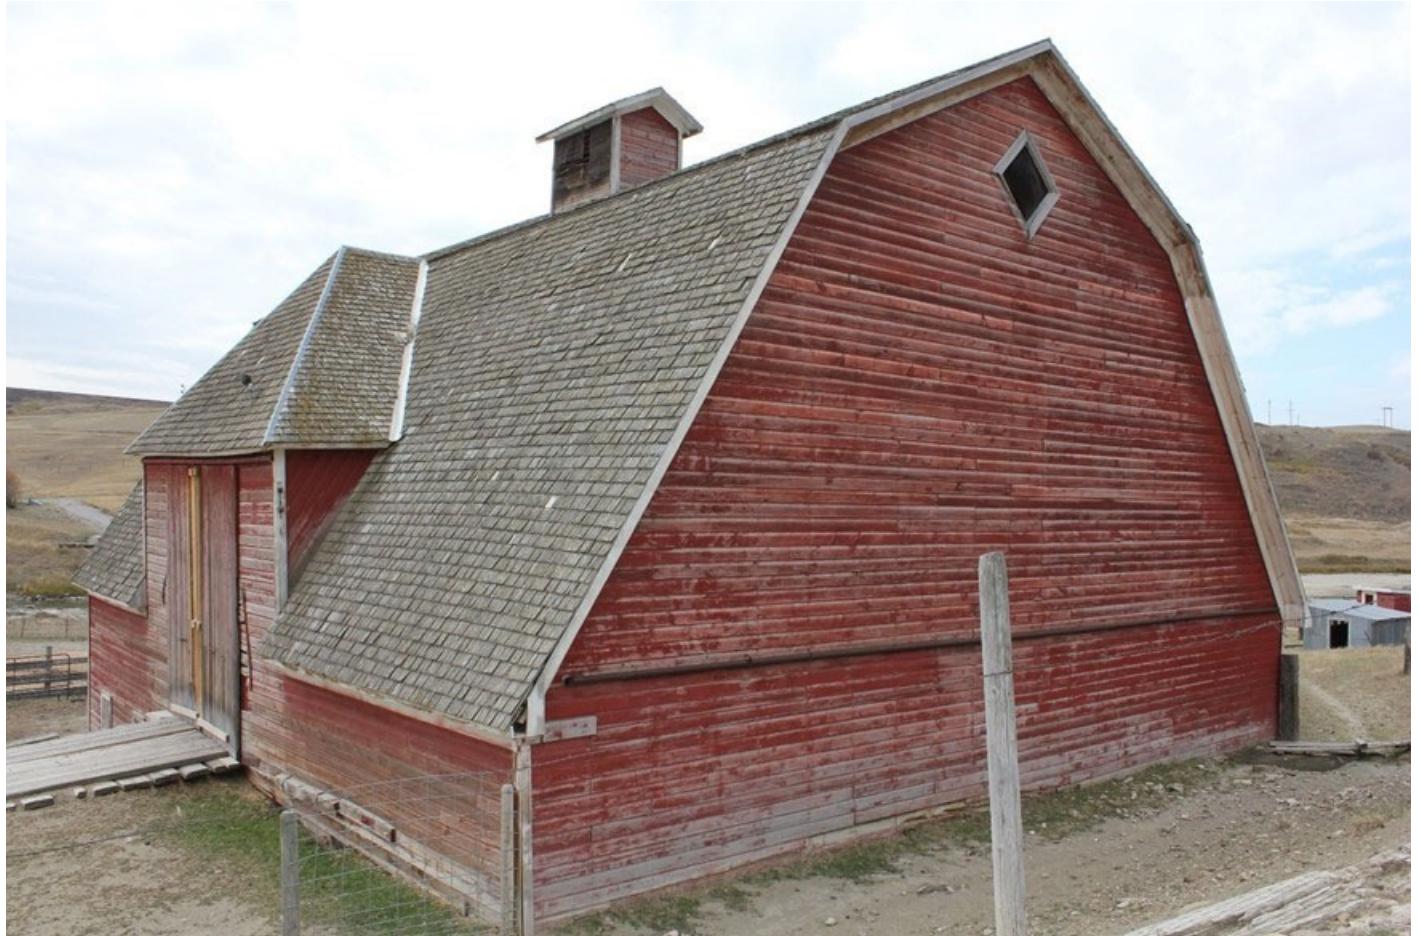
MT_GlacierCounty_RiverViewDairyBarn_0003, East and north elevations, view to the southwest.

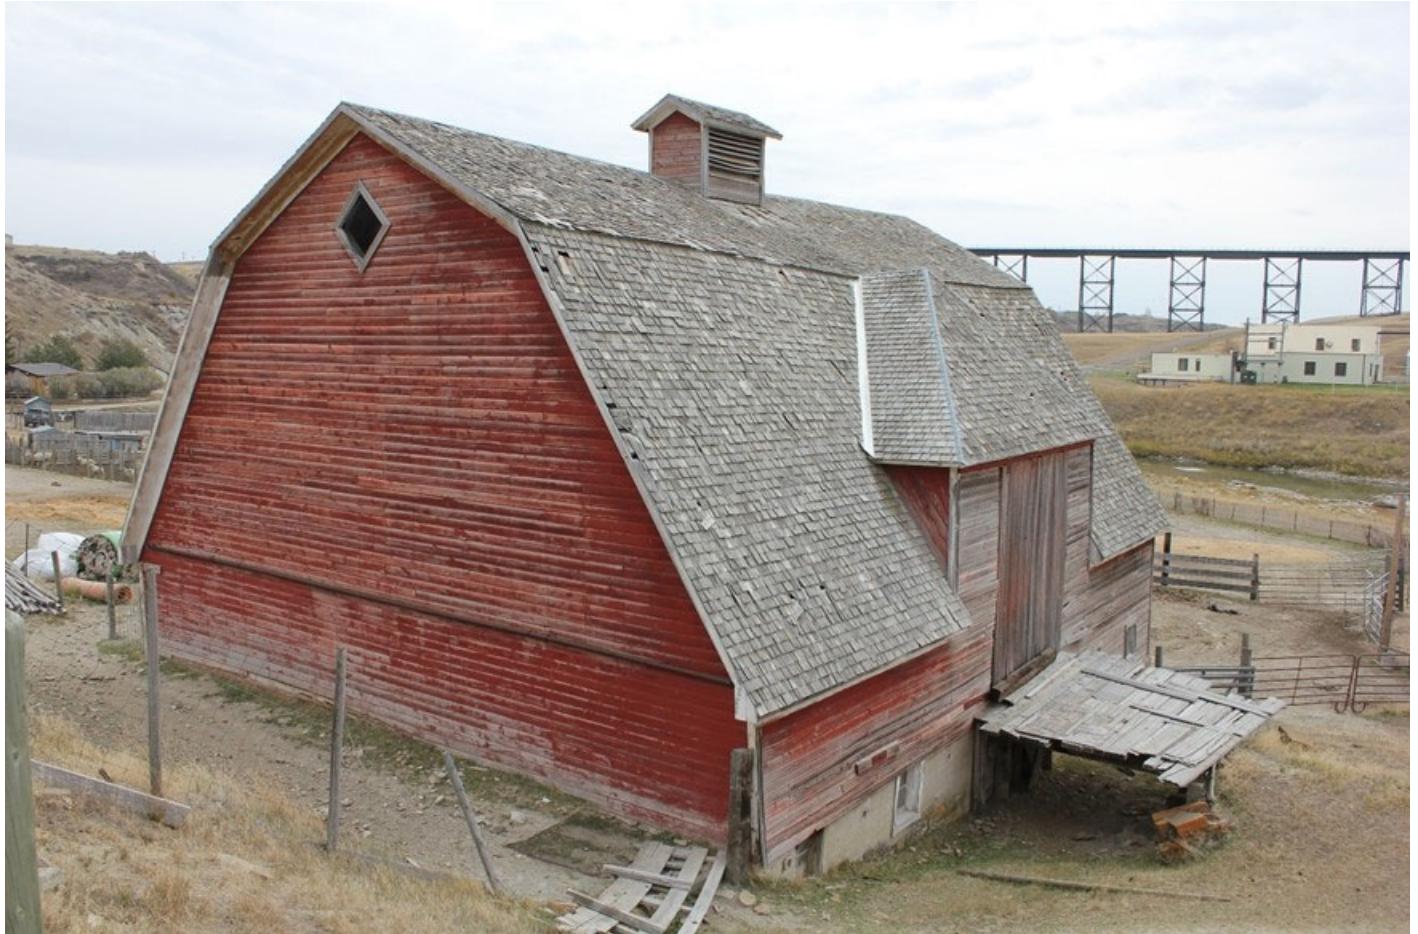
MT_GlacierCounty_RiverViewDairyBarn_0004, North and west elevations, view to the southeast.

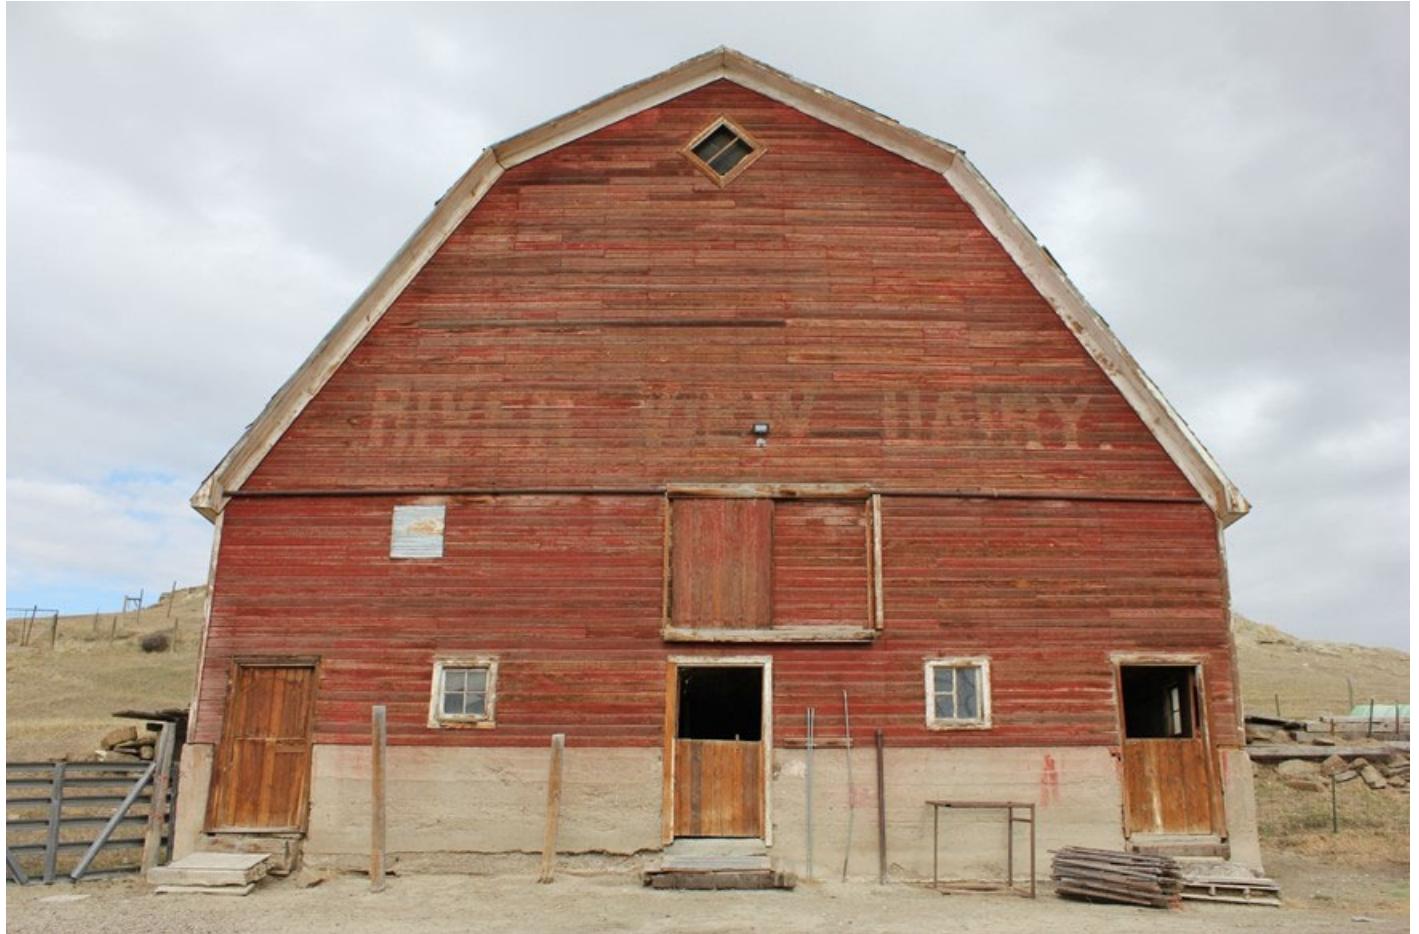
MT_GlacierCounty_RiverViewDairyBarn_0005, South elevation, view to the north.

The south wall holds several openings including paired sliding loft doors (one constructed of vertical boards and the other of simple drop siding), two square, fixed, four-light windows, and three slightly oversized openings with Dutch doors. Wood steps, represented by cut railroad ties, approach the concrete sills of the Dutch doors. A third square opening west of the loft doors is covered with a small sheet of corrugated metal. All the north and south elevation window and door openings exhibit wood framing. A metal pipe aligned with the top of the paired doors runs horizontally the length of the building. Immediately above the hayloft doors within the lower portion of the gable is a ghost sign that reads, "RIVER VIEW DAIRY."

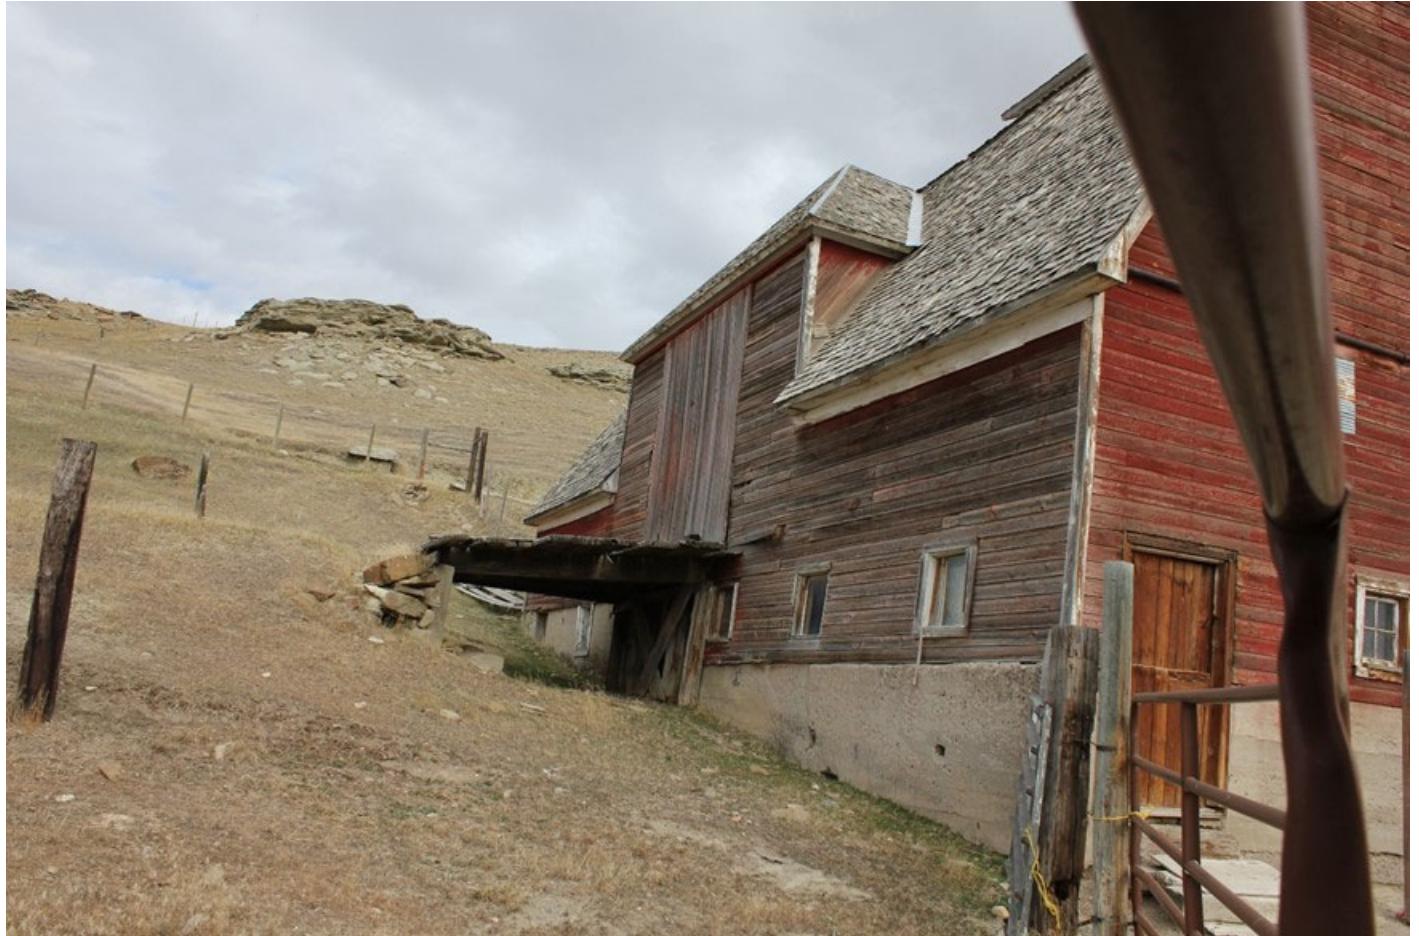
MT_GlacierCounty_RiverViewDairyBarn_0006, West elevation, view to the north north-east.

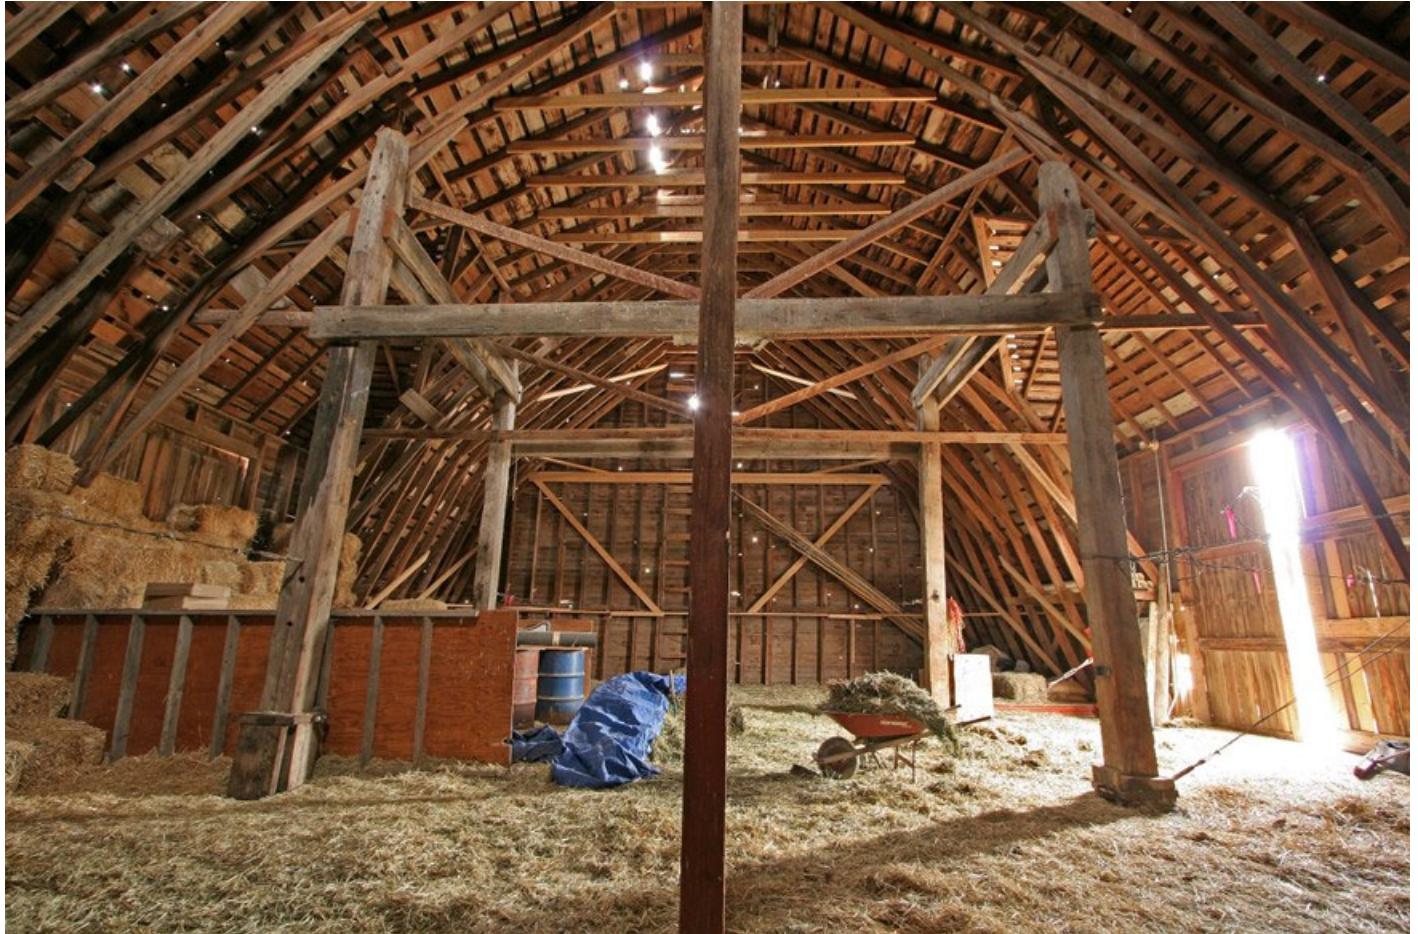
Photographer: Tom Ferris
Date Photographed: October 2017
MT_GlacierCounty_RiverViewDairyBarn_0008, Upper level interior.

Heavy planks serve as both upper and lower story flooring. The upper story interior remains open and is still used to store hay and feed. The lower level would have historically held 48 cows organized by two double rows of milking stanchions, 12 head catches in each row. Through the years, changes to the lower level occurred as the property evolved from a dairy operation to one that included lambs. The manure trench on the east side was filled in when the portion of the barn was adapted for other livestock. A large feeder centered in the middle of the east half of the barn was built for cows and calves with access provided from two sides that allowed separation. Smaller feeders for goats were added along the east row toward the front (south) of the barn at a later time. The west half of the barn retains all the stalls and feeders associated with its use as a dairy barn; however, the stalls and feeders on the east half were removed in the 1950s to reconfigure the space for sheep and lambs.¹ The south end of the lower floor of the barn contains a single room on each side of the main aisle near the central ground floor door. The walls of the western room display in heavy pencil the names of the milk cows and the dates they were bulling and serve somewhat as a tally over the years of these occurrences.

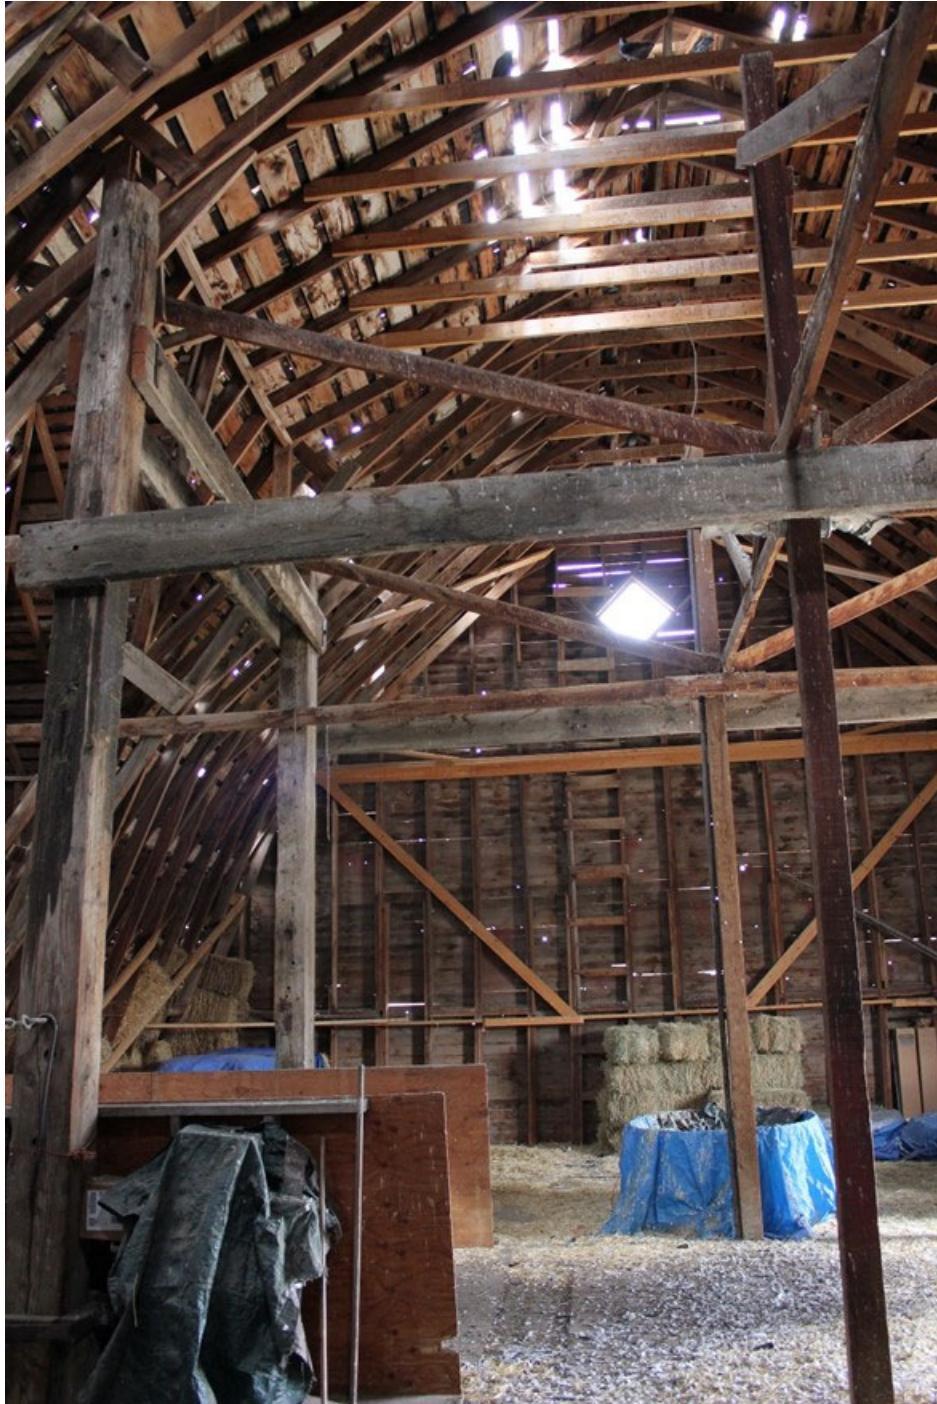
MT_GlacierCounty_RiverViewDairyBarn_0009, Upper level interior, roof structure.

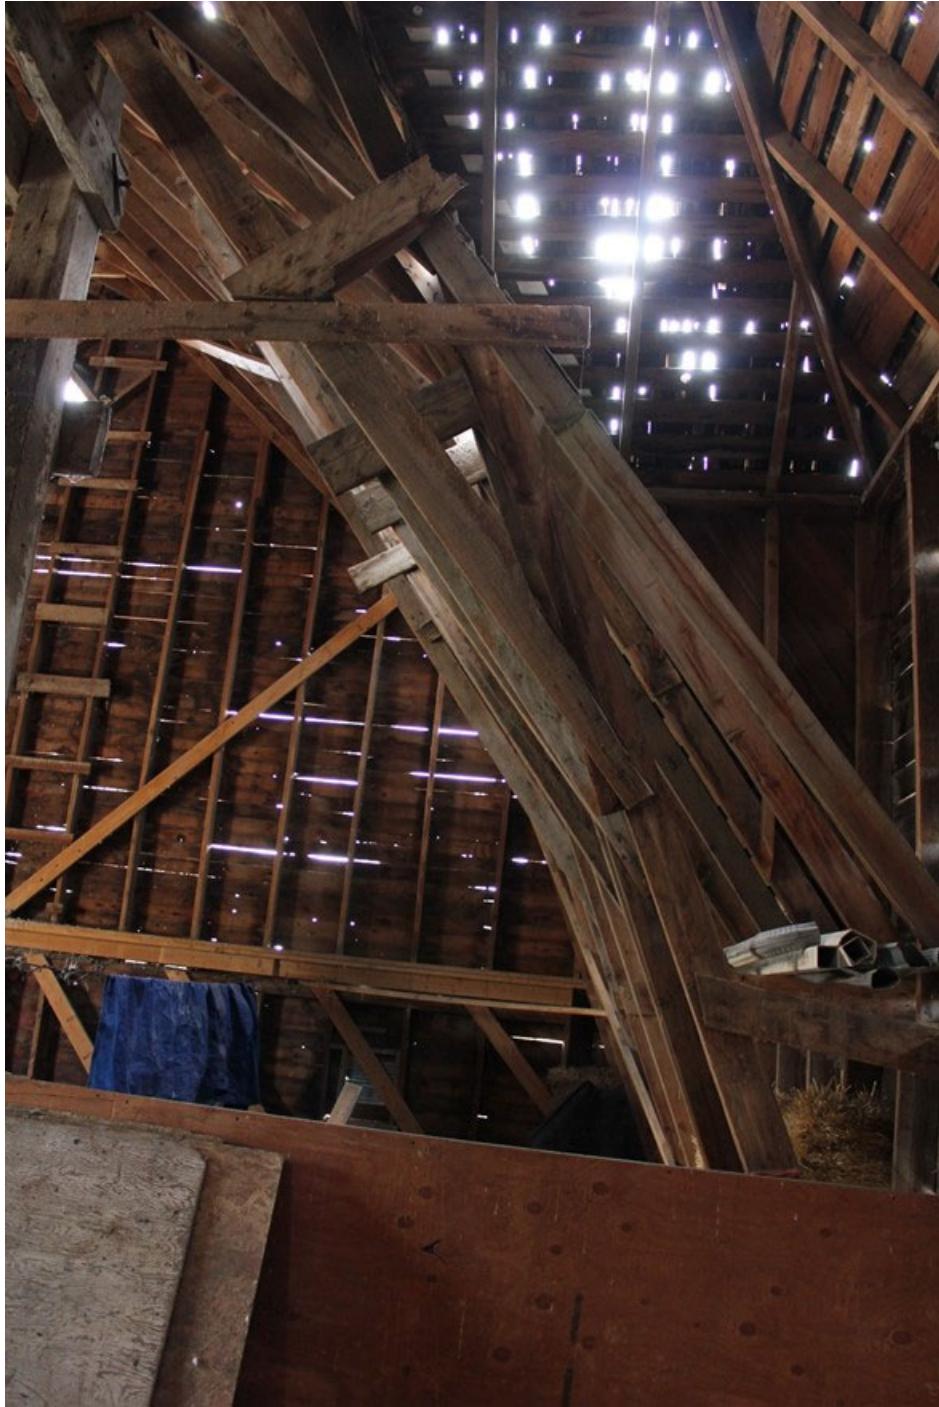
MT_GlacierCounty_RiverViewDairyBarn_0010, Upper level interior, roof structure.

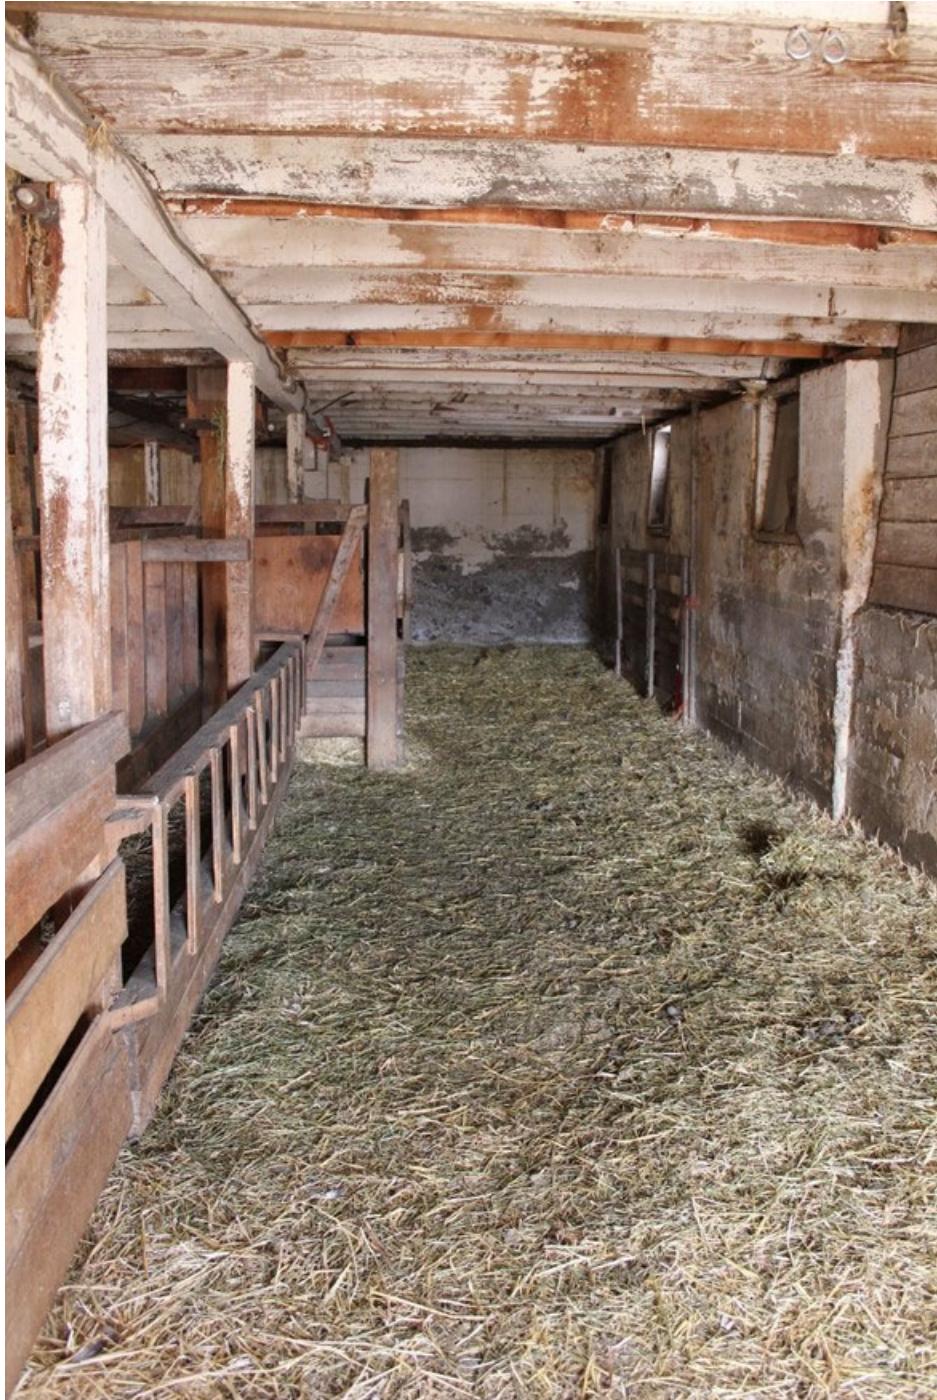
MT_GlacierCounty_RiverViewDairyBarn_0011, Lower level interior.

lower story exhibits a sequence of support posts that underlie horizontal beams that stretch the length of the barn positioned immediately below the ceiling supporting the floor above.

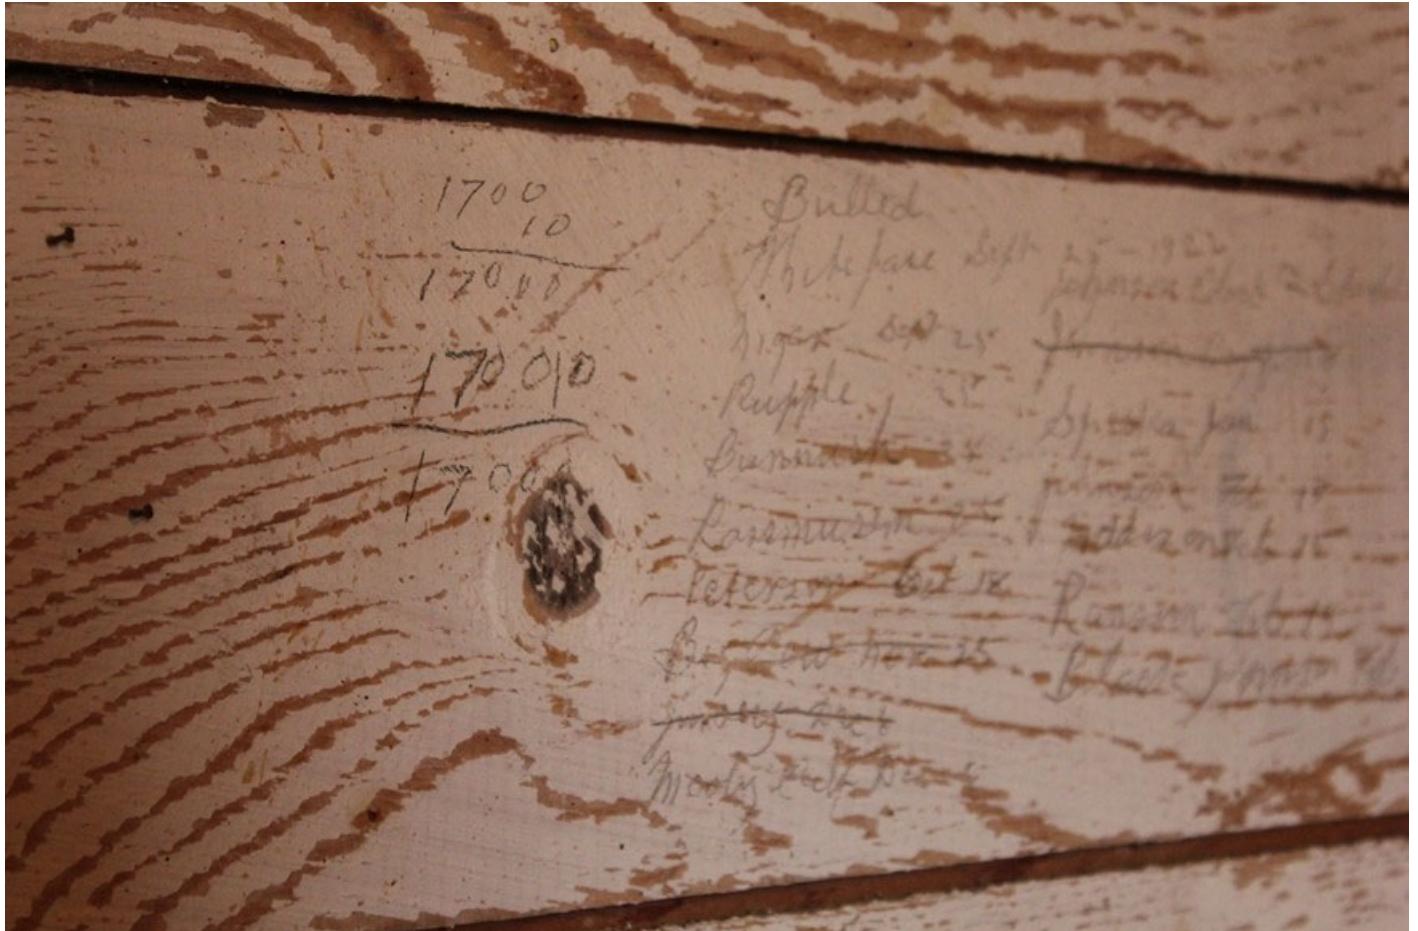
MT_GlacierCounty_RiverViewDairyBarn_0012, Lower level interior image of names of milk cows and the dates they were bulling.

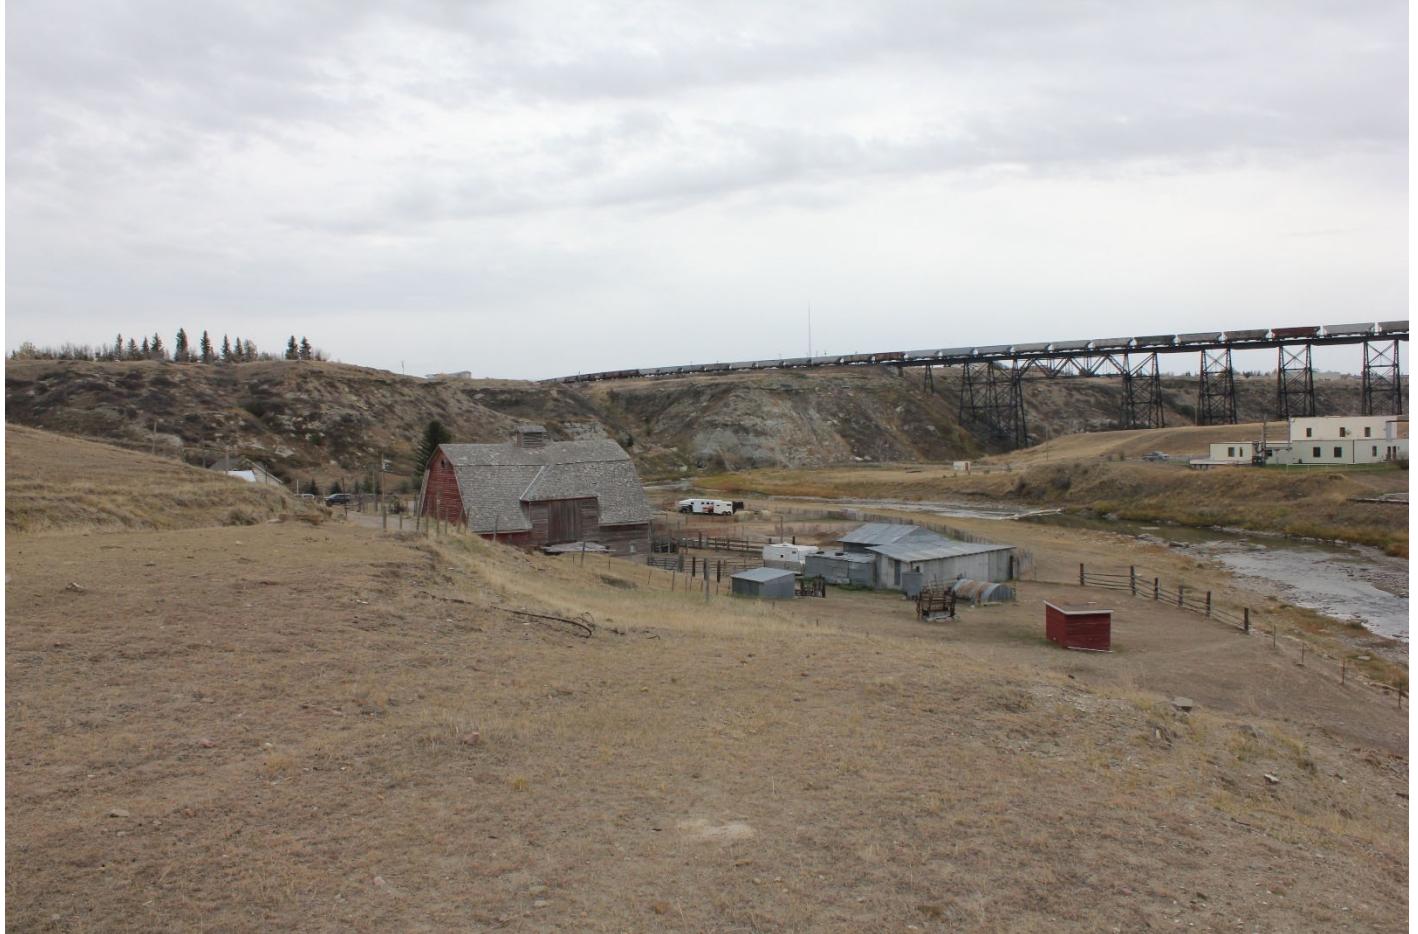
MT_GlacierCounty_RiverViewDairyBarn_0013, Overview of the River View Dairy Barn showing south corral, view to the southeast.
