National Register of Historic Places Registration Form

Historic name: Fort Harrison Veterans' Hospital Historic District

Other names/site number: Fort William Henry Harrison/24LC0123

Street & number: Two Miles Northwest of Helena, MT

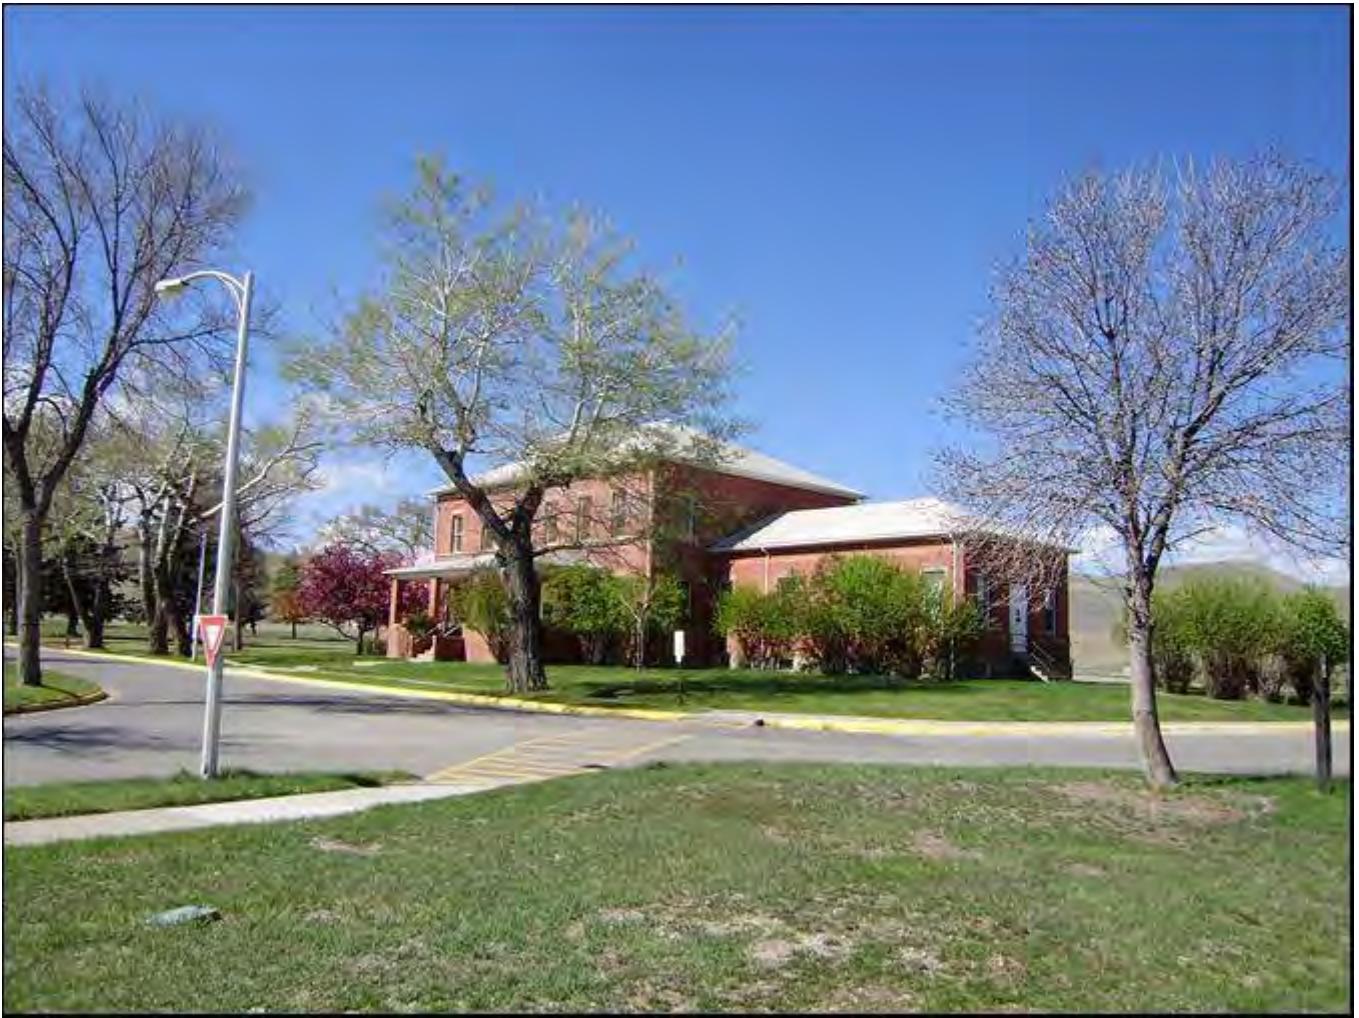
MT_LewisandClarkCounty_FortHarrisonVAHospitalHistoricDistrict_0001. Building 2. View to the southwest.

Building #2 is a 2½ story Late Victorian-style brick building constructed in 1895 that originally functioned as the post hospital. The building is oriented along a northwest to southeast axis and faces northeast onto Liberty Lane and the parade ground. The irregular plan building is covered by a hipped roof sheathed in asphalt shingles with soffits under the eaves. The building sits on a rough-faced stone foundation and has a stone belt course. Rectangular one-story wings attach to the northwest and southeast elevations. Windows throughout are 1/1 double-hung units with stone surrounds and continuous stone sills. A hipped roof dormer with asphalt shingled roofing is slightly offset from center. The walls of the dormer are clad in wood shingles and it features a ribbon window of three 12-light units.

The north wing, comprised of brick, rests on a rubblestone foundation. Stylistic details mimic the main section of the building, including stone lintels and continuous sills and 3-light casement windows in the daylight basement. Windows are also 1/1 double-hung units identical to the main building. A doorway is centrally located on the north elevation and is flanked by modern 2/2 double-hung windows. The doorway is partially in-filled with brick and contains a modern steel door with a single fixed light. The doorway, featuring a stone lintel and a granite sill, is reached by concrete steps flanked by steel railings. Daylight windows pierce the foundation on either side of the steps. The rear facade of the north wing contains four windows on the ground floor and three basement windows. A sealed coal chute pierces the foundation on the right.

The original building mass features six 1/1 double-hung windows on the second floor of the rear facade. A shed roof addition that contains an entry on the north end, projects west off the original building mass. The walls of the addition are comprised of brick and the foundation is concrete. The north-facing doorway, reached by concrete steps and a concrete stoop, holds a metal door. Three fixed single-light windows occur in the addition immediately south of the entry in the west elevation. South of the addition, in the original mass, is a doorway that is located right-of-center on the rear façade; features a flat arch brick lintel and a modern metal door. Concrete steps access it from the south. There are three daylight basement windows with three-light hopper type windows on the rear (west) façade of the main section of the building. A cellar doorway occurs to the north of the main entry doorway. The remains of an exterior brick chimney are situated between the roof of the southeast wing and the main building's roof. A steel fire escape with the steel steps opening to the south attaches to the façade of the original mass.

The southeast wing of the building is structurally and stylistically the same as the northwest addition. It has a hipped roof sheathed in asphalt shingles, brick walls and a stone foundation. Unlike the northwest wing, all windows feature flat brick arched lintels and a continuous stone sill. There are four windows each on the east and west facades, and the doorway is centrally located on the southeast elevation of the wing.

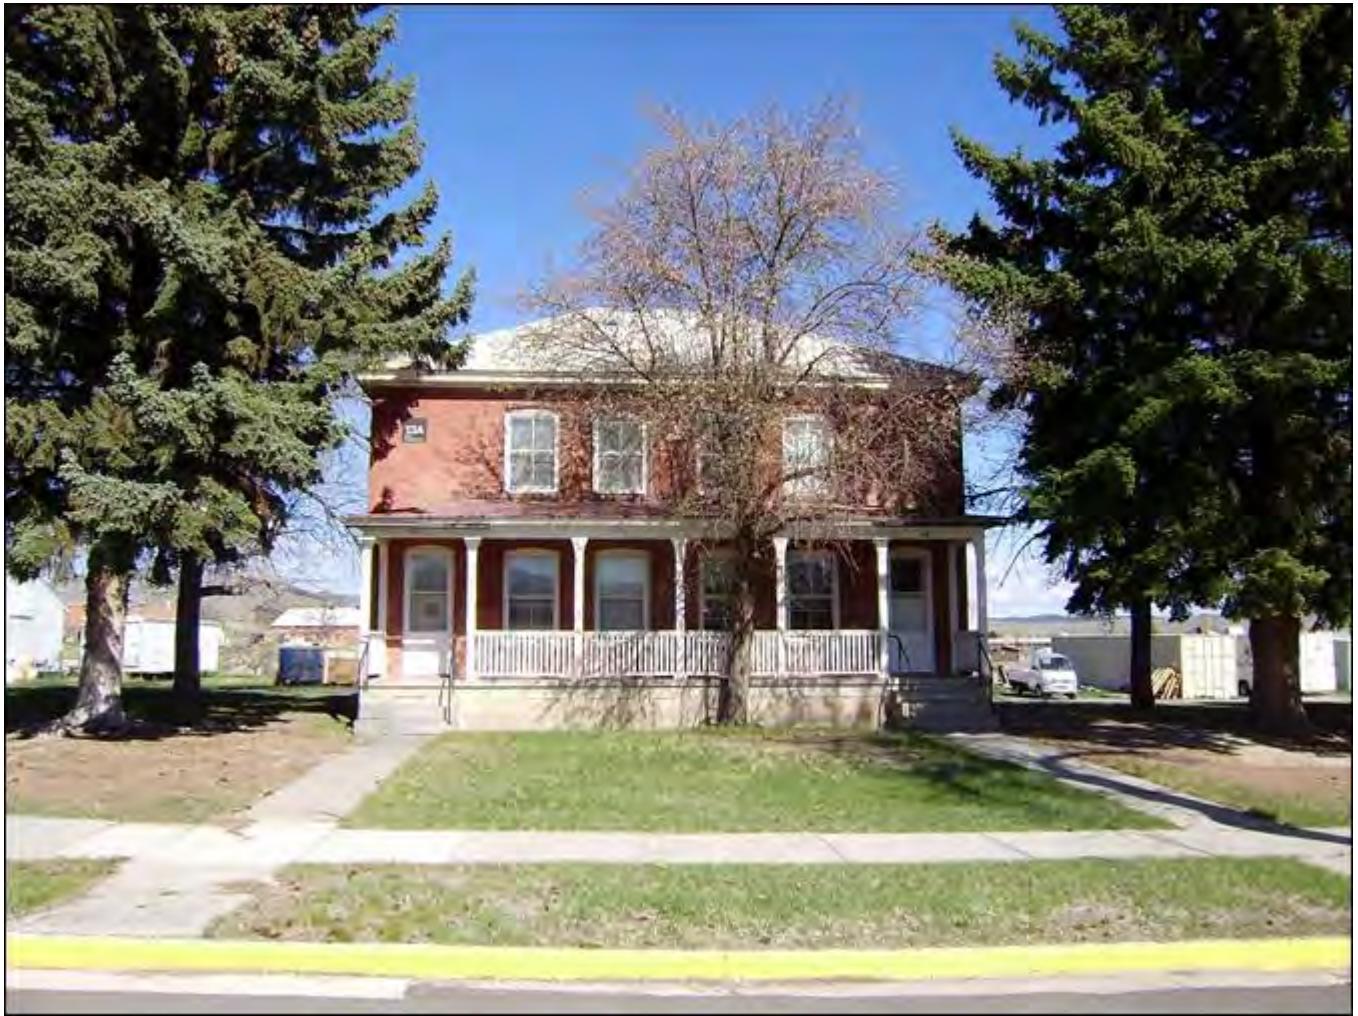
MT_LewisandClarkCounty_FortHarrisonVAHospitalHistoricDistrict_0016. Building 13. View to the west.

Building #13 is a 2-story Colonial Revival-style brick duplex constructed in 1895 that originally served as quarters for non-commissioned officers. The building is oriented along a north-south axis and faces east onto Freedom Lane. The hipped roof is sheathed in asphalt shingles and the overhanging eaves are corniced. The building rests on a rough-faced stone foundation with a cut stone water table and daylight basement. There is an interior brick chimney and window openings on the building have segmental brick arch lintels and granite sills. Windows (except where noted) are 2/2 double-hung. There is a full-width, open-air porch on the facade. It has a hipped roof clad with standing seam metal sheets and is supported by square wood posts. The porch has a concrete deck with decorative recessed concrete panels on the facade and walls. The porch is partially enclosed by a wood spindle railing and is reached by concrete steps with pipe railings. Primary entries on the east facade are located on the north and south ends. Both have wood paneled doors with single fixed lights and metal storm additions. There are four 4/4 double-hung windows located on the facade between the entries; four windows of the same style occur in the second story above these windows.

The north and south elevations feature a single 2/2 double-hung window in both the ground and second story, and two one-light hopper windows in the foundation.

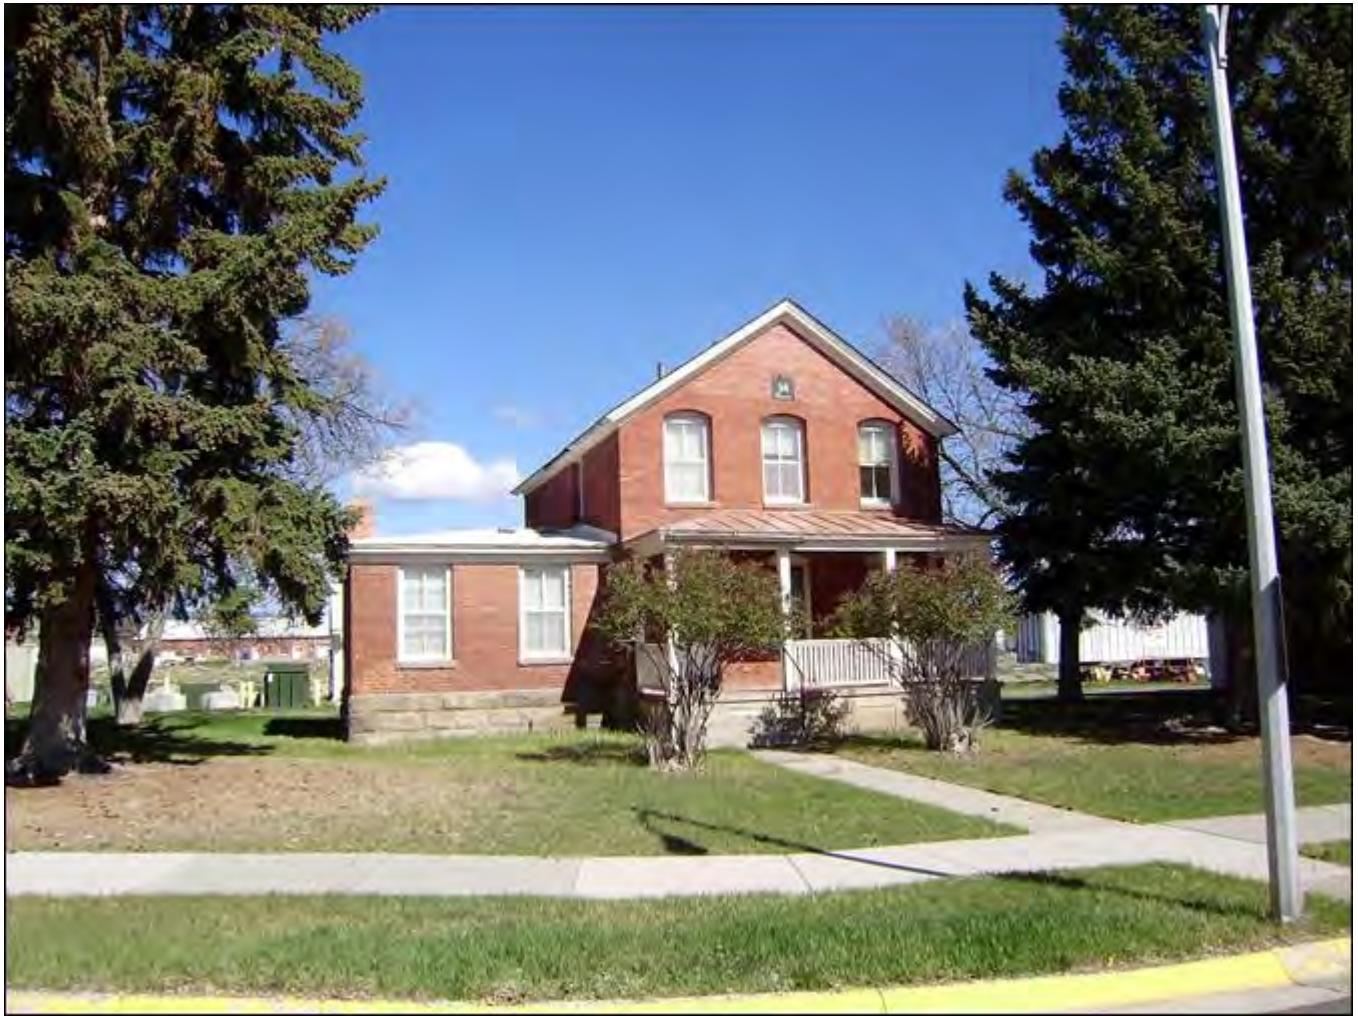
MT_LewisandClarkCounty_FortHarrisonVAHospitalHistoricDistrict_0018. Building 14. View to the west.

Building #14 is a 2-story brick (in a running bond pattern) National Folk Style gable-front-and-wing residence constructed in 1895 that originally served as quarters for stewards employed in the nearby hospital (Building #2). The building is oriented along an east-west axis and faces east. The building sits on a rough-faced granite foundation with a daylight basement. There is one interior brick chimney. All windows on the gable-front section have segmentally arched lintels with dressed stone sills. Windows are 2/2 wood double-hung. There are three window openings on the second floor facade. There is a full-width, open-air porch on the facade. It has a hipped roof covered in standing seam sheet metal. The porch foundation is concrete with concrete sheet veneer with recessed panels. The porch is reached by concrete steps located on the south end and the roof is supported by square wood posts; it is partially enclosed by spindle railing. There are two window openings adjacent to the doorway on the north.

A full-width wood frame entry addition attaches to the rear (west) facade. It has a hipped roof clad in standing seam sheet metal and rests on a stone pier foundation. The walls are clad in vertical tongue-and-groove siding. A doorway is centrally located on the rear facade and has a wood paneled door with a modern storm addition; it is reached by wood steps. There are single 4-light casement windows centrally located on the north and south elevations of the wood frame addition.

A window opening is located on the second floor of the south elevation. A one-story wing is attached to the south elevation directly below. It has a low-sloped hipped roof; the foundation is rough-faced stone. The east elevation contains two 2/2 double-hung units. A single 2/2 window occurs in the west elevation. None of the windows on the wing addition have segmental arches.

Integrity: The building is structurally identical to its neighbor to the north (Building #41). The Hospital Stewards Quarters was constructed in 1895 and appears in vintage photographs of the period. It is a simple gable-front and wing residence that served as quarters for army hospital stewards from 1895 until 1919 when it then housed medical staff at the hospital. Stylistically it is similar in design to other buildings on the post and includes the standard red brick walls, decorative window openings, front porch, and stone foundation with a daylight basement. There do not appear to have been any substantial changes made to the exterior of the building, except for the treatment of the rear porch addition (whose construction date is unknown).

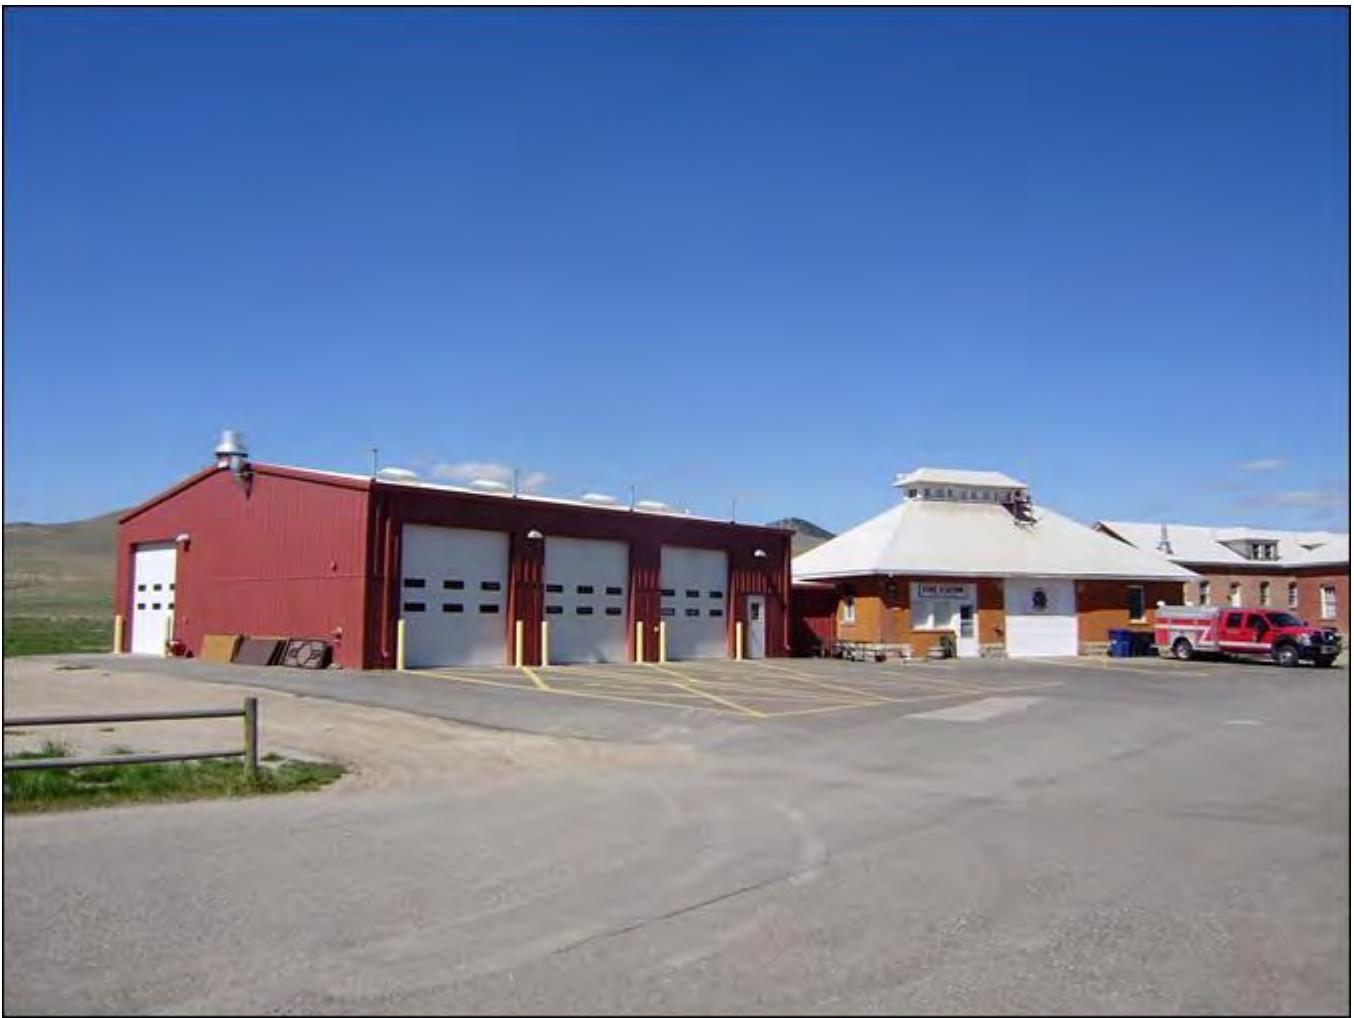
MT_LewisandClarkCounty_FortHarrisonVAHospitalHistoricDistrict_0020. Building 16. View to the NNW.

The Bakery (Building #16) is a 1-story brick No-Style building that was constructed in 1895 and has served as the VA hospital's fire station since 1945. The building is oriented along a north-south axis and faces east. A recently erected (2009) garage is attached to the bakery section on the south. The bakery/fire station is located across a gulch to the west of the main complex. The bakery building rests on a rough-faced stone foundation with a granite water table. The building has a hipped roof topped with a monitor with clerestory windows; the monitor displays boxed-in

A doorway with a wood door and modern storm addition is centrally located on the north elevation. The doorway is flanked by 1/1 double-hung windows that may be original to the structure. A shed roof brick addition attaches to the rear, south elevation, façade covering the entire length of the facade. The addition rests on a concrete foundation. A ribbon of three paired two-light units spans the north half of the addition. A 4/4 double-hung window is centrally located on the south elevation. It appears to have been removed from the main building and incorporated into the addition when the addition was added in 1973. The upper section of the window is currently covered with a sheet of plywood. A doorway into the addition occurs on the addition's north elevation; it contains a metal door.

Integrity: The Bakery/Fire Station was constructed in 1895 and is associated with the initial period of development at Fort Harrison by the military and then as a fire station by the VA. The bakery was an important part of the day-to-day operation of the post and it remained in use as a bakery until 1936 when a new kitchen and dining hall was built on the campus. The VA converted the building for use as a fire station in 1945. That change in use resulted in significant changes to the building, including the installation of a large bay doorway, changes to the facade of the building, the replacement of the windows, and an addition at the rear of the building. Based on those changes, the building only presents its basic historic appearance on the roof with the monitor roof, the original brick walls, and the historic footprint of the building. The most significant modifications to the bakery occurred during the historic period and reflect the adaptive reuse of the building. While the changes detract from the original appearance of the bakery, enough of the original features along with the modifications in 1945 have maintained the significance of the building to the history of Fort Harrison. The equipment garage was added to

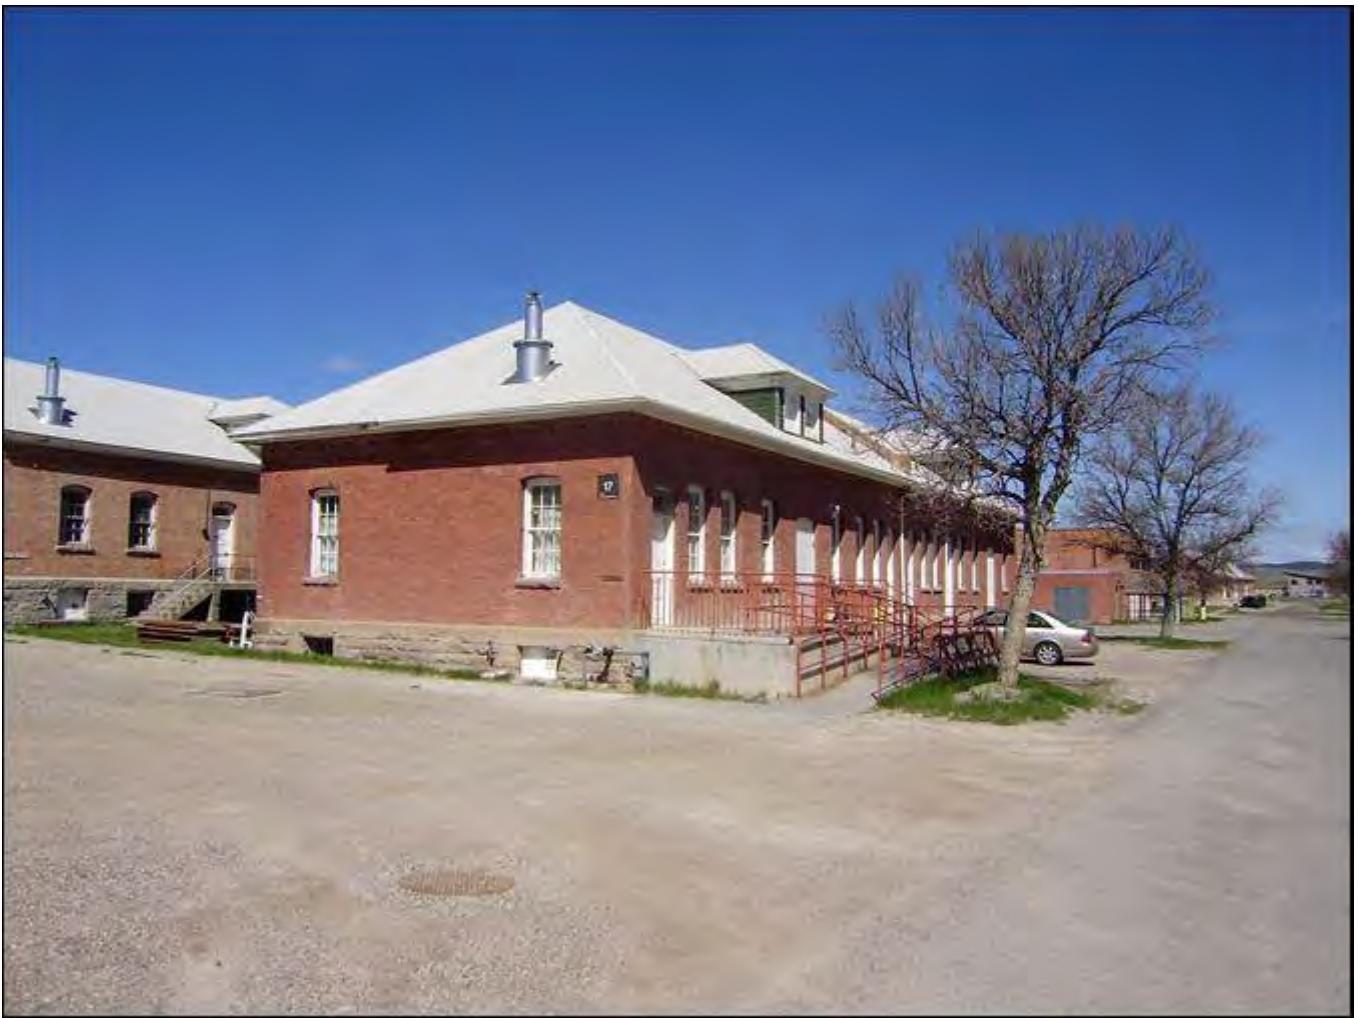
MT_LewisandClarkCounty_FortHarrisonVAHospitalHistoricDistrict_0023. Building 17. View to the NNW.

The Quartermaster's Commissary Warehouse (Building #17) is a No-Style brick building that was constructed in 1895. It is oriented along a north-south axis and faces east. A hipped roof covers a rectangular plan. A corbelled and stepped parapet interior fire wall is exposed on the front and rear facades as it penetrates the roof and divides the building into two halves to protect against the spread of fire. The building sits on rough-faced stone foundation with a finished stone water table and a daylight basement. The basement windows have 3-light casement windows fitted with iron bars. There are two dormers located on the north and south of the east facade. Both have hipped roofs, wide friezes, and brackets with the walls clad in asphalt shingles. Two window openings occur in each dormer; all are boarded over. All 11 windows on the ground floor have segmental brick arch lintels and stone sills. All windows are 6/6 double-hung. Six doorways exist on the façade with four holding tongue-and-groove doors with wood exterior braces. The doorway on the extreme north is boarded over with tongue-in-groove siding. The sixth doorway, located in the southern portion of the elevation, contains a modern metal door. Four of the six doorways feature 3-light transoms; the transoms of the remaining two doors are boarded over. The south doorway on the façade has metal bars over the transom. Modern concrete steps and a loading ramp lead to the south two doorways.

The north elevation holds a single window on the east and west sides of the elevation and a cellar doorway pierces the foundation on the east side. The cellar doorway is reached by concrete steps; the doorway holds a metal door. A basement window on the west side of the elevation has been in-filled.

Integrity: The Quartermaster's Commissary Warehouse (Building #17) was constructed in 1895 and is associated with the military's initial phase of development at Fort Harrison. It served a critical function to the well-being of the post by storing supplies for use by the troops stationed there. It is architecturally similar to other contemporary buildings at the post and includes brick walls, stone foundation, and decorative window openings. The barred windows also betray the

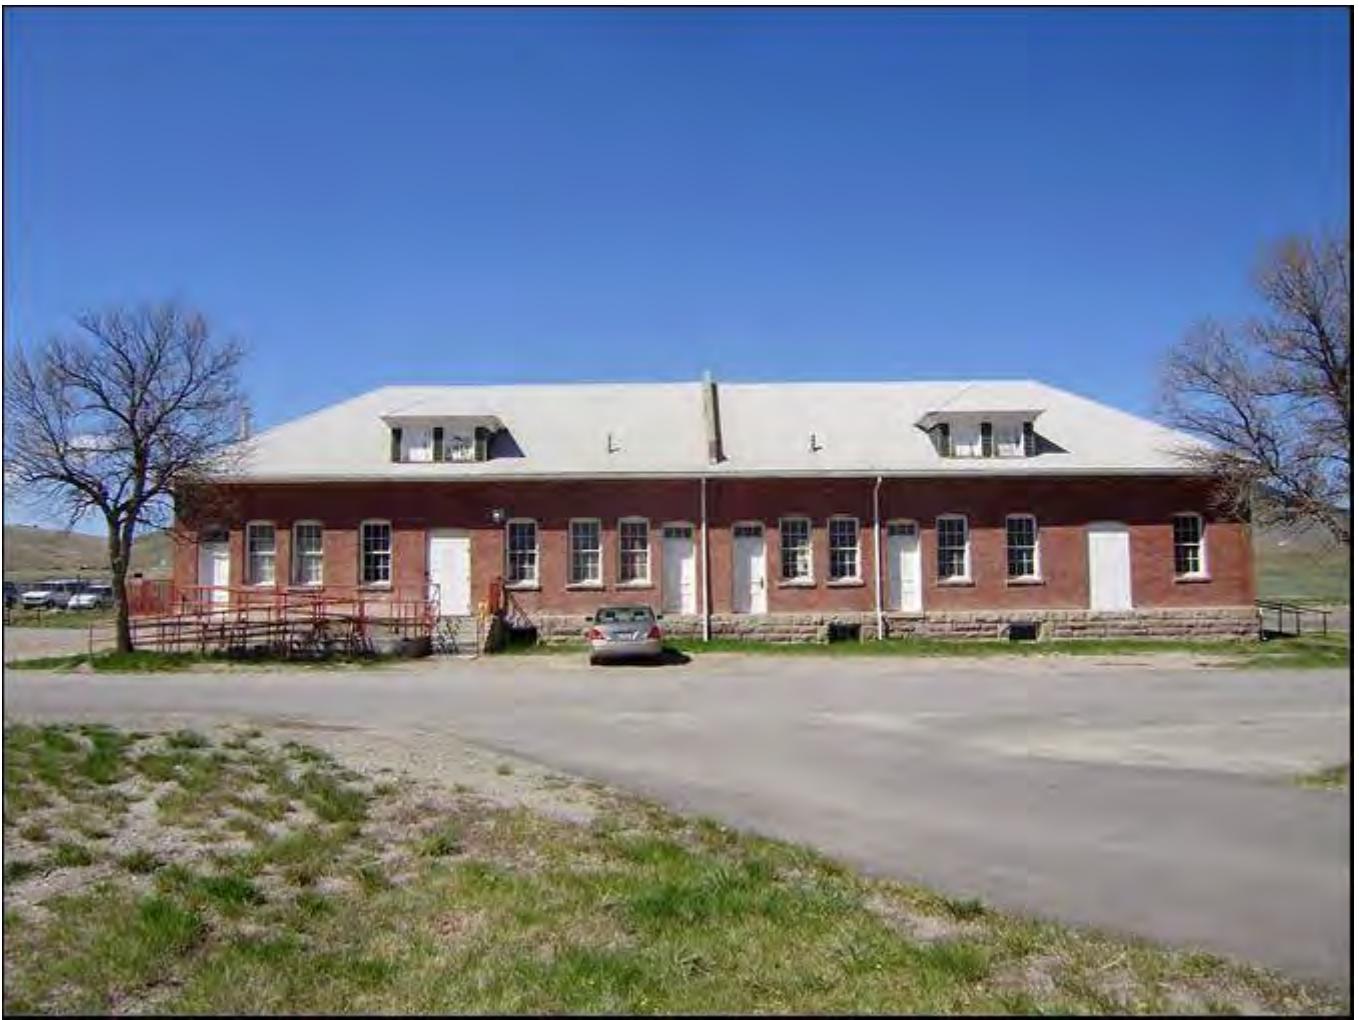
MT_LewisandClarkCounty_FortHarrisonVAHospitalHistoricDistrict_0024. Building 17. View to the west.

Two dormers on the west roof slope are stylistically identical to the dormers on the east elevation. Doorways exist on the north and south ends of the west elevation. The doorway on the south is boarded over. The north doorway still holds the original tongue-in-groove door with exterior braces. Both doorways have granite sills. There are single windows on the north and south of the facade and two sets of a ribbon of three windows central to the facade. The foundation features eight barred basement windows.

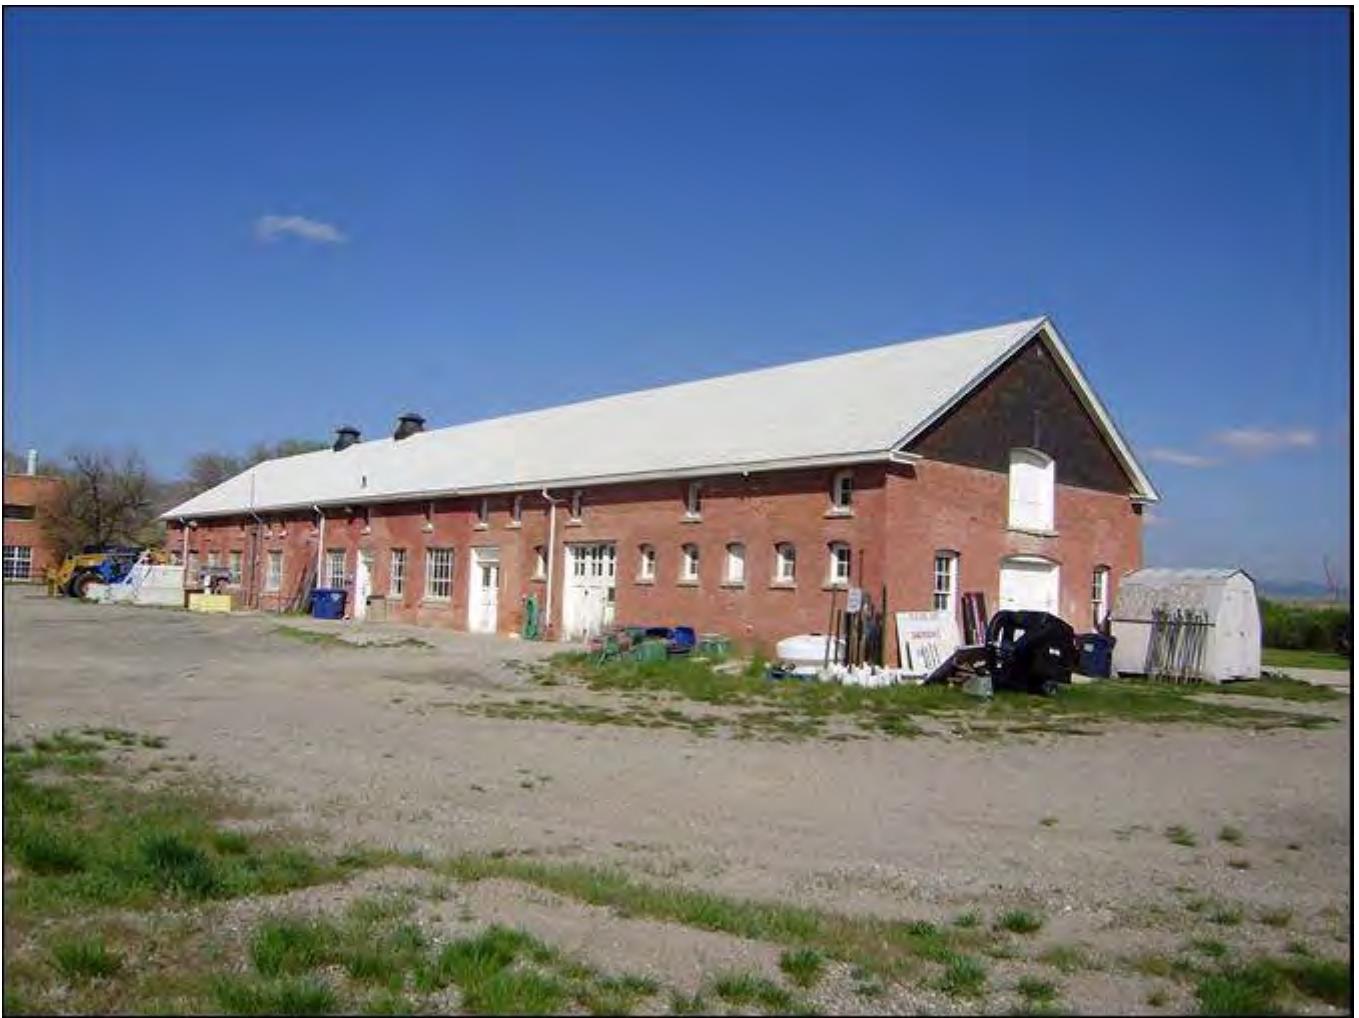
MT_LewisandClarkCounty_FortHarrisonVAHospitalHistoricDistrict_0026. Building 20. View to the northwest.

The Stable/Laundry (Building #20) is a 1½ story No-Style brick building constructed in 1895. It has a T-shaped plan covered by an intersecting gable roof. The building is oriented along an east-west axis with the leg of the "T" oriented along a north-south axis. The building rests on a rubblestone foundation with a granite water table only visible on the north elevation. The gable-ends feature partially returned eaves with pressed tin cladding the gables. Slightly arched loft doorways contain double wooden doors in all the gables.

The north elevation of the east-west mass west of the juncture with the north projection contains three 15-light casement windows near the junction; above these windows are two fixed 4-light windows and below are four fixed 4-light windows on the ground level. The east portion of the north elevation east of the north projection contains three 15-light casement windows, a 16-light casement, and eight fixed 4-light windows on the ground level; six fixed 4-light windows are above. Considerable evidence of damage to the east-west segment of the building by the October 1935 earthquakes is visible. There are large sections displaying brick repair after the 1935 earthquakes returning the building to its pre-1935 appearance.

The east elevation of the north projection also shows evidence of damage caused by the 1935 earthquakes, including repaired brick and steel bolts and plates reinforcing the walls. The wall features five fixed four-light windows across the upper wall and twelve fixed four-light windows on ground level with one 15-light casement window on the north end. The west elevation of the
